STAR ONLINE PUBLICATION

Case Number: S2018000007

Symptom/Vehicle Issue: Diagnostic Trouble Code (DTC) P0299 – Turbocharger Underboost Additional Diagnostics

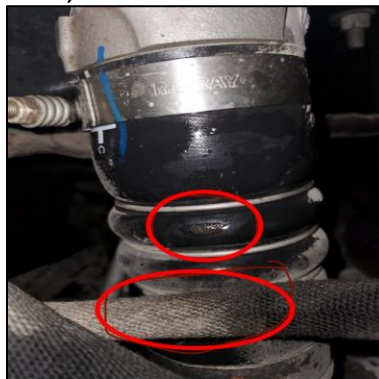
Figure 1

1. Ensure that the Charge Air Cooler (CAC) system is properly pressure tested per the steps outlined in Service Library Service Information Section 09 – Engine, 6.7L Diesel > Turbocharger System > Diagnosis and Testing – Leaks. While performing the CAC leak testing, pay close attention to the CAC boot connected to the turbo outlet for leaks possibly caused by potential wire harness rub through. Please see (Figure 1).

2. If the boot is found damaged, replace as necessary, and retest the CAC system for any additional leaks. Repair as necessary.
3. Remove the EGR Crossover tube from the EGR valve, and inspect the EGR inlet to see if there are signs that the valve internal seat has begun to rotate. Please see (Figure 2). The EGR internal shaft should be completely visible when looking into the crossover tube inlet.

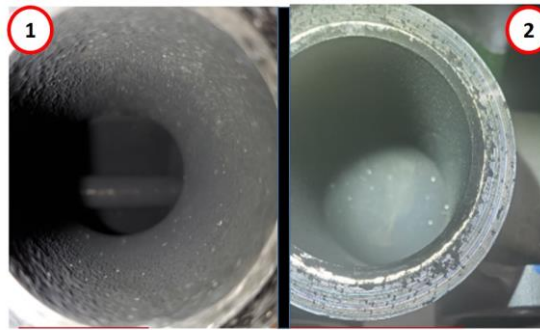
Figure 2

1. Healthy part
2. EGR with rotated seat
