STAR ONLINE PUBLICATION

Case Number: S2023000033

Symptom/Vehicle Issue: Fuel Door Button Inoperative Or Sticking

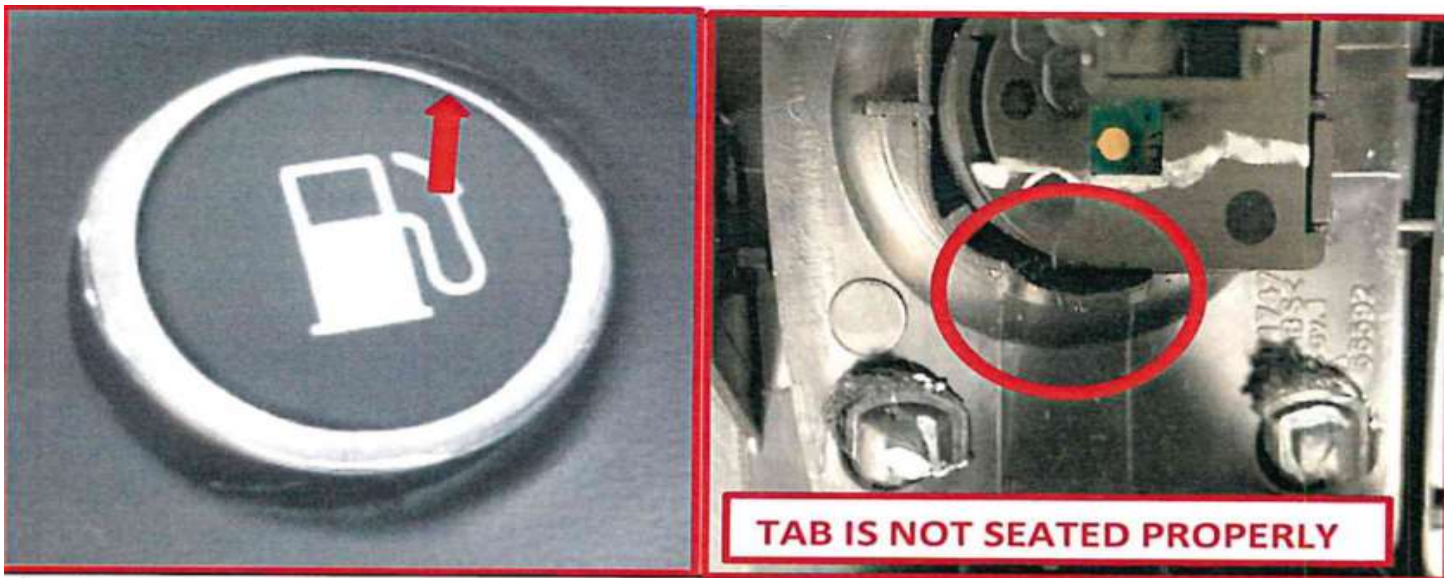
Fig 1

Discussion: The button for the fuel door release should be centered in the knee blocker panel (fig 2). If it is not inspect the switch for being fully seated in the knee blocker panel (fig 1). Locking tabs should fully engage the panel. Remove and reinstall the switch. If the locking tab(s) are not able to be fully seated, do not replace the switch. Replace the knee blocker panel.

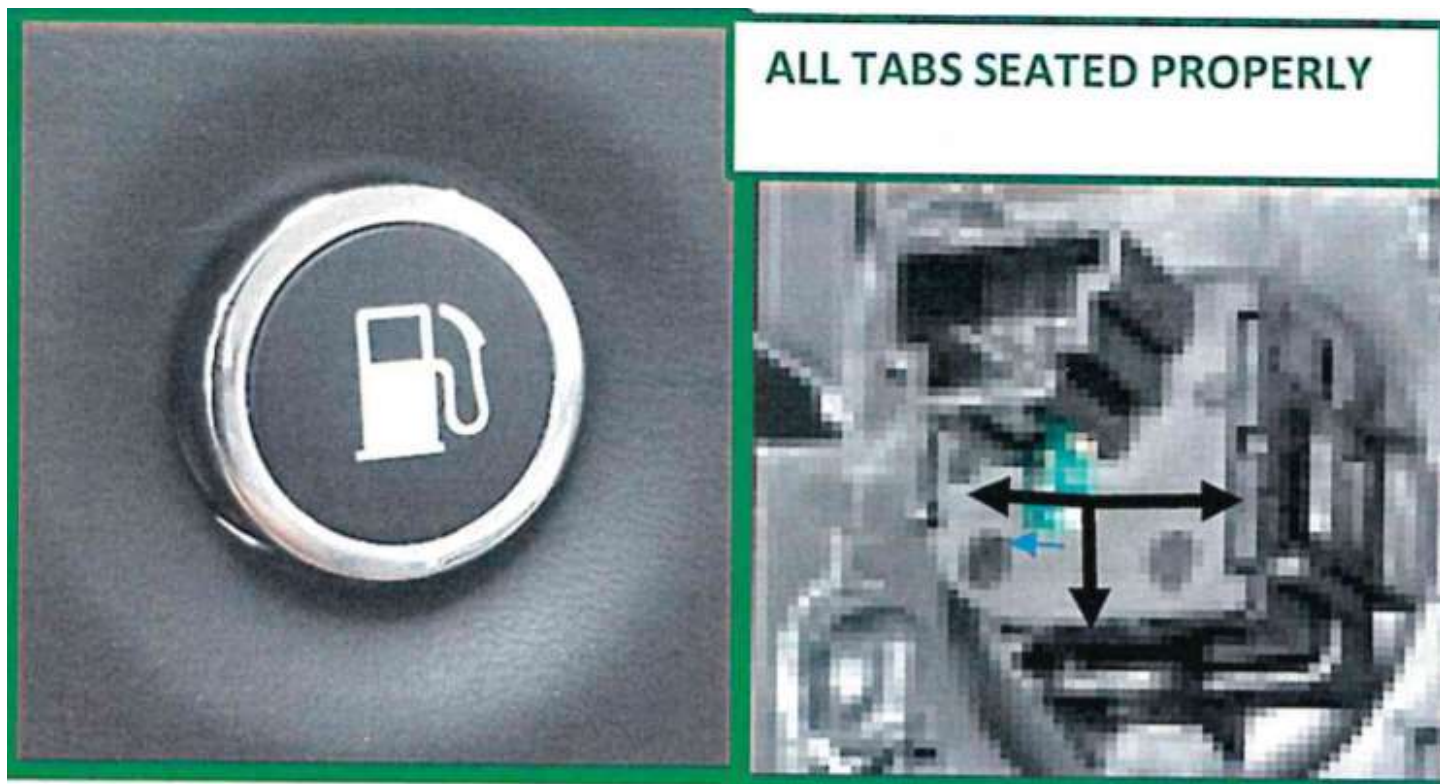
Fig 2 properly installed.
