**NUMBER:** 21-038-20

Transmission Case Oil Leak

2019 (K8) Jeep Grand Commander (China)

**NOTE:** This bulletin applies to vehicles equipped with a 9-SPD 948TE FWD/AWD Auto Transmission (Sales Code DFH).

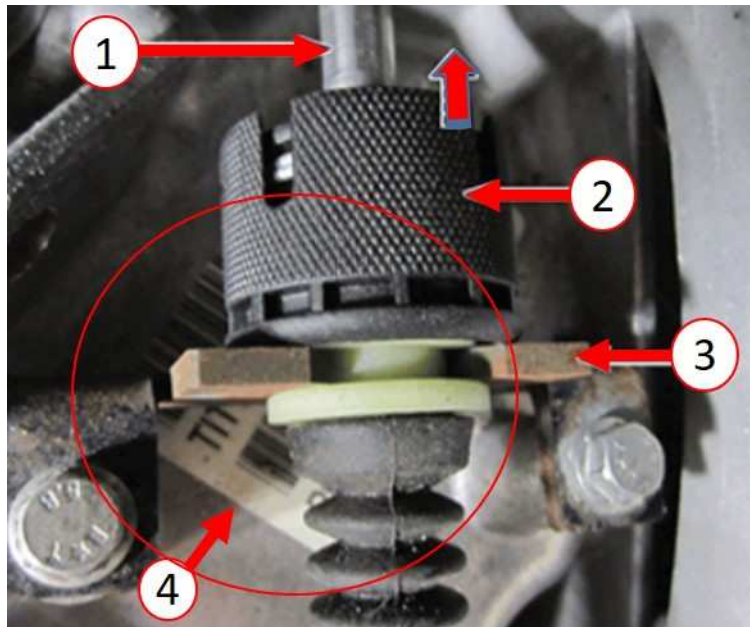
**Fig. 1**  
**(Reference Picture) for Transmission Tag Location**

1. Inspect the transmission tag located under the shifter cable, for the plant code and build date (Fig. 1) .

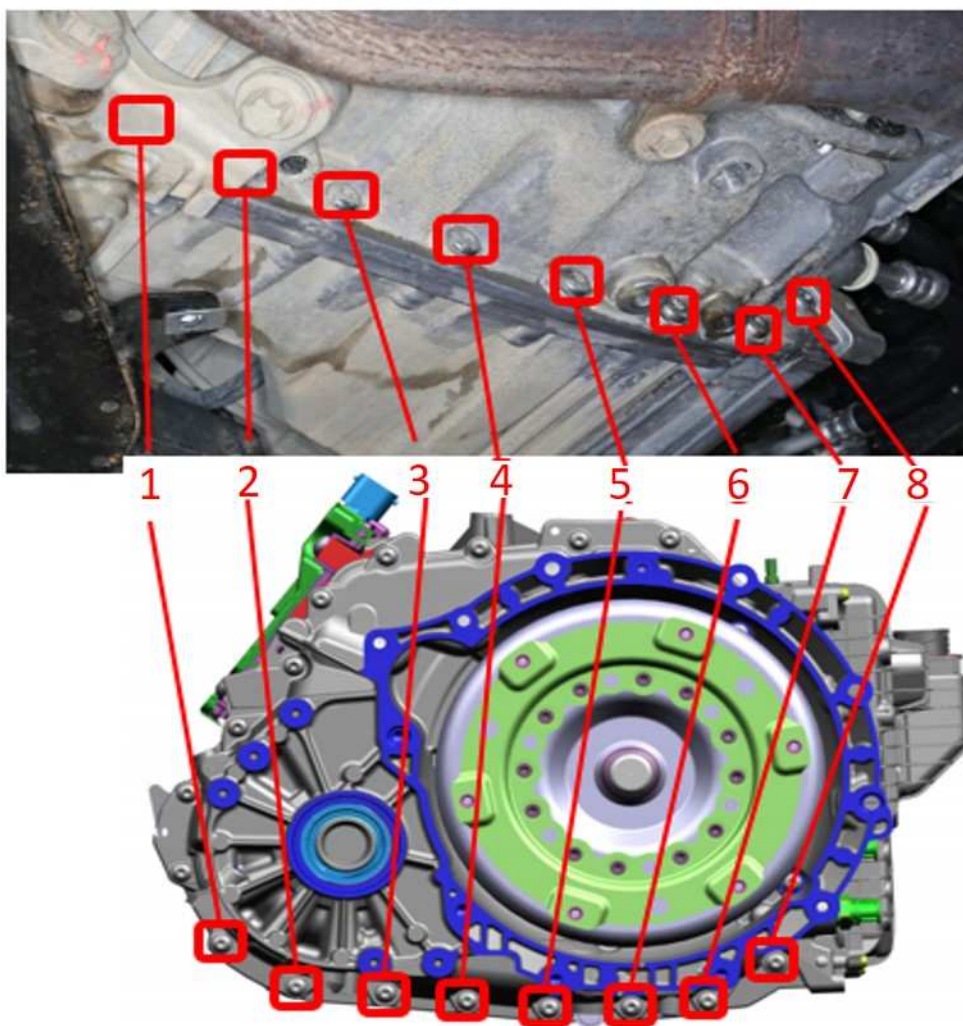
Fig. 4

(Reference Picture) Eight Bolts to be Torqued to Specifications at Potential Leak Area at the Case Split

3. Starting at bolt #8 and then working to bolt #1, torque bolts to 35 N·m (26 ft. lbs.) (Fig. 4) .

**CAUTION! Do not rotate the bolts counter clockwise.**
