NUMBER: 23-018-20

Active Head Restraint (AHR) Inadvertent Deployment - X88 Warranty Extension

2014 - 2015 (WD) Dodge Durango

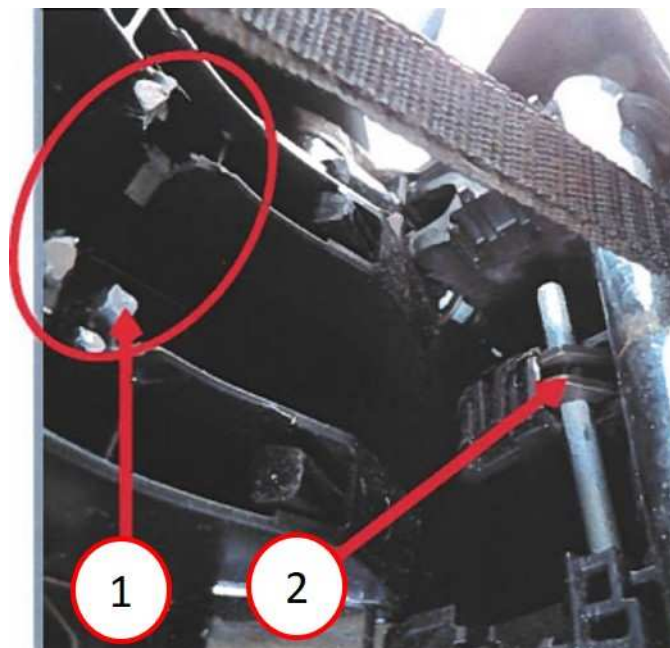
Fig. 1

- The AHR has inadvertently deployed (Fig. 1) and (Fig. 2) on one or both front seats and will not reset.

Inadvertent Deployed Position AHR

- 1 - Sled Fractured And Pin In Latch
- 2 - Pin Fastened To Sled

1. Attempt to reset the front AHR. Refer to the detailed procedures available in DealerCONNECT > Service Library> under: 10 - Restraints/Restraint, Active Head/Standard Procedure Standard Procedure - Active Head Restraint Reset.
2. Did the front AHR reset?
 - YES>>> This bulletin has been completed, use reset LOP (23-20-48-95) to close the bulletin.
 - NO>>> Proceed to [Step 3](#) of the Repair Procedure.
3. Replace the AHR. Refer to the detailed procedures available in DealerCONNECT > Service Library> under: 23 - Body/Seats/Headrest, Front/Removal/Installation.

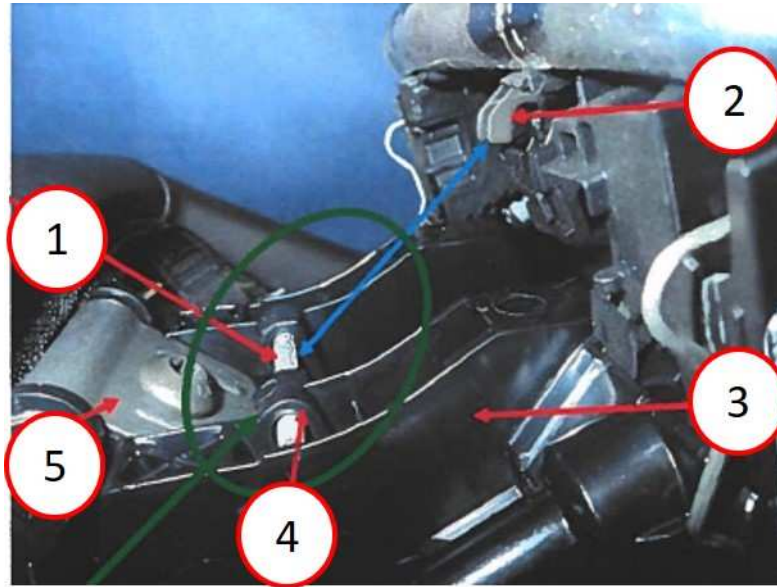
Fig. 2
Normal Deployed Position AHR

- 1 - Striker Pin
- 2 - Latch Pawls
- 3 - Sled
- 4 - Sled Bracket
- 5 - Tilt Clip
