NUMBER: 09-009-20

Improperly Installed Exhaust Gas Recirculation (EGR) Valve

2018 - 2019 (DS) RAM 1500 Pickup

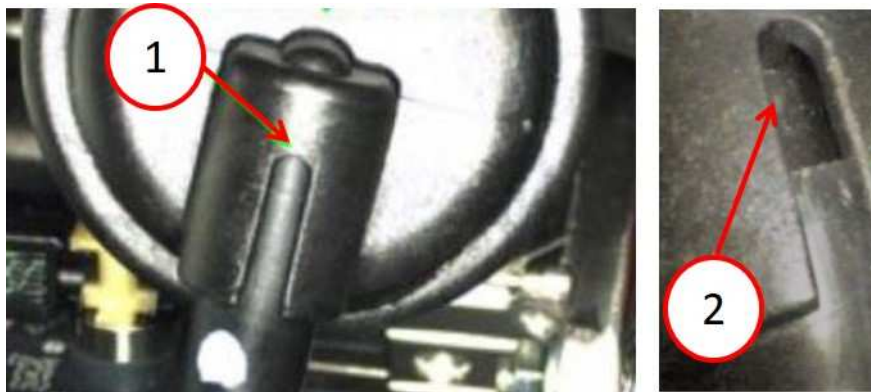
Fig. 2
No Gap And Gap Shown On

3. Inspect the vacuum tube is fully seated in the vacuum actuator and there is no gap present (Fig. 2) .

- 1 - Vacuum Tube Fully Seated (No Gap Present) In The Vacuum Actuator
2 - Vacuum Tube Not Fully Seated (Gap Is Present) In The Vacuum Actuator
-

NOTE: To ensure the vacuum hose is fully seated on the vacuum actuator, a soapy water solution may be used to facilitate fully seating the vacuum hose on the vacuum actuator. Ensure components are dry afterwards if soapy water is used.

4. Is the vacuum tube fully seated in the vacuum actuator (Fig. 3) ?
- YES >>> Proceed to [Step 5](#) of the Diagnostic Procedure.
 - NO >>> Fully seat the vacuum tube on the vacuum actuator. Proceed to [Step 5](#) of the Diagnostic Procedure.

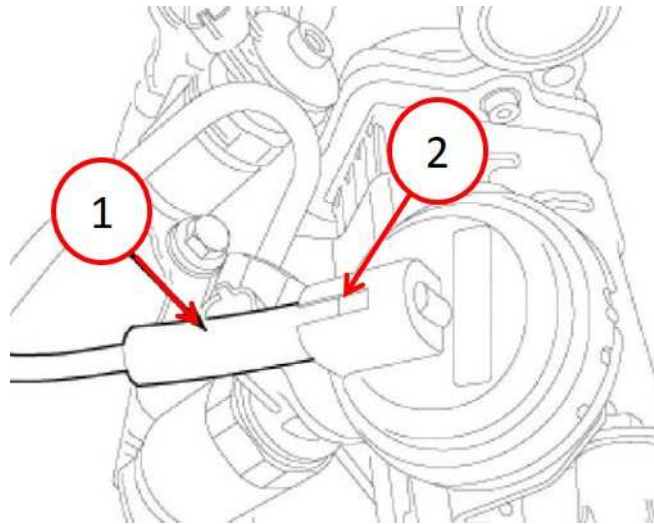
Fig. 3
Vacuum Tube And Vacuum Actuator

- 1 - Vacuum Tube
2 - Vacuum Actuator
-

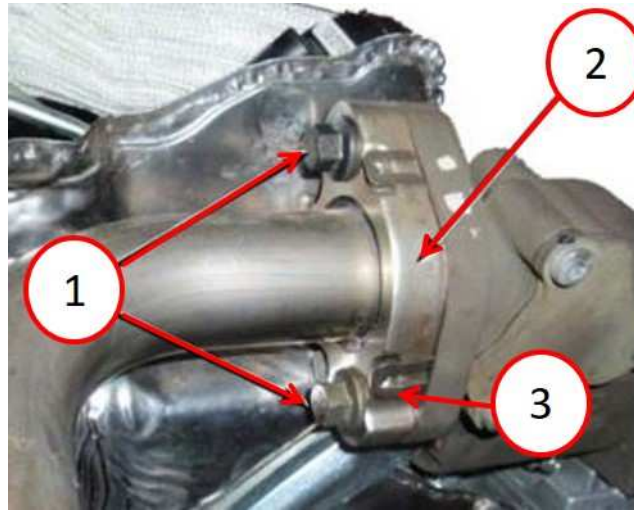
Fig. 4

5. Inspect both the upper and lower EGR tube gaskets (inlet – from turbo/outlet – to intake) that are mated to the EGR valve and that all gasket tabs showing on the **exterior of the tube flange** (Fig. 4) .
Also inspect that all upper and lower EGR tube flange bolts are tight (Fig. 4) .

Example Of Lower Tube Flange Bolts, Flange And Gasket Tabs (Upper Tube Similar)

- 1 - Lower Tube Flange Bolts
- 2 - Lower Tube Flange
- 3 - Gasket Tabs Shown Properly Installed On Exterior Of Flange

6. Is the either upper or lower EGR tube gasket damaged, missing, gasket flange tabs not showing or the flange bolts loose?
 - YES >>> Proceed to [Step 1](#) of the Repair Procedure.
 - NO >>> Proceed to [Step 7](#) of the Diagnostic Procedure.
 7. Re-torque all the tube flange bolts to 25 N·m (18 ft. lbs.).
 8. Install the fuel injector silencer and engine cover. Refer to the detailed service procedures available in DealerCONNECT/Service Library under: 09 - Engine, 3.0L Turbo Diesel/Cover, Engine/Installation.
- This bulletin has been completed, use inspection LOP (25-01-43-90) to close the active RRT.

NOTE: If the EGR tube flange bolts appear tight, it is recommended all flange bolts be re-torqued.

3. Clean surface and install the upper EGR intake air tube using a new tube to EGR gasket, with gasket tabs bent over on the exterior of the flange ([Fig. 4](#)) . Refer to the detailed service procedures available in DealerCONNECT/Service Library under: Service Info>25 - Emissions Control/Exhaust Gas Recirculation, Diesel/Tube, Exhaust Gas Recirculation (EGR)/Installation.

7. Remove the two bolts holding the lower EGR tube to the EGR valve.
8. Carefully pull the lower EGR tube away from EGR valve and discard the gasket.
9. Clean surface and install the lower EGR tube using a new tube to EGR gasket, with gasket tabs bent over on the exterior of the flange (Fig. 4) .
10. Install the EGR tube bolts and tighten the bolts to 25 N·m (18 ft. lbs.).
11. Install the fuel injector silencer (Fig. 6) .
12. Install the intake air tube. Refer to the detailed service procedures available in DealerCONNECT/Service Library under: Service Info>09 - Engine, 3.0L Turbo Diesel/Air Intake System/Tube, Intake Air/Installation.
13. Install the engine cover. Refer to the detailed service procedures available in DealerCONNECT/Service Library under: 09 - Engine, 3.0L Turbo Diesel/Cover, Engine/Installation.
14. Using the wiTECH 2, clear all DTCs that may have been set.

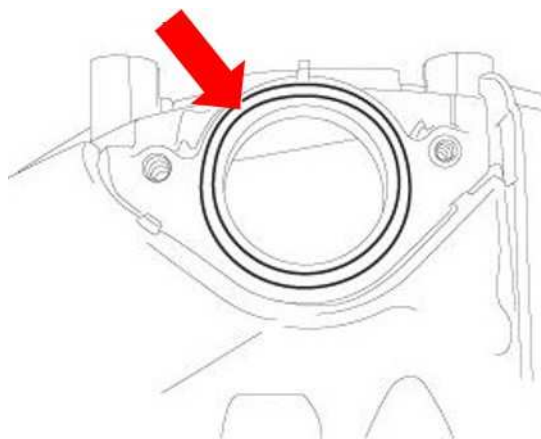
Fig. 5

Re-Use Rubber Upper Tube To Intake Gasket

NOTE: Do not discard the rubber upper tube to intake gasket (Fig. 5) . This rubber gasket is to be re-used.
