**NUMBER:** 18-051-20

P00C0-00 Turbocharger-Supercharger Bypass Valve 2 Control Circuit

2017-2019 (GA) Alfa Romeo Giulia

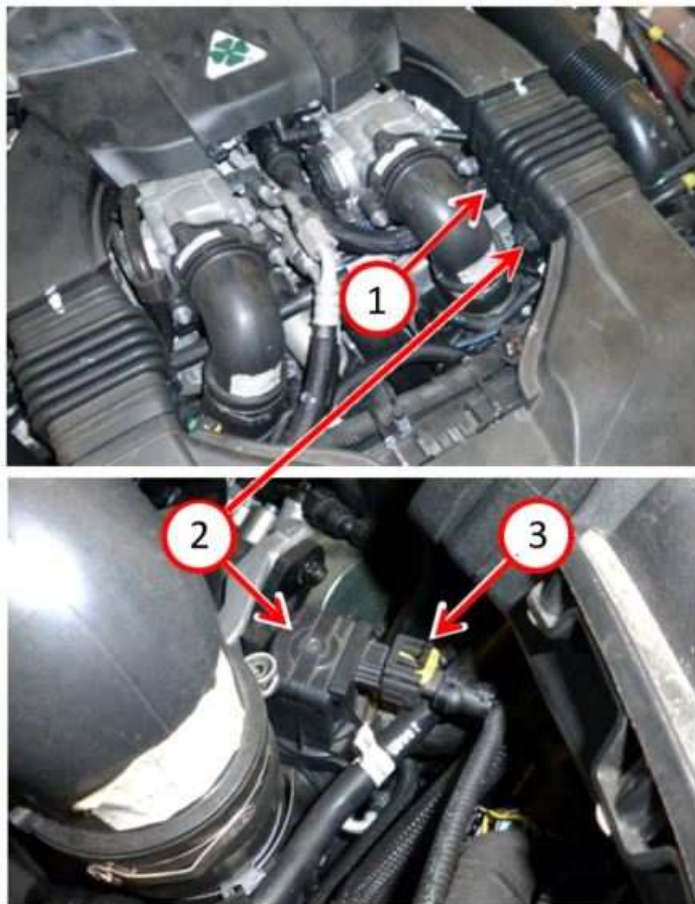
**Fig. 1****By-pass Valve and Connector Location**

1. Remove the left fresh air intake duct and inspect for any damage to the By-pass valve connector (Fig. 1) .
2. Was the connector damaged?
  - YES >>> Replace the connector. Proceed to [Step 3](#)
  - NO >>> This bulletin does not pertain. Normal diagnostic need to be performed.

3. Disconnect the By-pass valve connector.
4. Remove the wires from the plastic sleeve, cut the wires and remove the old damaged connector.
5. Splice the new connector (68369901AA) wires onto the main harness. Refer to the detailed service procedures available in DealerCONNECT> Service Library under: 29 - Non-DTC Diagnostics / Circuit Testing Procedures / Standard Procedure
6. Put the new connector wires back into the protective sleeve and connect the new connector to the By-pass valve.
