**NUMBER:** 23-019-20

Right Front Tire Rubbing on Wheel Well Liner

2019 - 2020 (LA) Dodge Challenger

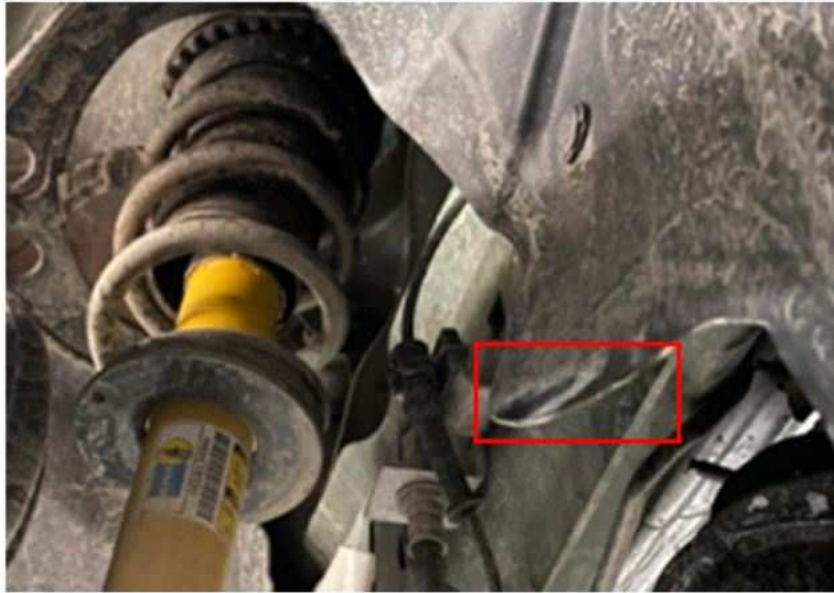
Fig. 1

- A rubbing noise in the right front when make hard left turns.

2. Raise the vehicle on a hoist. Refer to the detailed service procedures available in DealerCONNECT/Service Library under: 04 - Vehicle Quick Reference / Hoisting / Standard Procedure.
3. Visually inspect the right front wheel liner for tire rub marks, (Fig. 1) and (Fig. 2) .

Location of the Tire Rubbing on the Wheel Well Liner

1. Replace the right front wheel liner. Refer to the detailed service procedures available in DealerCONNECT/Service Library under: 23 - Body / Exterior / Shield, Splash, Front Wheelhouse / Removal and Installation

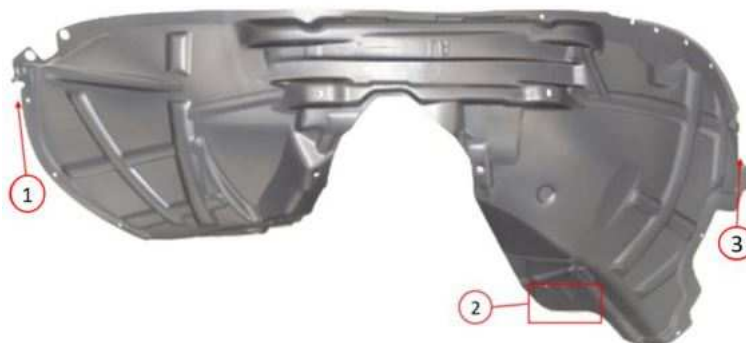
Fig. 2

Right Front Wheel Well Liner

- 1 - Rear of Wheel Well Liner, in Front of the Passenger Door  
 2 - Location of Tire Rubbing  
 3 - Front of the Wheel Well liner
