NUMBER: 08-065-20

DATE: June 24, 2020

RAN RAP RAG and RSD 2.5 Radio Software Enhancements

2017 - 2019	(GA)	Alfa Romeo Giulia
2018 - 2019	(GU)	Alfa Romeo Stelvio

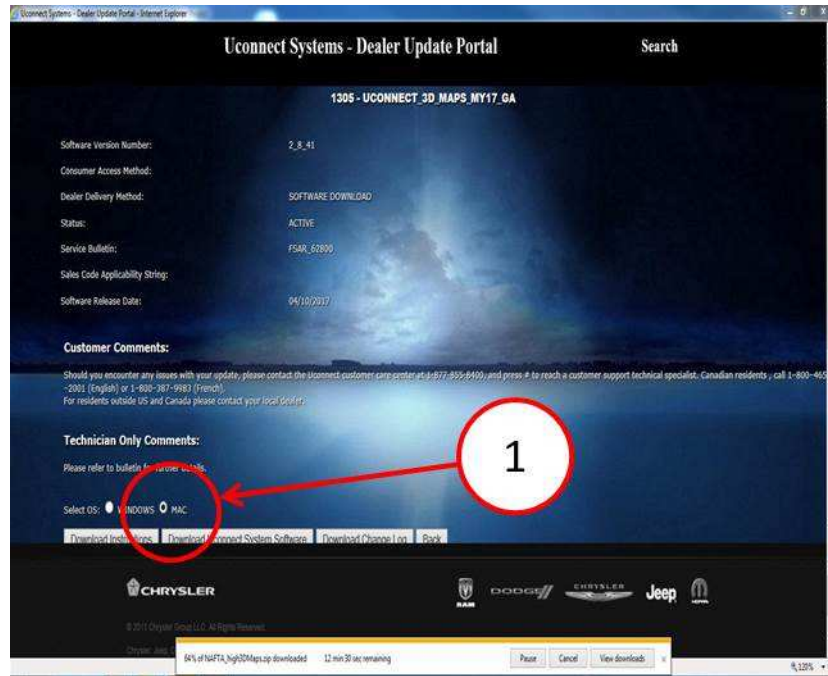
Fig. 2
Uconnect Update Portal

1 - Select the "MAC" for Map only

4. To download the software files to USB flash drives, follow the on-screen instructions and perform the following:
 - Acquire a blank USB flash drive with at least 16GB.
 - A blank USB flash drive will be needed for each software update (one for each software update). Additional updates can not be on the same USB flash drive.
 - Once the file is saved to the USB flash drive, it is recommended to label the USB flash drive with the bulletin number.
 - The USB flash drives must be formatted as New Technology File System (NTFS) structure.
 - Download the software update files to your local PC’s desktop. Make sure to select the “MAC” for 3D Navigation downloads only ([Fig. 2](#)) .
