## Air Conditioning System Occasionally Does Not Cool Correctly At Outside Temperatures Greater Than 40°C

Topic number	LI83.30-P-070309
Version	5
Function group	83.30 Air conditioning
Date	06-15-2020
Validity	Model series 118, 177 and 247 from SOP to clean point of the manufacturing plant; see list
Reason for change	Addition of model series 247 and the production plant clean points for the new evaporator
Reason for block

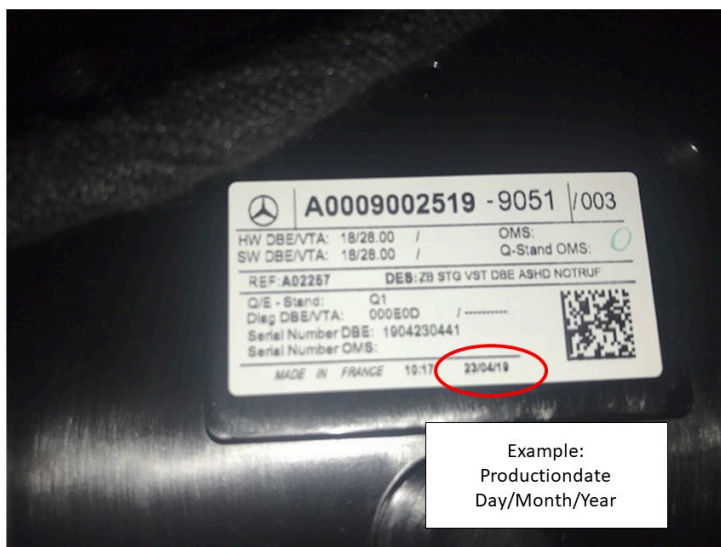
pic.1.jpg:

Attachments	
File	Description
pic.1.jpg	OCP picture

- 5) Remove overhead control panel (OCP) and check that manufacturing date is later than April 6th, 2019 (Pic.1)
- 6) Connect A/C charging station and compare pressure values on the manometer with the value of pressure sensor B12/2 in Xentry.
- 7) If the values differ, replace pressure sensor B12/2.
- 8) If able to reproduce issue readily: With Xentry Diagnostics, select "A/C control unit", then "Actual values" and "Display measurement values" and click on all options.
