Non-Airliner Rear Suspension Crossmember Fastener Change

31-043

Freightliner Service Bulletin

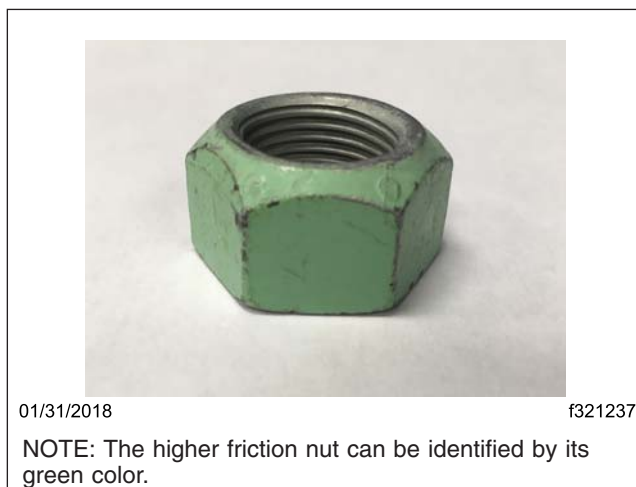
With the start of production on March 2, 2020, the fasteners used to assemble the non-Airliner rear suspension (bogie) crossmember have changed. The rear suspension bogie crossmember gussets to the C-channel will be assembled with 5/8–18 fasteners. This change includes a revision to a higher friction nut that requires an increase in tightening torque. The new higher friction nut can be identified by its green color. See [Fig. 1](#). If the crossmember gusset to the C-channel mounting hardware is being removed, replace with new hardware as indicated by the part numbers in [PartsPro®](#).

Fig. 1, New High Friction Nut

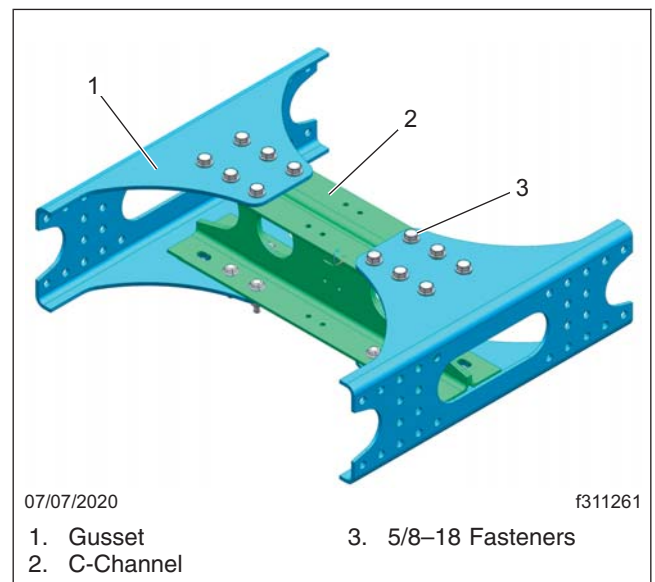
Fig. 2, Rear Suspension Bogie Crossmember

Tighten the bogie suspension crossmember gusset to c-channel using 5/8–18 fasteners from the bolt head to 181±13 lbf·ft (245±17 N·m). See [Fig. 2](#).
