Non-Airliner Rear Suspension Crossmember Fastener Change

31-016

Western Star Service Bulletin

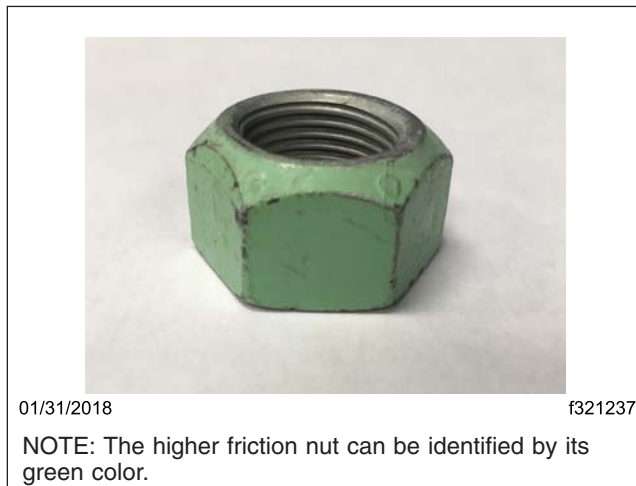
Fig. 1, New High Friction Nut

With the start of production on March 2, 2020, the fasteners used to assemble the non-Airliner rear suspension (bogie) crossmember have changed. The rear suspension bogie crossmember gussets to the C-channel will be assembled with 5/8–18 fasteners. This change includes a revision to a higher friction nut that requires an increase in tightening torque. The new higher friction nut can be identified by its green color. See **Fig. 1**. If the crossmember gusset to the C-channel mounting hardware is being removed, replace with new hardware as indicated by the part numbers in **PartsPro®**.
