SIB 41 01 20

2020-06-03

CREAKING NOISE FROM REAR INTERIOR

E-Series	Model Description	Affected Option Code
G05	X5 Sports Activity Vehicle	Without 4UB (3 rd row seat)

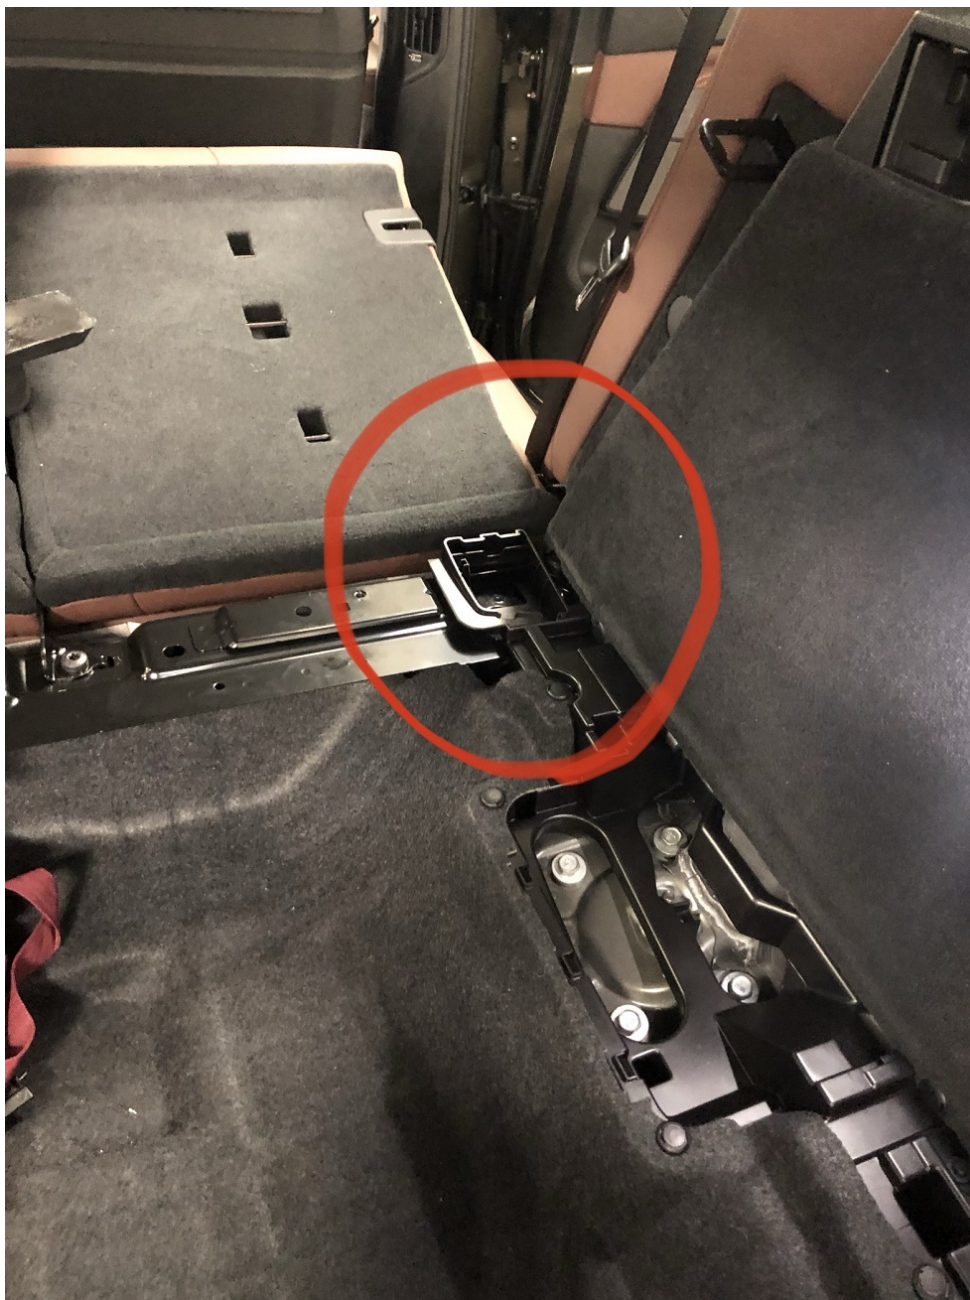
A creaking sound can be heard from the inside of the rear of the vehicle on either side, around the rear seat backrests at the floor. Most commonly, this noise is a short series (2 or 3 times) of creaking or popping sounds coming from the area shown below, during acceleration from standstill:

Interference between two sheet metal panels just below the rear seat bracket.

Rework the area with an additional weld to stabilize the two sheet metal panels.
