SIB 51 18 20

TAILGATE DOES NOT OPEN COMPLETELY

2020-06-04

E-Series	Model Description	Production Date
G06	X6 Sports Activity Coupe	Up to May 13, 2020

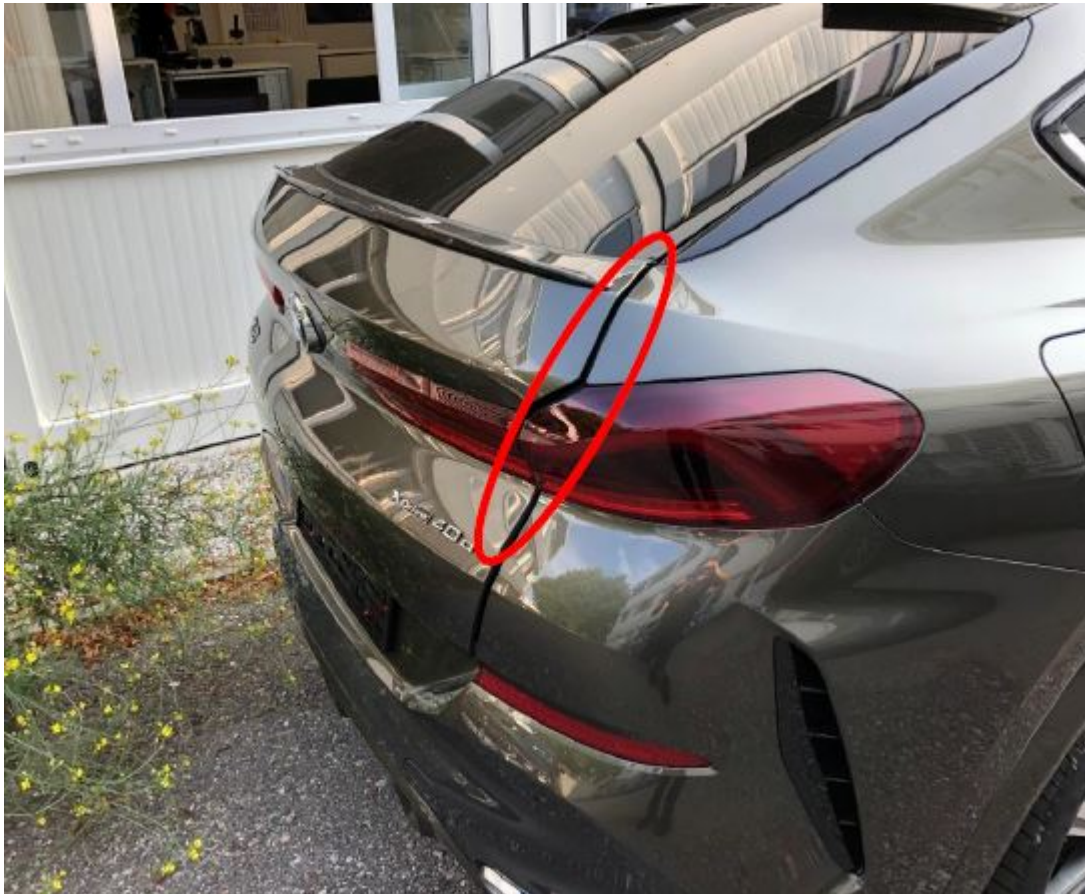
When opened either from the remote key, activation button on the driver's door panel, or using foot motion via Comfort Access; the tailgate will not open completely. The tailgate will release, open a small amount, and stop as shown below:

A software error in the automatic tailgate control unit (HKFM).

Program the vehicle using ISTA 4.23.1x (I-level S18A-20-03-558) or higher.
