SIB 66 29 19

2020-06-23

TOP VIEW CAMERA: IMAGE IS MISALIGNED

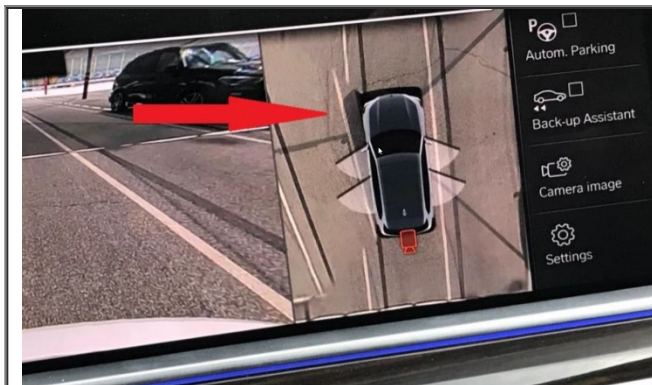
The top view image of the vehicle is misaligned when observed in the Control Information Display (CID). When the vehicle is parked in a parking spot with line markings, it is clearly noticed in the CID that the lines are not parallel to the side of the vehicle. This may be noticed on either the driver side, passenger side or both.

The arrow identifies the line which is shown as not parallel or straight alongside the vehicle.

Side view camera loose fitment in the exterior mirror bracket, causing changes to the top view image.

Reposition the camera in the exterior side view mirror with felt tape. The tape serves to firmly position the camera within the mirror bracket.
