Freightliner Service Bulletin

Vehicles affected include all Business Class M2 and 108SD/114SD vehicles built from 2013 to the present.

54-334

Front Lighting Ground Splice Pack Failure

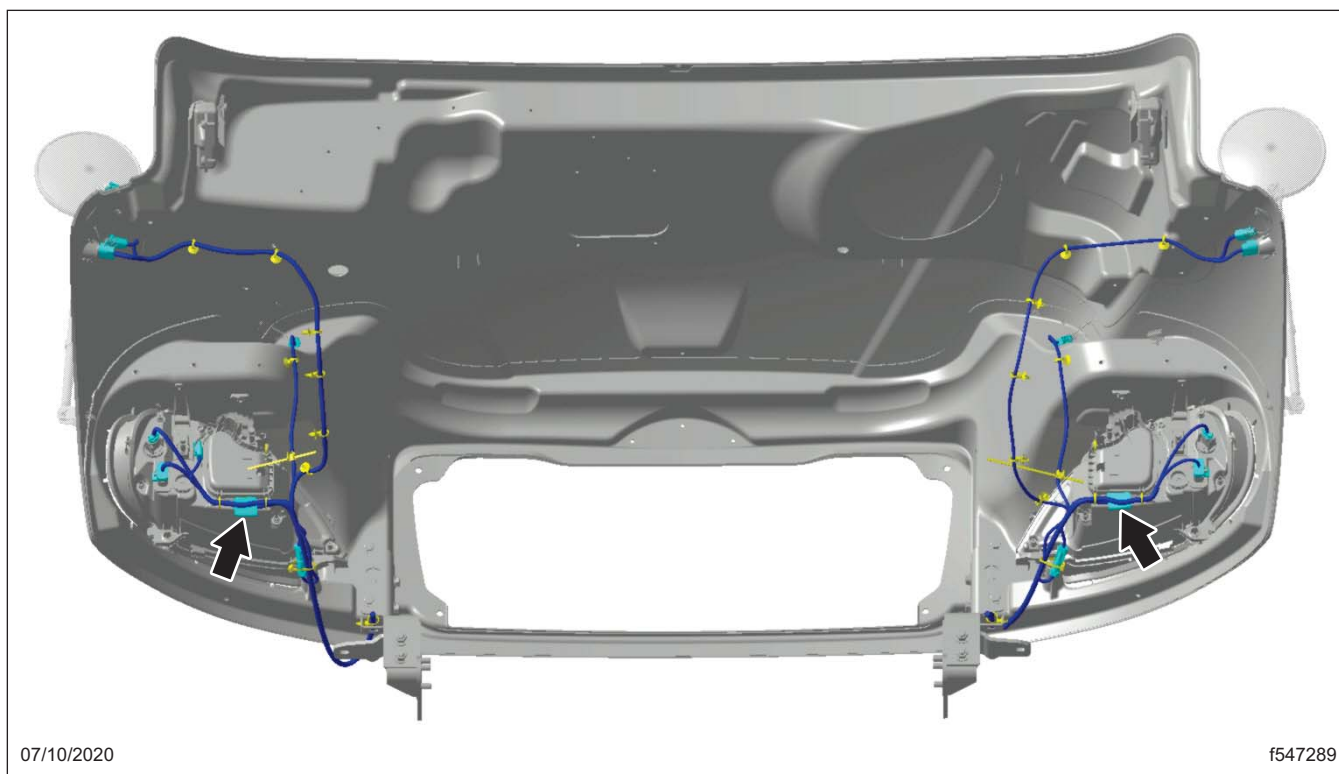
Fig. 1, Location of Splice Packs

The left and right hood lighting of these vehicles have separate ground paths to the frame and use the same splice pack parts. The splice packs are part of the hood commodity and located near the headlight assemblies. See [Fig. 1](#).

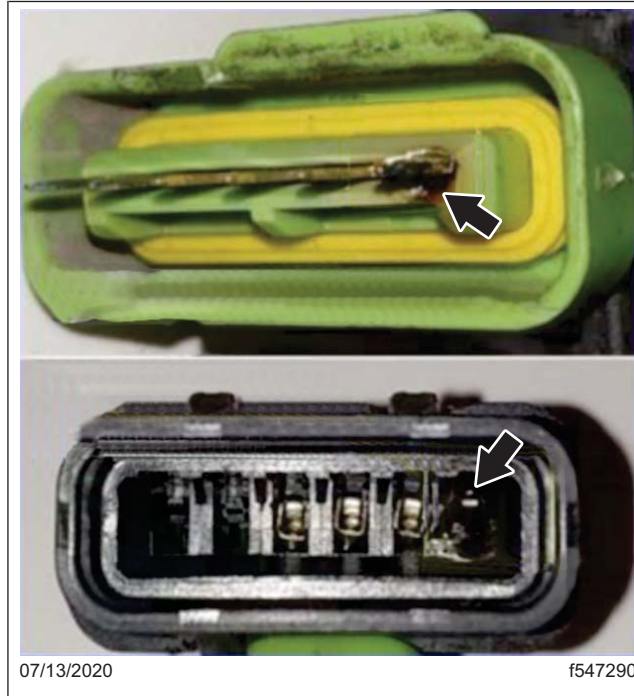
Fig. 2, Failed End Cap Comb and Burnt Terminal in Splice Packs

These splice packs can fail, resulting in either the left or right lighting becoming intermittent or inoperative. There are no reports of a vehicle losing both headlights or both sets of hood lighting at the same time.

Failures can be easily identified by removing the green end cap from the splice pack and looking for burnt sections of the comb or burnt terminals. See [Fig. 2](#).
