Business Class M2
Cascadia
108SD/114SD
> New Cascadia

**Freightliner
Service Bulletin**

General Information

New Cascadia vehicles with light emitting diode (LED) headlamps built from January 1, 2017 through February 17, 2020 may experience intermittent disabled headlamps due to an issue with the universal light ballast (ULB).

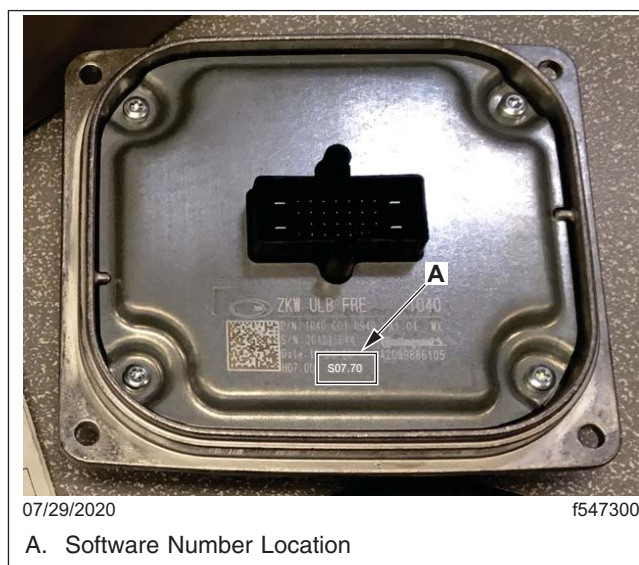
Fig. 1, Inner ULB Cover With Software Number

The LED headlamps can turn off if the supply voltage drops below approximately 9V. This low voltage commonly and momentarily occurs when cranking the engine on a vehicle with batteries that are not fully charged. The momentary low voltage may cause the electronic ULB control unit to malfunction. The ULB may not resume normal function until the power supply to the headlamp is disconnected.

If this malfunction occurs, the entire headlamp does not need to be replaced. Replace the ULB control unit with a new ULB, DTNA part number 66-01405-050/software number S07.70 or newer. **Do not** replace it with the same or older ULB, DTNA part number 66-01405-040/software number S07.26. See [Fig. 1](#) for software number location.

When replacing the ULB on one headlamp, replace the ULB on the other headlamp, if it has not previously been replaced.
