NUMBER  
PI1803Y/Z (Rev 3, 07/01/2020)

**SUBJECT:** ENGINE REPLACEMENT INSTRUCTIONS  
FOR DTC P1326 (PI1803Y/Z)

This bulletin provides information related to the Technical Service Bulletin previously published in July 2018 (PI1803, Rev 10, 03/16/2020) titled "Knock Sensor Detection System - ECU Logic Improvement". Specifically, this bulletin provides instructions on which procedures to follow if, after installation of the KSDS, any one of the subject vehicles below returns to the dealer with Diagnostic Trouble Code (DTC) P1326 (Knock Signal Range/Performance).

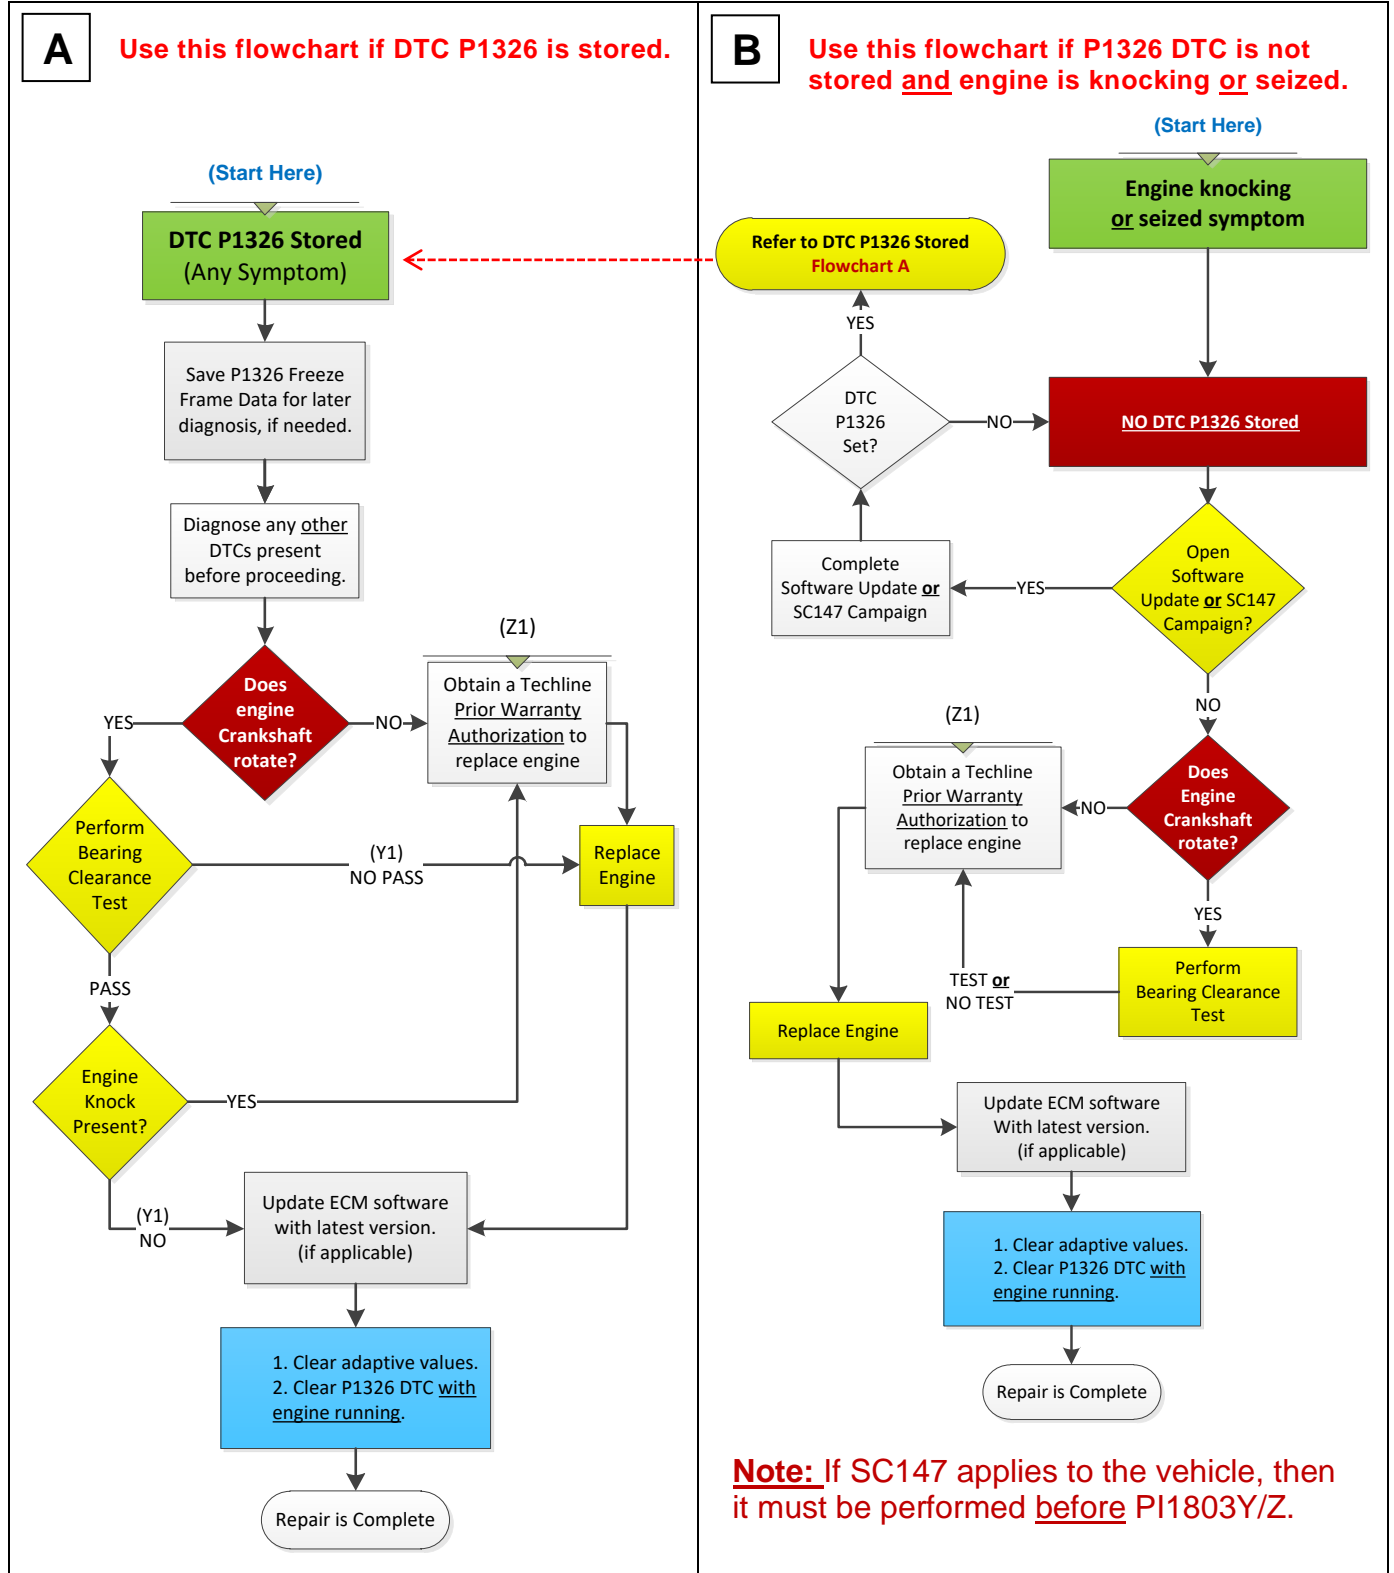
- **Scenario 1** – Vehicle is in with DTC P1326 stored (A).
- **Scenario 2** – Vehicles is in with no DTC P1326 stored but engine is knocking or seized (B).
- **Scenario 3** – Vehicle is in with DTC P1326 stored and also engine is making noise or seized (A).

**Note:** If any concerns arise after completing the flow chart, open a Techline case online.

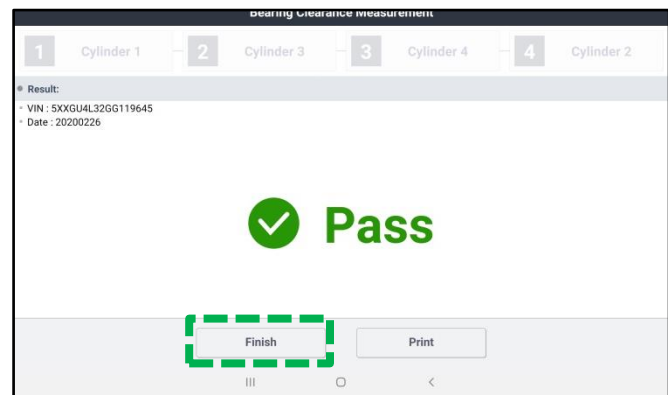
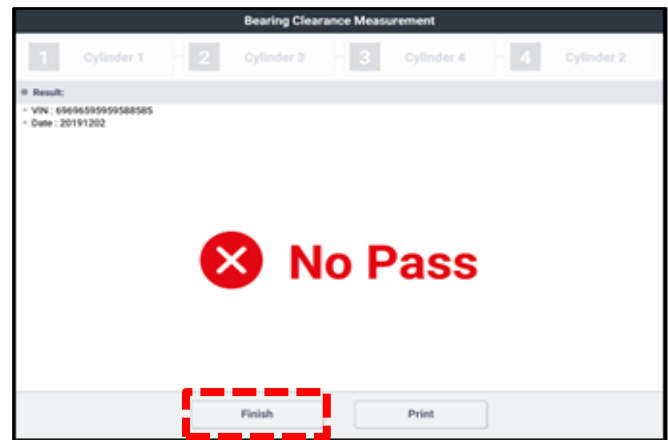
28. If the test result displays **“PASS”**, capture the screen image/screenshot for record keeping.

If the test result displays **“NO PASS”**, capture the screen image/screenshot for record keeping. Then proceed to replace the engine assembly per the instructions.

- Proceed to **page 11** to replace the engine assembly as outlined in this bulletin

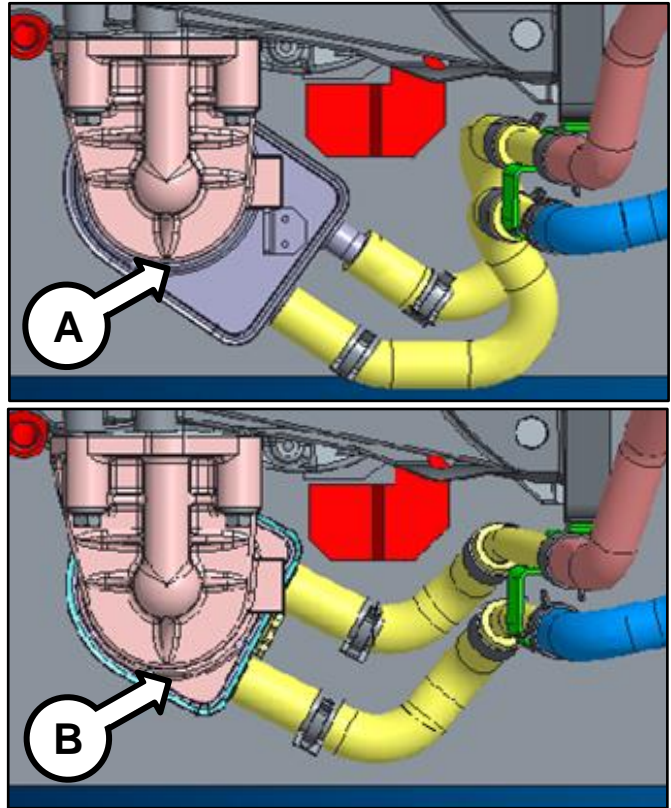
New engines may be supplied with a different oil cooler. Use steps below to determine the need for a replacement oil cooler tube assembly.

- If the new engine's (bigger) oil cooler (A) does not match the old engine's (smaller) oil cooler (B), replace the oil cooler tube assembly with the improved part. See parts table on page 24.
- If the new engine's (bigger) oil cooler (A) matches the old engine's (bigger) oil cooler (A), reuse the old engine's oil cooler tube assembly.
- If the new engine's (smaller) oil cooler (B) matches the old engine's (smaller) oil cooler (B), reuse the old engine's oil cooler tube assembly.
