MODEL
2020MY
Telluride (ON)

NUMBER
PS665

FRONT SEAT BELT OPERATION

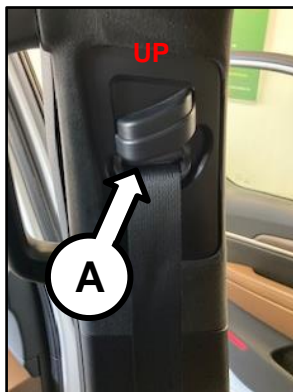
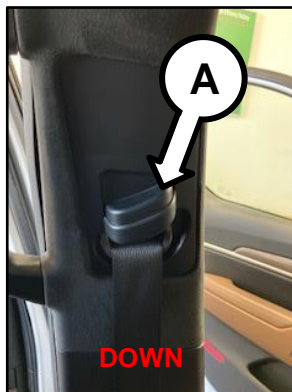
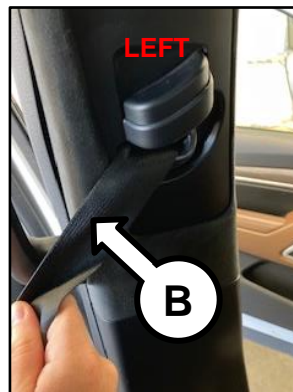
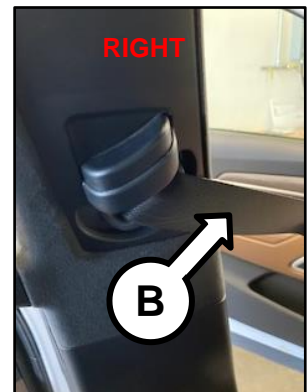
This Pitstop provides information regarding concerns with the function of the front seat belt on some 2020MY Telluride (ON) vehicles which may exhibit a seat belt that will not pull out or retract which may be caused by a twisting of the seat belt webbing or a pinching of the seat belt webbing behind the pillar trim.

1. Confirm seat belt will not pull out or retract.
2. If so, move the seat belt height adjuster (A) up and down and move the webbing (B) from left to right. (see images below) while attempting to pull and releasing a few times.

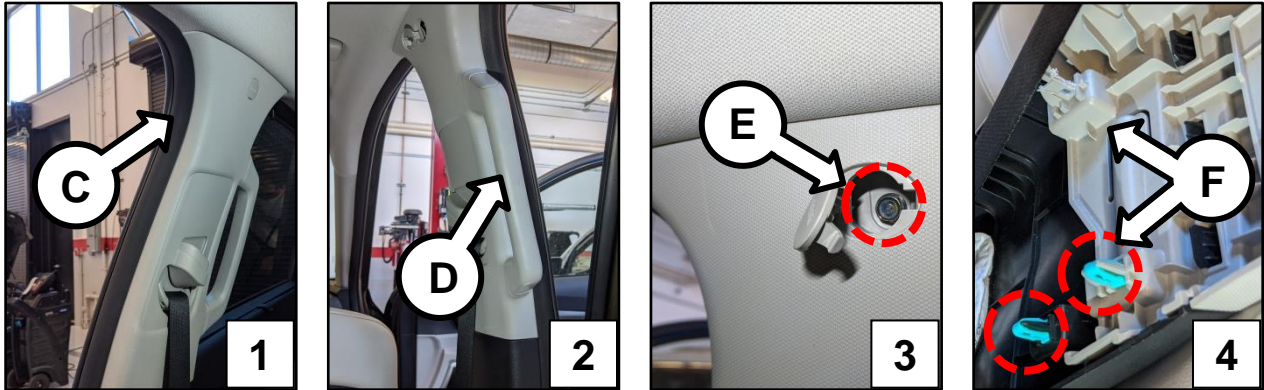
If the seat belt will still not pull out or retract, inspect behind the center upper and lower pillar trim to check for obstruction in the seat belt webbing (page 2).

1. Remove the front and rear door weather strip (C) along the center pillar trim area only.
2. Remove the center pillar assist handle (D).
3. Remove the upper center pillar trim retaining bolt (E).
4. Detach the upper/lower pillar trim clips (F) by pulling on the trim joining area.

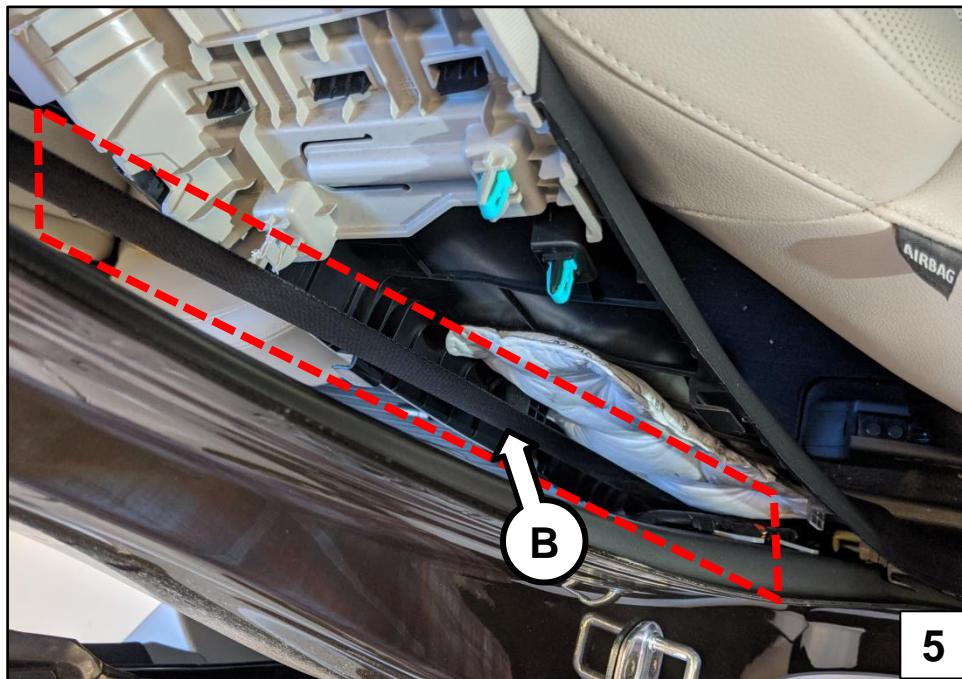
5. Inspect the seat belt webbing (B) for any twisting or pinching.
 - Pull the belt webbing (B) to cycle/retract and confirm that it operates as designed.
 - Seat the pillar trim and pull on the seat belt buckle and confirm that the seat belt cycles/retracts as designed.

If the seat belt **does** cycle/retract normally, reinstall all removed parts in the reverse order of removal and return vehicle to the customer.

If the seat belt **does not** cycle/retract normally, then seat belt assembly may be faulty. Proceed to diagnose normally.
