MODEL
2019-2021
Multiple Models
with IVT

NUMBER
200 (Rev 2, 07/23/2020)

TECHNICAL SERVICE BULLETIN

**SERVICE ACTION: IVT SOFTWARE LOGIC
IMPROVEMENT AND/OR IVT REPLACEMENT (SA424)**

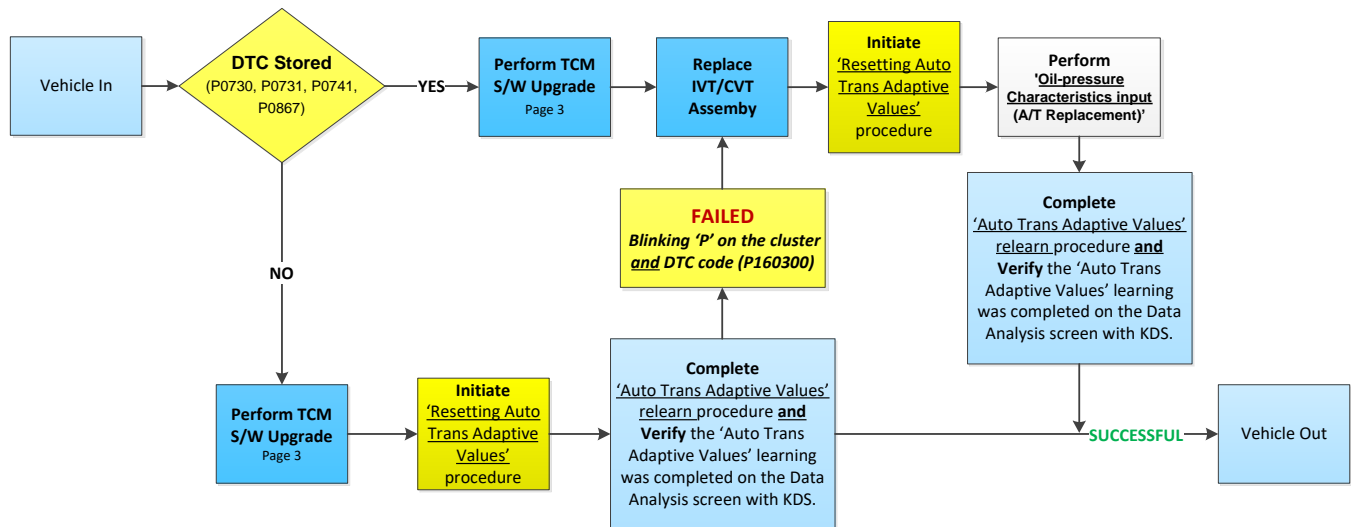
Flowchart:

- P0730 – Incorrect Gear Ratio
- P0731 – Gear 1 Incorrect Ratio
- P0741 – Torque Converter Clutch Circuit Performance or Stuck Off
- P0867 – Transmission fluid pressure

- P160300 – P-Learning Fail (CVT System)

When replacing the IVT/CVT assembly, carefully follow the installation procedure outlined on KGIS to complete the Auto Trans Adaptive Values learning procedure. Performing the 'Oil-pressure Characteristics Input', refer to the IMPORTANT and NOTICE boxes on page 10. The adaptive values learning procedure may require that the engine be shut OFF/ON multiple times until the values are fully learned; start the vehicle, confirm the vehicle is idling in 'Park' without accelerator or brake input and verify the 'CVT Learning – P Range' Current Data reads 'ON'.

A **Vehicle Diagnosis Number (VDN)** must be created with at least one of the five (5) DTCs listed above, prior to IVT replacement. If a VDN is not created, Parts Ordering and Warranty claim submission issues WILL occur.
