Technical Service Bulletin

01 "Switch off the engine and check coolant" message in the instrument cluster, DTC P000000 is stored in the ECM

01 20 73 2058890/2 July 24, 2020. Supersedes Technical Service Bulletin Group 01 number 20-50 dated March 18, 2020 for reasons listed below.

Model(s)	Year	VIN Range	Vehicle-Specific Equipment
A4	2017 - 2019	All	3.0 TFSI
A5, Q5	2018 - 2019	All	3.0 TFSI

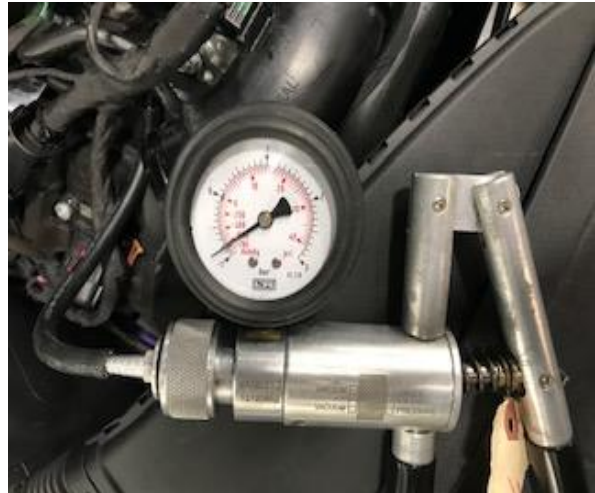
DTC P000000 with symptom 33688 indicates a possible malfunction of the mechanical coolant pump.

Figure 1. Checking the vacuum at the output port of N649.

A. Check for vacuum (using VAS6213) at the output port of solenoid N649 which commands the water pump sleeve (Figures 1 and 2). The engine needs to be cold to generate a command signal to the N649 solenoid to switch to a vacuum. **With the engine cold**, start the engine briefly and monitor that vacuum is created.

B. If there is no vacuum measured at the output port of N649, the cause of the fault could be related to the solenoid valve N649 or the vacuum hoses (check for leaks). In this case, repair and check the operation of the vacuum system.

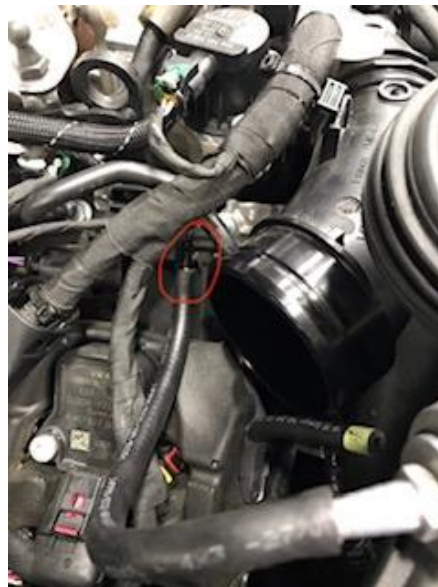
Figure 2. The output port of N649 (close-up picture).

4. If there are no malfunctions found in the vacuum system, check the operation of the water pump sleeve by applying a vacuum to the hose going to the water pump (hose connected to the output port of N649). When applying a vacuum to the pump, pay attention to the clicking sound of the water pump sleeve. If no clicking is heard or felt, replace the mechanical coolant pump.
