# Driveline Vibration Under Deceleration Around 30 – 10 mph

YEAR(S)	MODEL(S)	ADDITIONAL INFORMATION
2016 - 2019	Tacoma	VDS(s): CZ5AN, GZ5AN, SZ5AN Engine(s): 2GR Drive Type(s): 4WD Transmission(s): 6AT

The information contained in this bulletin supersedes Service Bulletin No. T-SB-0171-16.

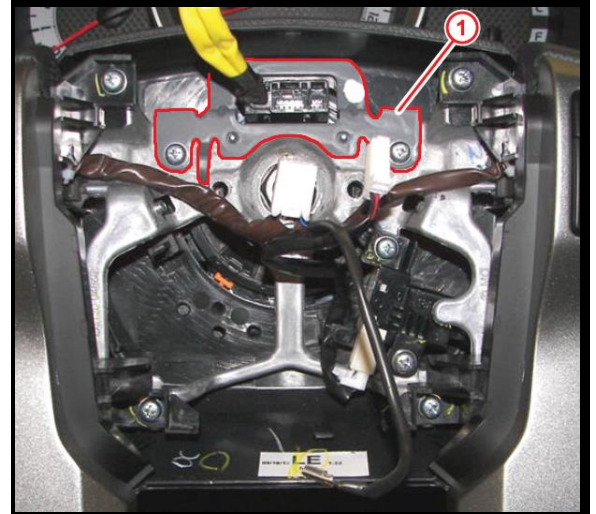
**Figure 1.**

<b>1</b>	<b>Steering Wheel Switch Wire Harness Retainer Bracket</b>
----------	--

- Remove the steering wheel switch wire harness retainer bracket (ONLY for vehicles with steering wheel mounted switches).

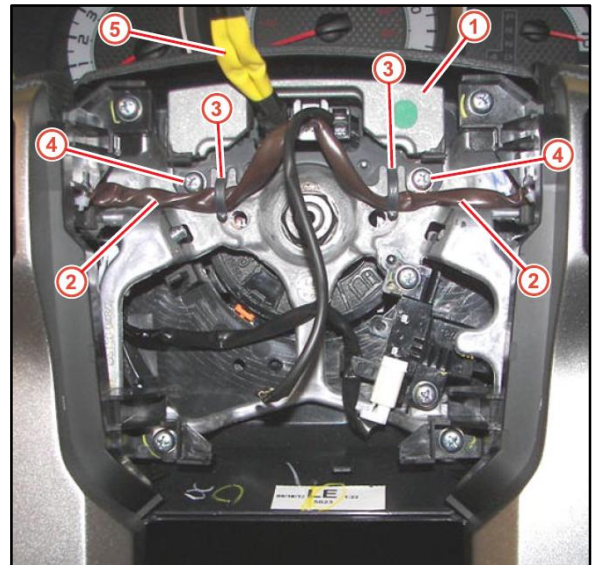
**Figure 2.**

<b>1</b>	<b>Damper</b>
<b>2</b>	<b>Steering Wheel Switch Wire Harness</b>
<b>3</b>	<b>Damper Bracket Wire Retainer Hook</b>
<b>4</b>	<b>Screw</b>
<b>5</b>	<b>Driver Side Airbag Wire Harness</b>

- Install the steering wheel damper using two NEW screws in the locations shown.  
**Torque: 2.35 N\*m (24 kgf\*cm, 20.8 in\*lbf)**

**NOTE**  
Secure the steering wheel switch wires to the steering wheel damper bracket hooks as shown.

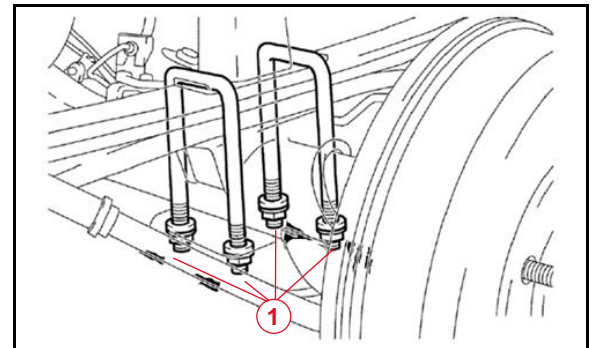
**Figure 15.**

<b>1</b>	<b>U-bolt Nuts</b>
----------	--------------------

17. Replace the leaf spring using the part information in the following table:

When tightening the U-bolt nuts, make sure to set to the following torque:

**Torque: 60 N\*m (610 kgf\*cm, 44 ft\*lbf)**

Per the repair manual, fasteners for shocks and leaf spring bushings should be pre-tightened while the vehicle is lifted. Final torque should be set while the vehicle is on the ground.
