Vehicle Pull, Steering Wheel Off Center, and Alignment Best Practices

Service Category Suspension

Section Alignment/Handling Diagnoses

The information contained in this bulletin supersedes Service Bulletin Nos. ST005-01, SU001-08, and T-SB-0391-08.

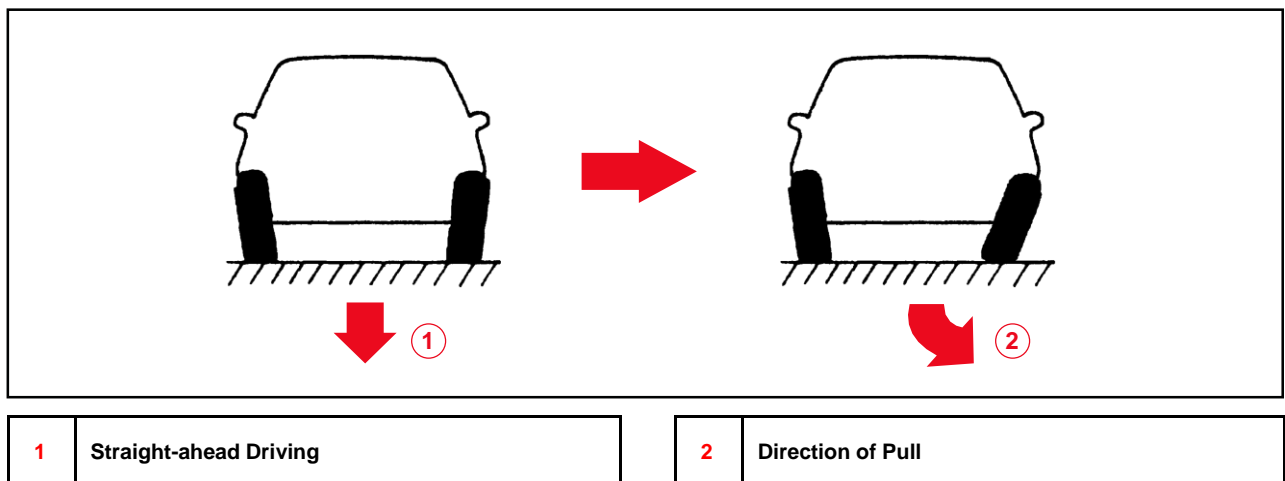
Figure 1. Camber

When the cross camber or caster of the front wheel alignment is large, it can cause vehicle pulling.

WHEEL ALIGNMENT	DIRECTION OF VEHICLE PULL
Camber	Vehicle Pulls in Direction of Wheel with Large Camber Value (See Figure 1)
Caster	Vehicle Pulls in Direction of Wheel with Small Caster Value (See Figure 2)

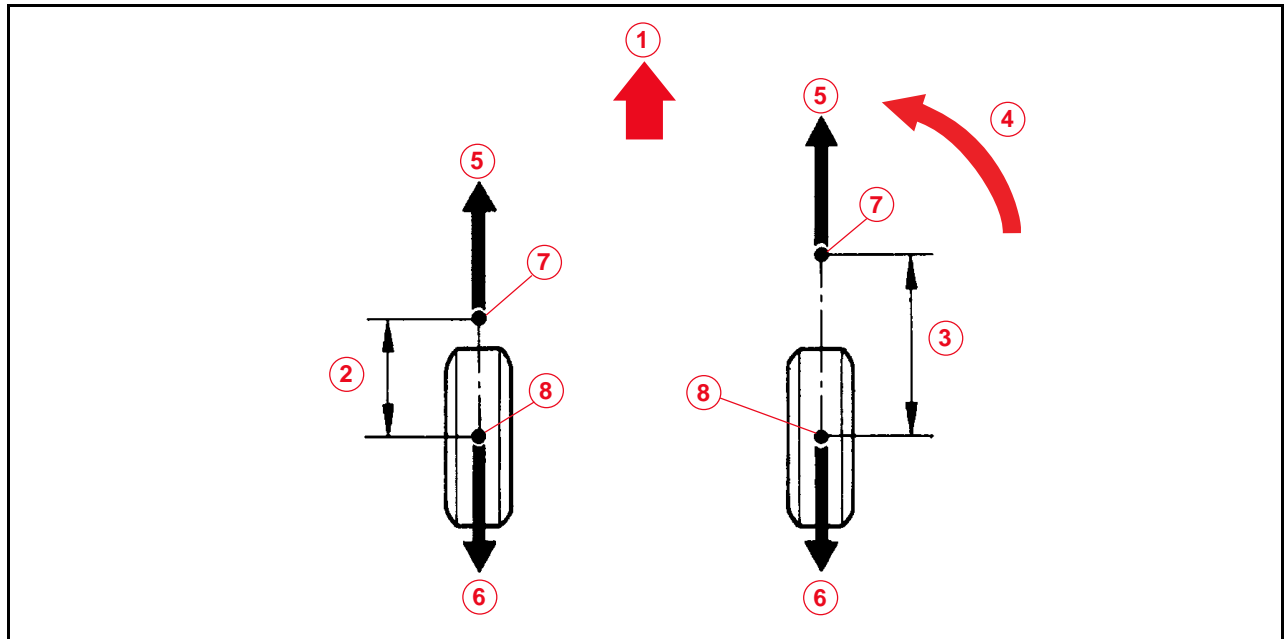
Figure 2. Caster

If the cross camber or caster is within the specified range (30' or less), noticeable vehicle pulling will not occur due to side-to-side differences in camber or caster.

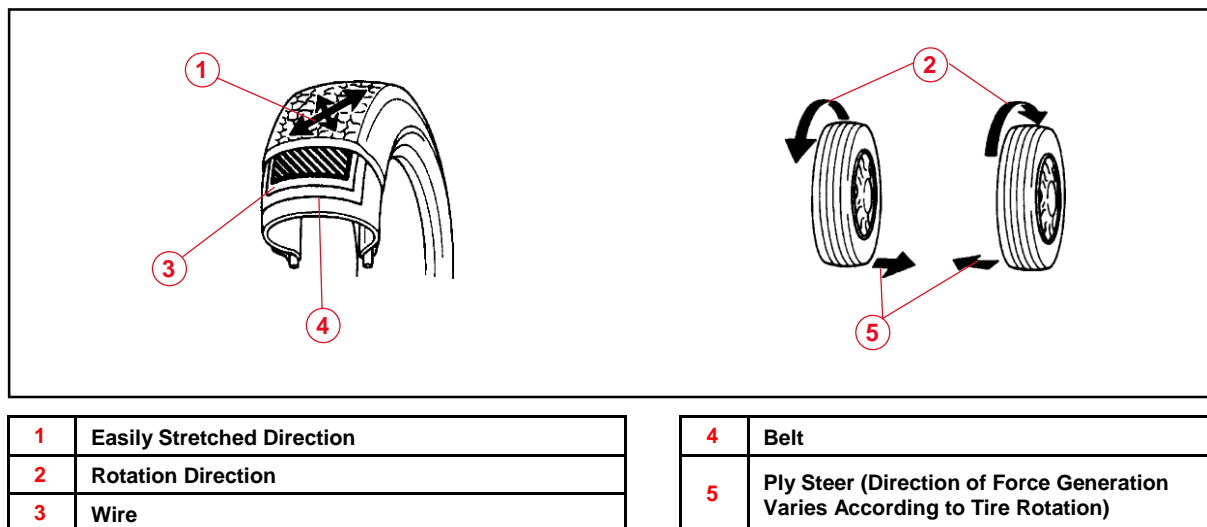
Figure 3. Ply Steer

Lateral force due to ply steer is produced by the construction of the belts inside the tire tread. With radial tires, the wire of the belt is slanted as shown in the illustration below. Thus, it is in the lateral direction that tire tread easily changes shape (stretches), and lateral force is generated between the tire and the road surface in the lateral direction.

Lateral force from ply steer prevents vehicle drift caused by road crown, so in many cases lateral force to the left is provided to compensate for road crown to the right.

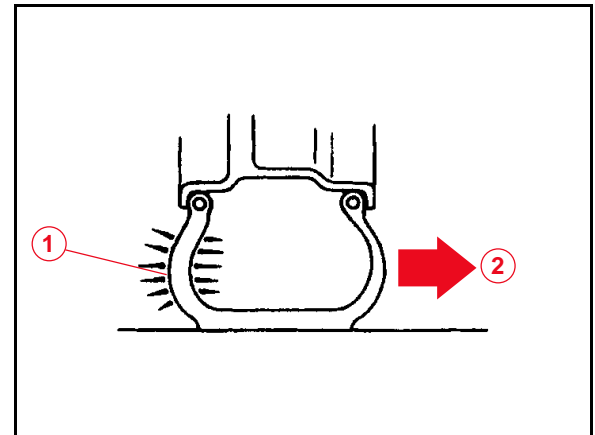
Figure 4.

Conicity is lateral force resulting from uneven formation of the left and right sides of the tire. The direction the lateral force is exerted depends on the hardness of the side walls and the difference in height between the left/right sides of the tire. The greatest effect on vehicle pulling is most often the lateral force caused by tire conicity.

When vehicle pulling is due to conicity, the amount of drift can be reduced, and the direction of drift can be changed by changing the location of the tire or reversing the tire when installing it on the wheel.

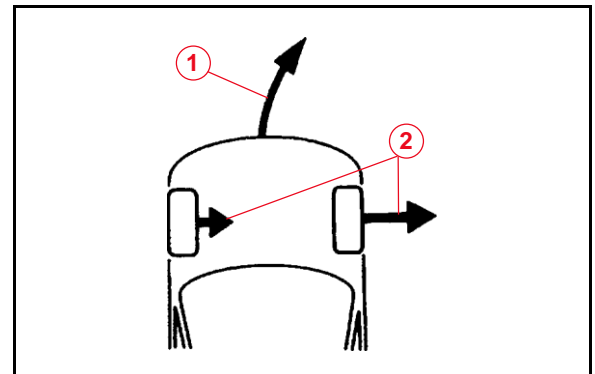
Figure 6. Original Tire Positions

3. Decide if vehicle pulling is due to wheel alignment or tires.
 - A. Switch the left and right front tires (if the tires are non-unidirectional).
 The direction of lateral force from tire conicity becomes reversed when the left and right tires are switched. Therefore, if the pulling direction changes when the tires are switched, it can be concluded that vehicle pulling is caused by tire conicity.
 - The vehicle is pulled to the right by the lateral force exerted to the right.

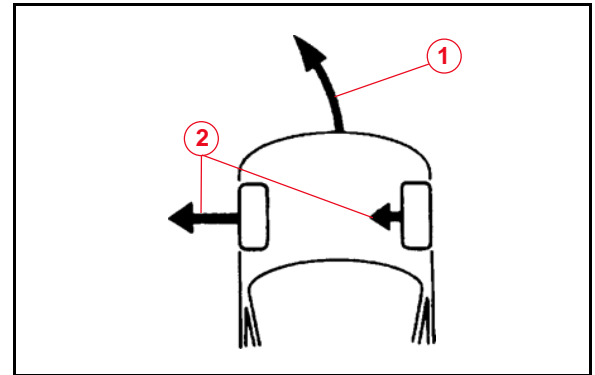
Figure 7. Tires Switched

- The direction of the tires which exerted lateral force to the right has been changed. The tires now exert lateral force to the left, and the vehicle now pulls to the left.

If the pulling direction does NOT change AFTER the front tires are switched, the cause of vehicle pulling is NOT tire conicity. In this case, the likely cause is a front wheel alignment condition.

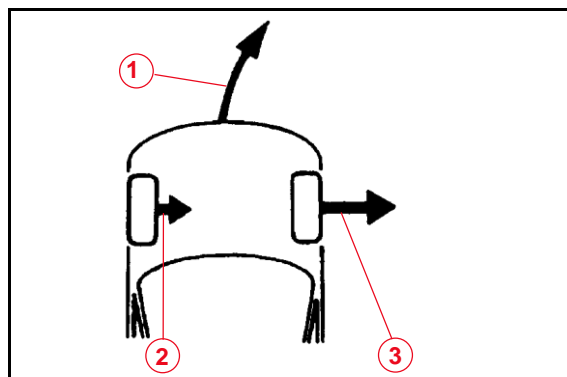
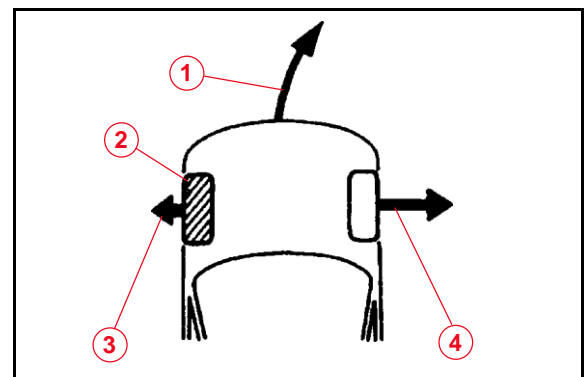
The lateral force generated by the right front tire is greater than the left tire, so the vehicle is pulling due to the lateral force of the right tire.

1. Remove the front left tire from the wheel and reverse the tire, if the tire is not unidirectional. Then, perform a road test and check for changes in the pulling direction.

2. Rotate the LARGER lateral force front tire with the rear tire and check the change in the vehicle pulling if the front and rear wheel and tire assemblies are the same size.

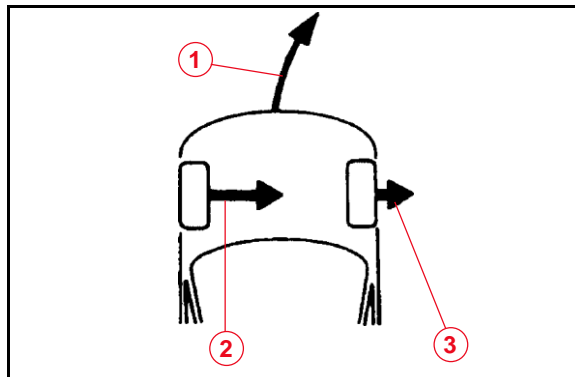
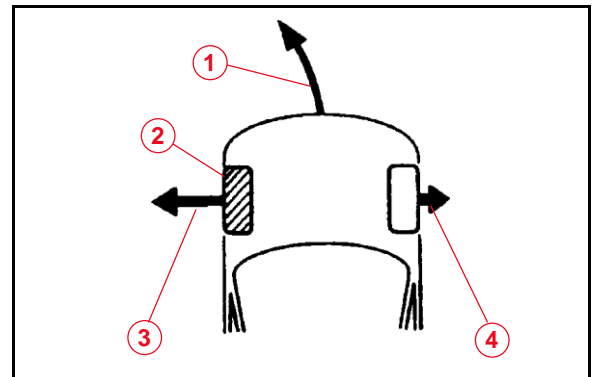
The lateral force generated by the left front tire is greater than the right tire, so the vehicle is pulling due to the lateral force of the left tire.
