## **SERVICE INFORMATION BULLETIN**

**SUBJECT:** Rear Frame and Stabilizer Bar Bracket

Mounting Bolt- Design Changes

**NUMBER: 12-296-20R**

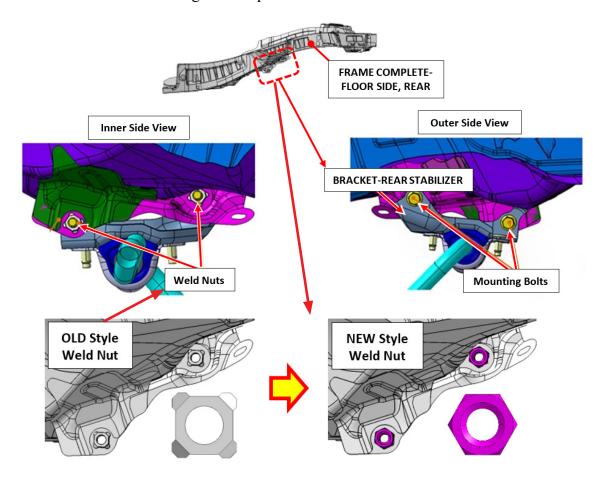
- The new Flange Bolts <u>listed in the table on pg. 1</u> are <u>NOT</u> compatible with weld nuts used in the original frames. Using the new-style Flange Bolts on the original frames will damage the weld nuts.
- The original Flange Bolts (p.n. 010108200) are reusable and readily available if needed.
- The new Flange Bolts (p.n. 20058FL010) have a special lubricant applied to their threads and are now One-Time use items.
- There have been no changes to the part numbers of the stabilizer bar brackets.
