SERVICE BULLETIN

APPLICABILITY: All 2019-21MY Vehicles with Gen 2 Telematics **NUMBER:** 15-219-18R
SUBJECT: Error Code 202 and / or 204 Generated During **DATE:** 06/21/18
Gen 2 Telematics Subscription Process **REVISED:** 07/17/20

INTRODUCTION:

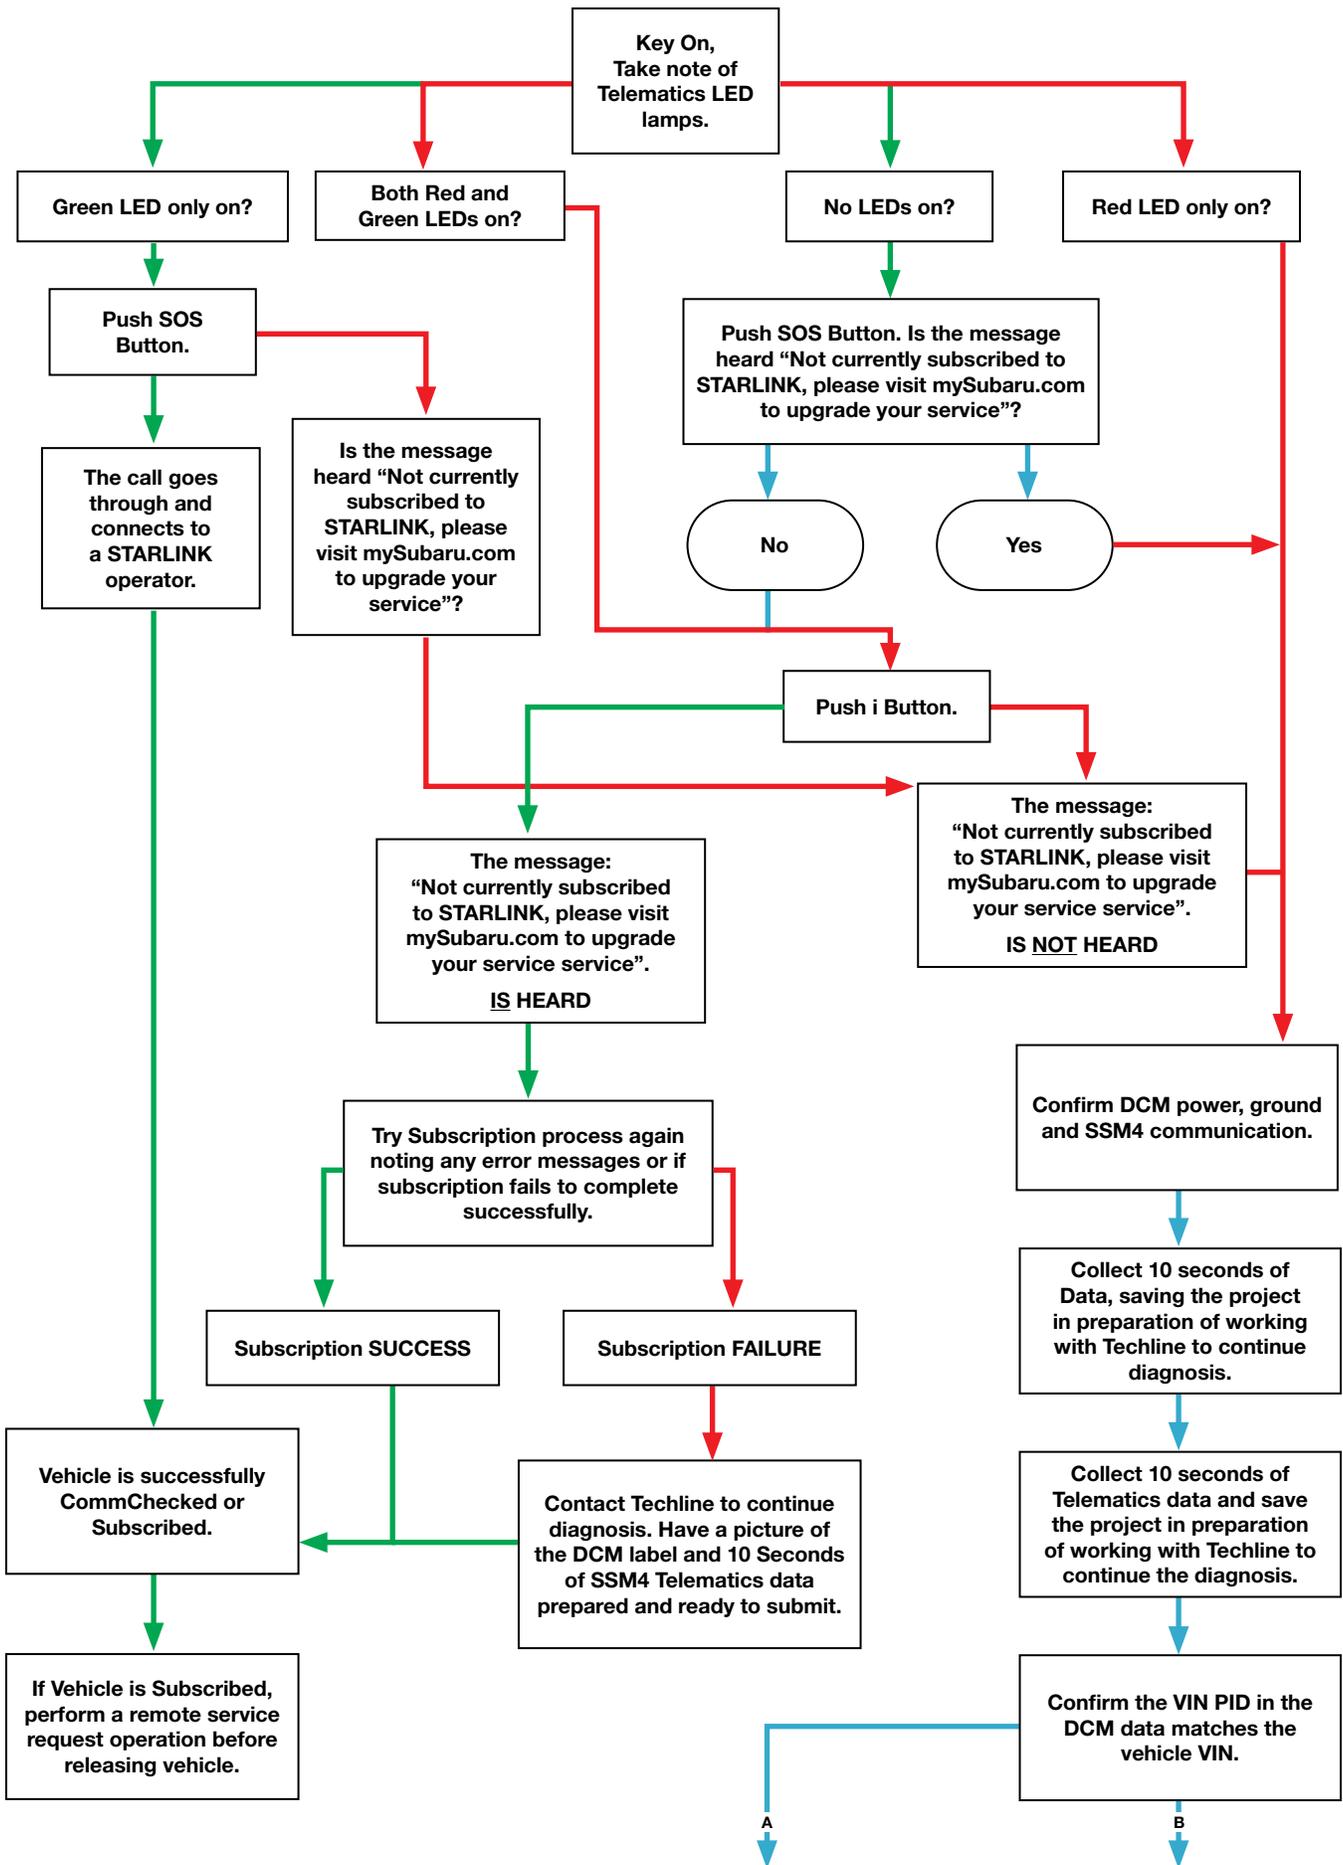
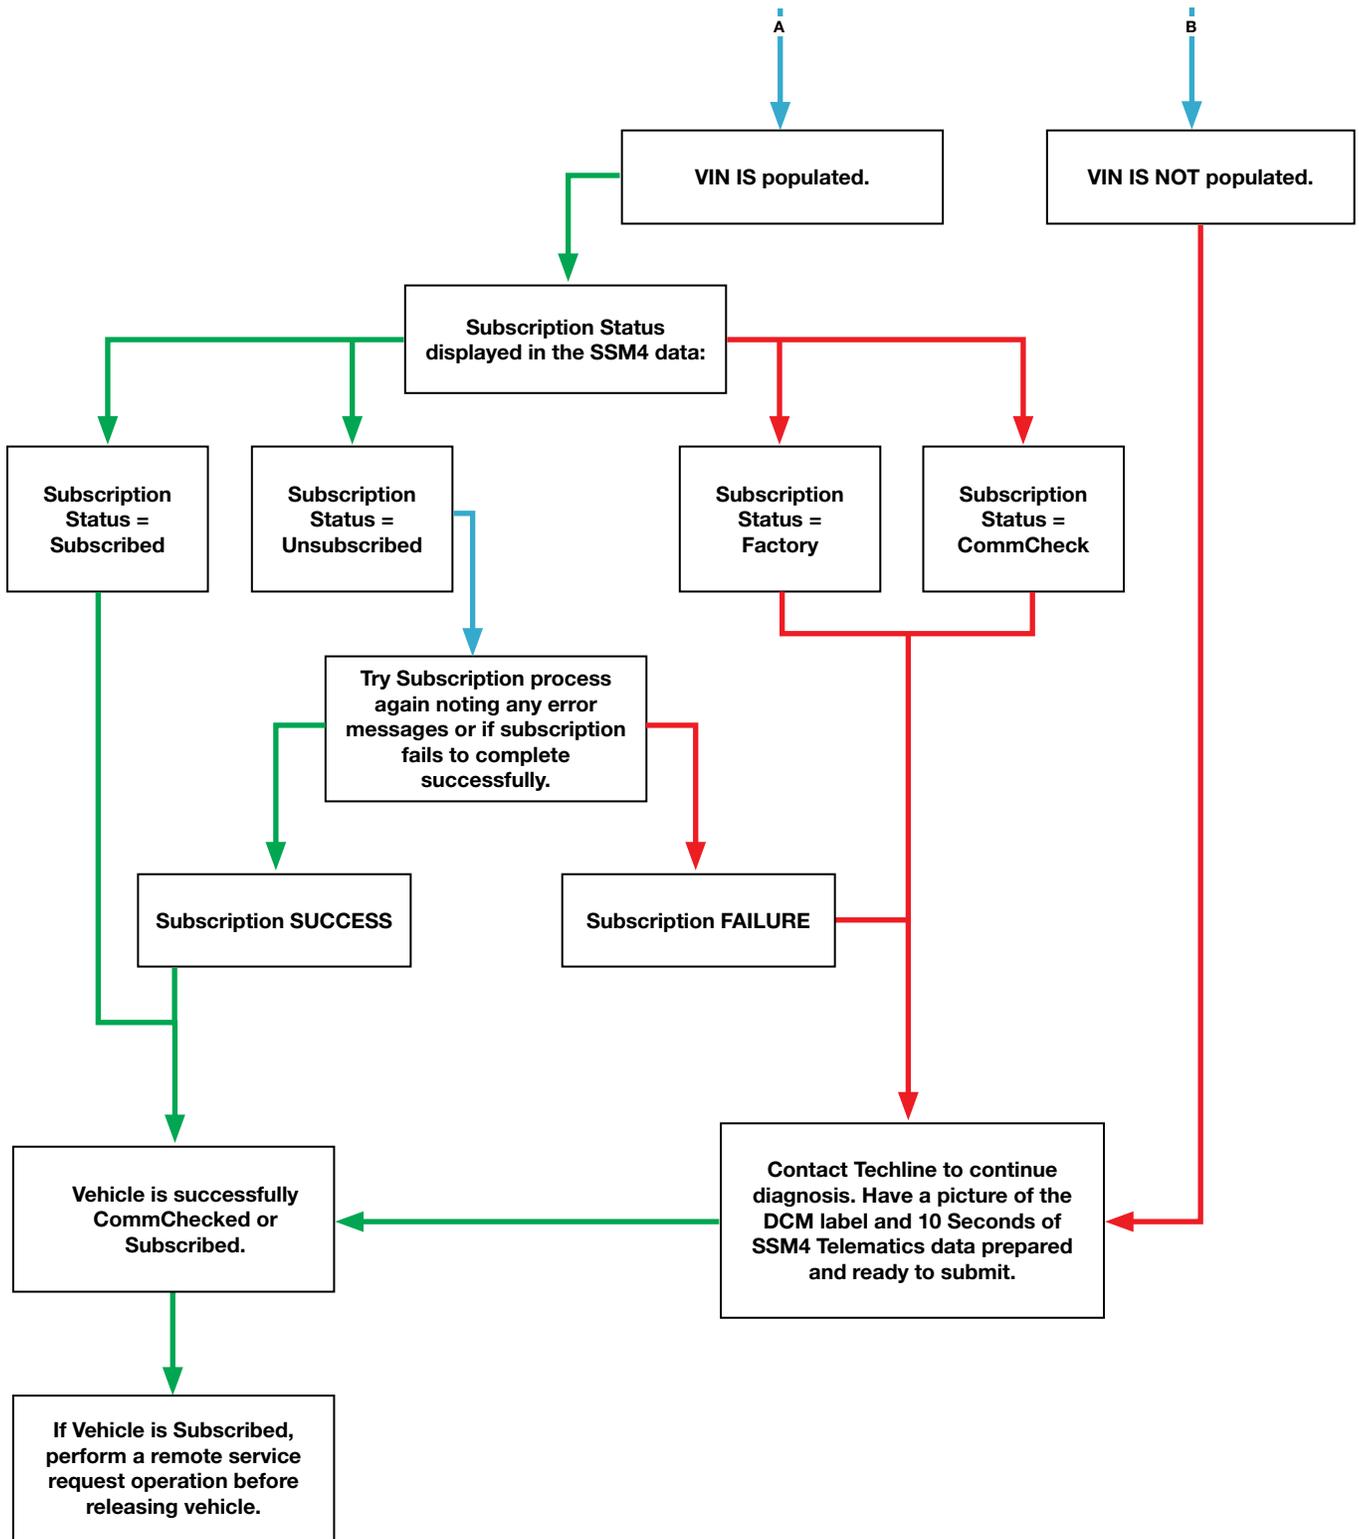
“Appendix A”

NOTE: A flow chart to use as an additional diagnostic reference tool has been provided in “APPENDIX A” beginning on pg. 5.
