**SERVICE INFORMATION BULLETIN**

**APPLICABILITY:** All Models 2019MY to Current with Gen 2 Telematics **NUMBER:** 15-264-20R  
**SUBJECT:** WiFi Hotspot: Diagnostic TIPS and Helpful Hints **DATE:** 06/22/20  
**REVISED:** 07/14/20

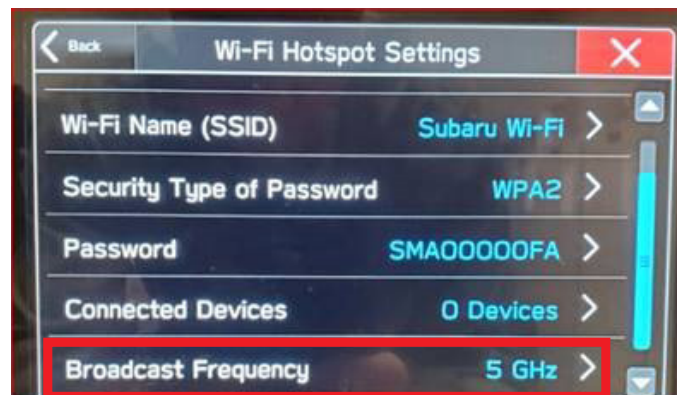
It is also important to duplicate the condition on both WiFi Hotspot broadcast frequencies, 2.4GHz and 5GHz (when equipped). Customers are often unaware the broadcast frequency is configurable on certain Subaru vehicles because during set-up, the user must scroll down to see where the choice can be made.

**TIP:** An easy test is, after verifying the concern, change the selected broadcast frequency and recheck to see if the concern persists. When the condition can only be confirmed on one frequency, it is an indicator of a compatibility and / or configuration issue with the device. The WiFi Hotspot network in a vehicle is similar to a home network as both are susceptible to performance issues caused by network interference. Because the WiFi Hotspot network is mobile, the surrounding environment constantly changes. Ensuring the customer concern is present on both broadcast frequencies will help eliminate environmental and surrounding network interference as a contributing factor.
