Articles Contained in this Issue

03 At Learning Control Information

15 Updated Helpful Infotainment Operational Tips

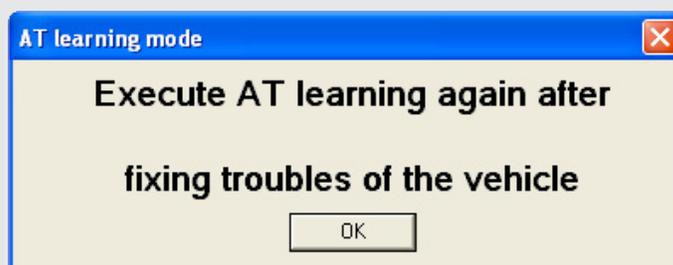
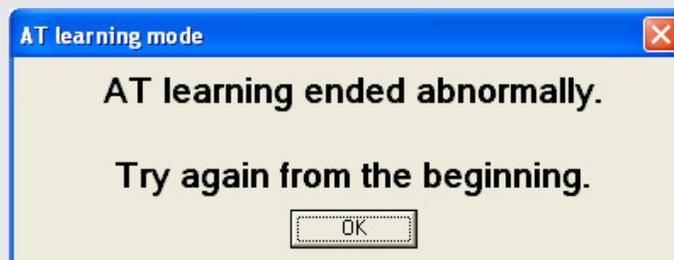
Figure 1 Error Messages and Explanations

There have been a limited number of reports brought to the attention of Techline involving the Learning Control process aborting and being accompanied by the message "AT learning ended abnormally". When Technicians encounter this error, referring to the applicable Service Manual to verify the procedure should be the first step to determine the root cause. Another source of information pertaining to this can be found under the Help tab in the Subaru Select Monitor III. **Figure 1** shows the two different error messages you can receive during the AT Learning Control process. Each has a different diagnostic approach. Incorporated with the error messages are the Main Cause and Remedy tables, which are found in both the applicable Service Manual and under the Help tab of Subaru Select Monitor III.

Main causes of the contents shown	Remedy
Detection of DTCs	Correct the DTCs and then perform the AT learning procedure again.

Main causes of the contents shown	Remedy
Detection of DTCs	Correct the DTCs and then perform the AT learning procedure again.
<ul style="list-style-type: none"> • Un-instructed operations were taken during the AT learning process. • Depressing the brake pedal is not enough • Pulling the parking brake lever is not enough • Abnormal Idle Up 	Execute the [AT learning mode] again from the beginning

When performing the Learning Control procedure, be aware of items such as:

Brake pedal application

- Firm pressure applied to the pedal is required. If insufficient pressure is applied to the brake pedal, the process will abort.
- When commanded to release the brake pedal, do so immediately and let the pedal return on its own.

Throttle input

- No throttle input should be used at any point during the Learning Control procedure.
- Any RPM deviation not created by the Learning Control process will abort the procedure, so verify there are no outside influences that could affect this.

Parking brake application

- Application of the parking brake requires enough force to keep both rear wheels stationary. Any movement of the rear wheels will abort the process.
- Verify the parking brake operates appropriately (no adjustments needed, calibration performed, etc.) according to the applicable Service Manual.

Fluid Temperature

- Please refer to the applicable Service Manual for the appropriate Learning Control procedures, including the required fluid temperature range.
- The process cannot be performed at the incorrect fluid temperature.
- Verify the fluid level is correct, as this will affect fluid temperature in some cases.

In rare cases when the tips provided above do not aid in completion of the Learning Control process, performing a short test drive of 5-7 miles may resolve the issue. In the event a test drive is determined as the next step, keep in mind the fluid temperature may rise beyond the specification required for Learning Control to complete, in which case a cool down period will be necessary.

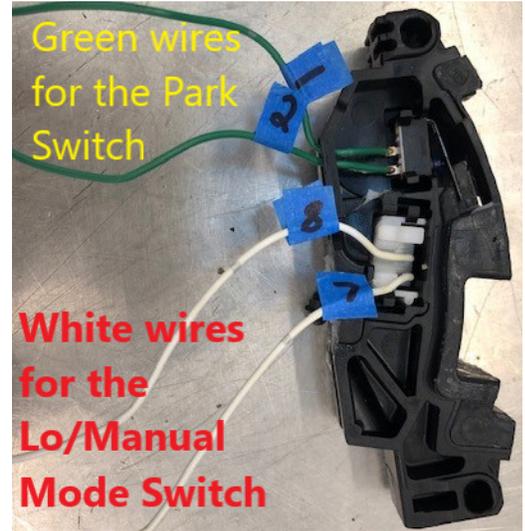
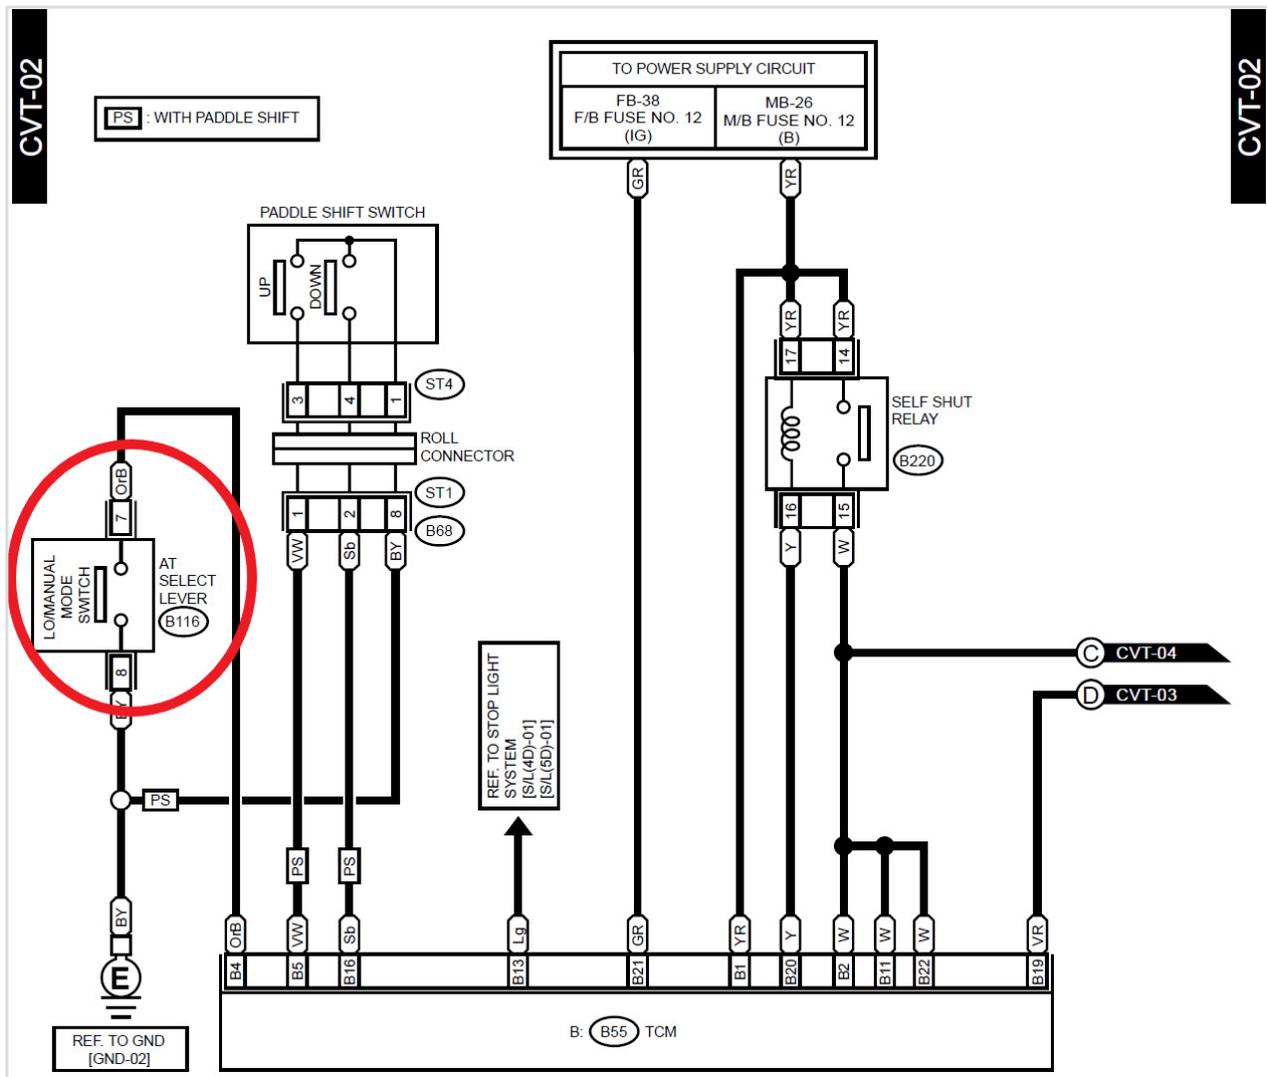
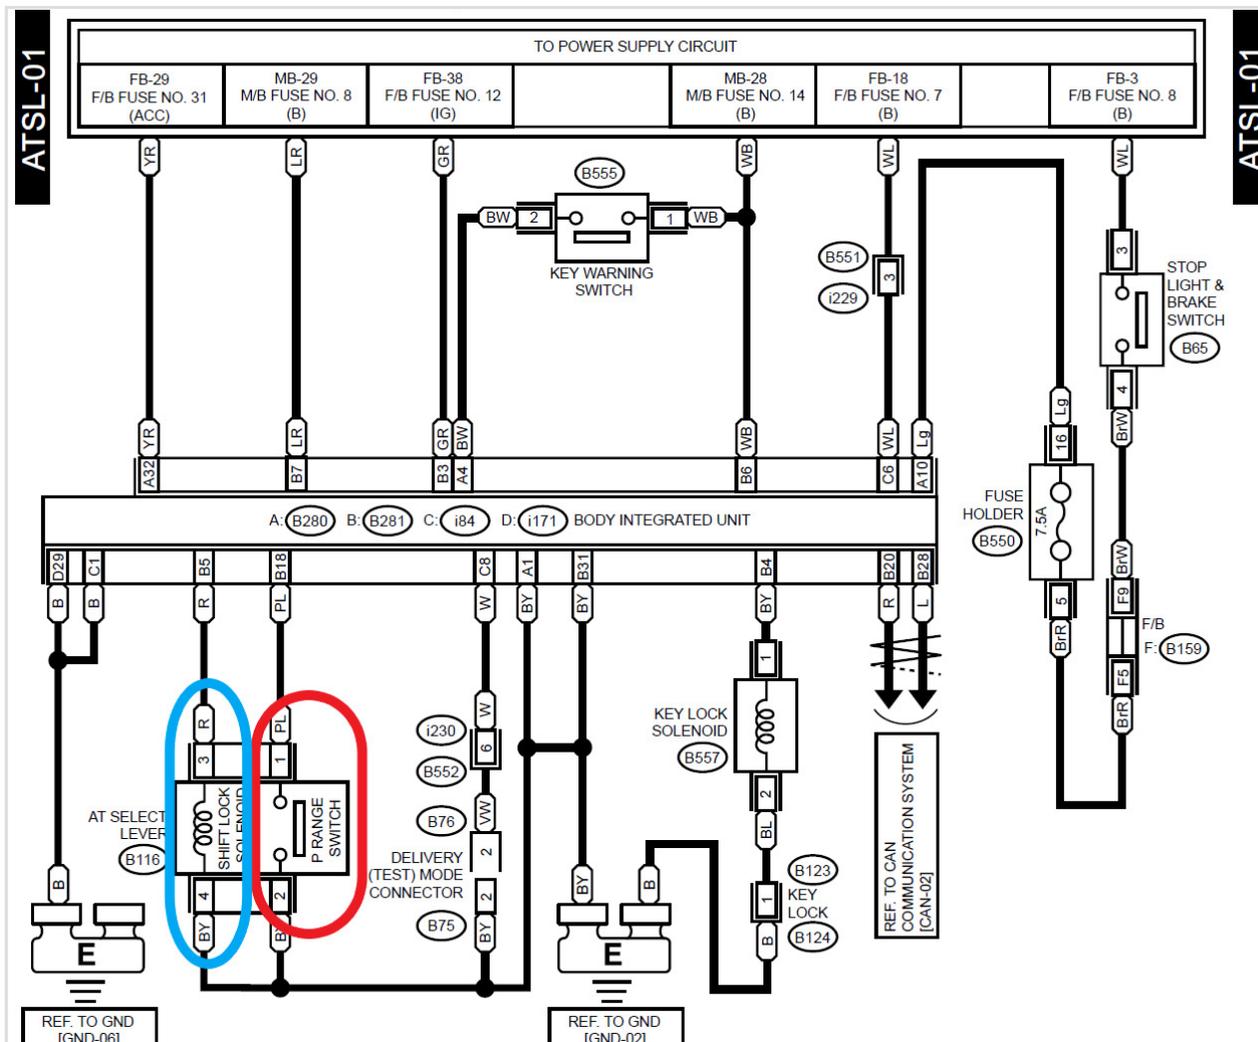
There has been some confusion regarding the installation of Guide Plate B on vehicles that are affected by TSB 16-112-18R. Specifically, the wire colors may vary from the original guide plate to the replacement part. Here is a quick guide of how to identify which pins to remove from the connector and where to place the replacement part pins into the connector. For the guide, we are using parts and diagrams from a 2012 Impreza.

There are two separate switches included within Guide Plate B. The green wires are for the Park Switch, the white wires are for the Lo/Manual Mode switch for this vehicle. The Park Switch uses pin numbers 1 & 2 of connector B116 and the Lo/Manual Mode switch uses pins 7 & 8 (pins 3 & 4 are used for the shift lock solenoid coil and are removed during the shift lever disassembly procedure.)

Remember, the wire color might vary from what is shown in the photo. Make sure to identify the point where the wires originate and which switch they are for as shown in the first photo.

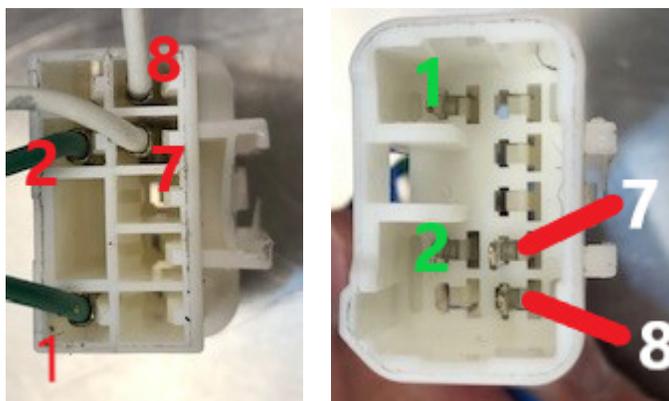
The pin numbers are identified in the CVT control and the shift lock solenoid wiring diagrams for the 2012 Impreza.

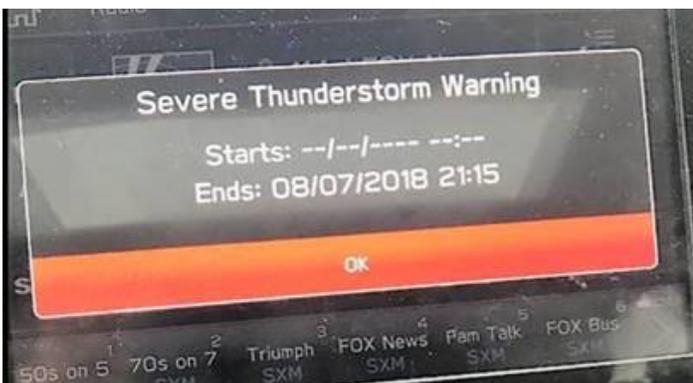
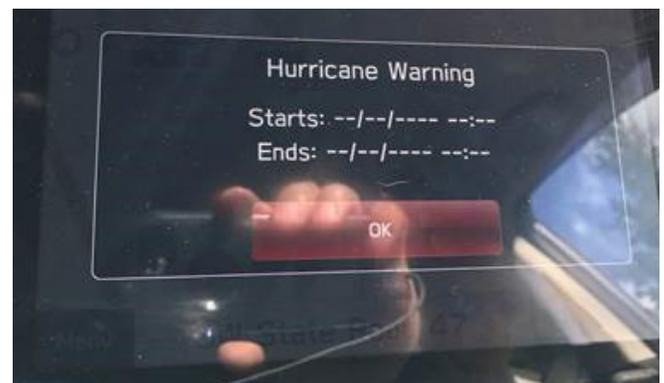
The head unit is designed to receive severe weather alert information from Sirius XM (SXM) and display a pop up window with the alert message, whenever there is a signal from SXM. So far, we are only aware of HIGH grade units to have this feature available.

Please note when there is no date information supplied by SXM, the details (dates/ times) will be shown as --/--/---- --/-- in the alert notification message. The head unit is operating as designed when this occurs.

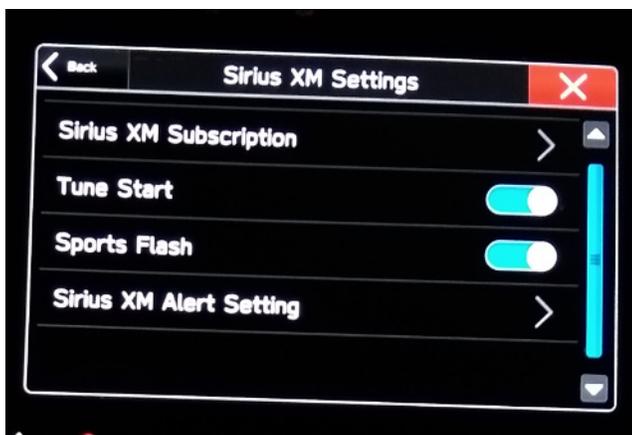
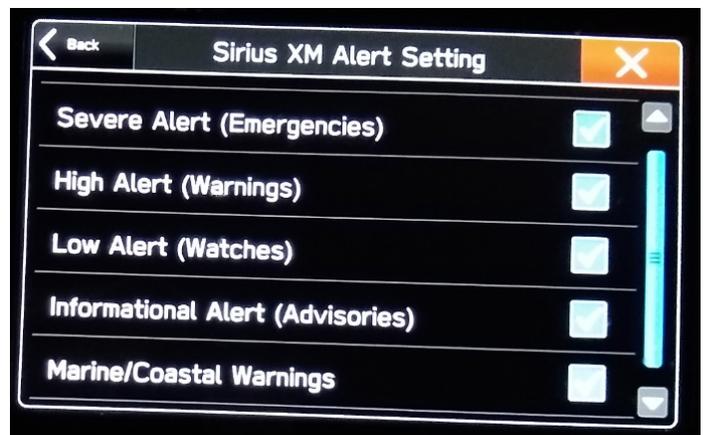
Effective with the version 6 software, Harman has implemented an enhancement to allow user control of some weather alerts from Sirius XM service. Settings are found under Settings/General/Sirius XM Settings. See below.

Please note this feature is available only in HIGH grade units.

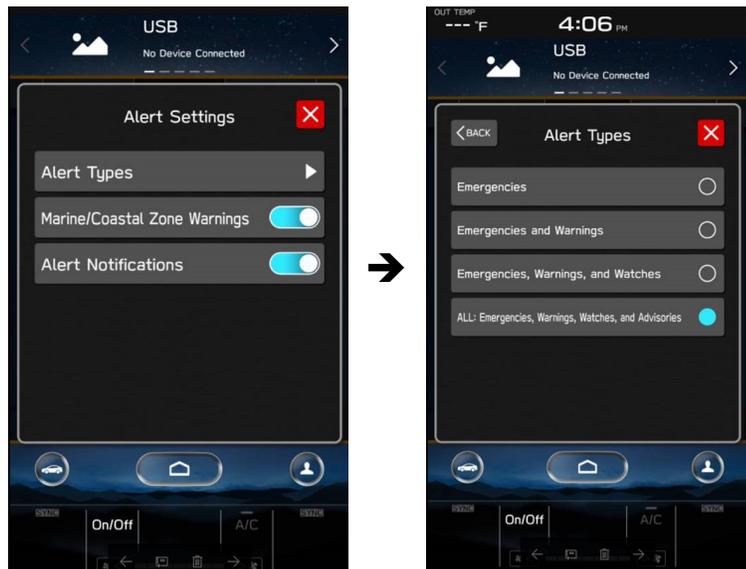
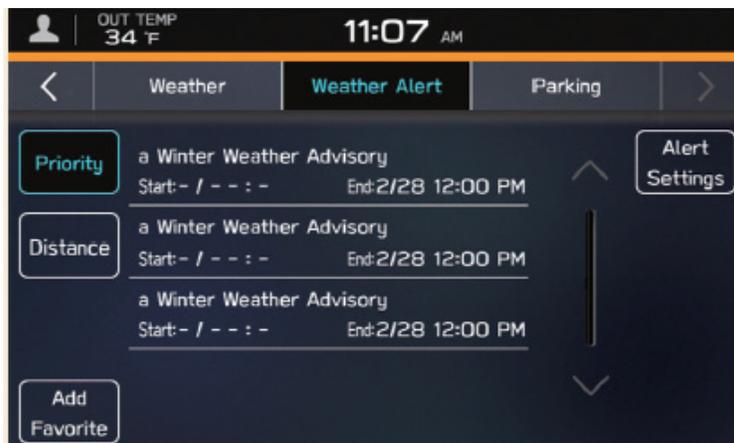
Please note Denso also implemented an SXM weather alert settings within the Gen 4 CP1 controls. These settings control all alert types as well as the ability to completely turn the alerts off. Unlike Gen 3 Harman, the settings for Weather alert in Gen 4 Denso are under SiriusXM Travel Link menu (Applications).

See Gen 4 screens here.

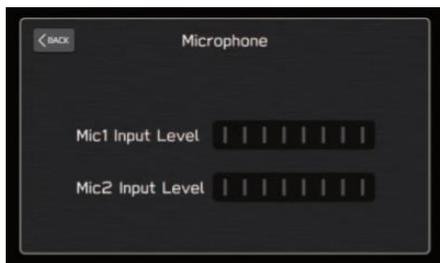
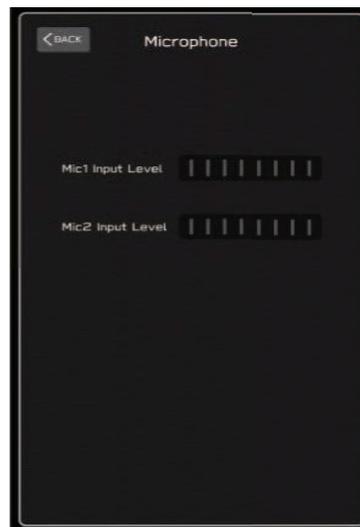
If you perform the diagnostic check for microphone operation using DIAGNOSTICS MODE (Dealership Mode/ Function Check/Microphone), you might notice the level gage reading appears weaker than expected or than you may have seen in prior testing. In some cases, you may notice a time lag, see no bars or just one bar displayed when speaking into the microphone. This behavior is noted for both input levels and does not necessarily indicate a concern with the microphone.

There is a known bug with the RC2003 software update which was released in June 2020. **See Appendix B** in TSB [15-261-20R](#) to confirm, if the software of the unit you are working on is impacted by this bug. This bug affects only the display of the microphone test and in no way impacts actual microphone operation. With this display being impacted, it is recommended to use other diagnostic methods. Alternatively, troubleshoot the microphone operation using the Voice Recognition feature, to confirm the unit receives voice input correctly or making a voice call. If concerns remain, perform continuity and voltage drop testing to confirm if a poor contact or connection may exist. Reference the applicable service manual for the related wiring diagrams for the Cockpit Control Module and microphone wiring diagrams with or without Telematics depending upon the vehicle under review.
