SERVICE BULLETIN

APPLICABILITY: 2019-20MY Impreza
 2019-20MY Crosstrek (Including Hybrid Model)
 2019-20MY Forester
 2019MY Legacy/ Outback
 2019-20MY WRX
 2019-20MY BRZ- Navigation -equipped ONLY
 2019-20MY Ascent

NUMBER: 15-236-18R

SUBJECT: Reprogramming File Availability for Optimization of
 Harman Gen 3.1 Audio and Navigation Head Units

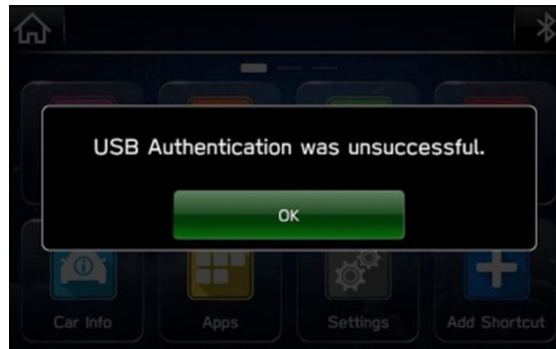
NOTE: If an attempt is made to install the wrong “grade” file into the wrong grade head unit (EXAMPLE: “Base” update file into a “Base Plus or Mid” or “High” head unit), the USB Authentication error screen below will be displayed:

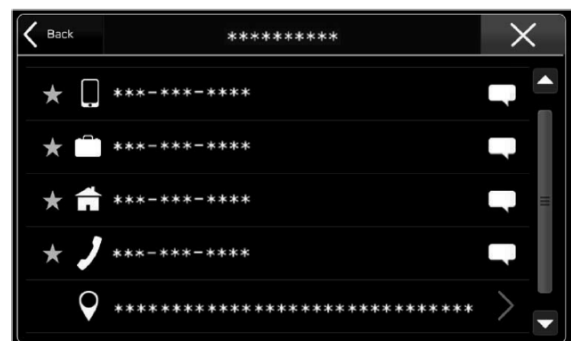
- 1) AM/FM radio station presets are lost.
- 2) Favorite Phone Contacts list is lost.

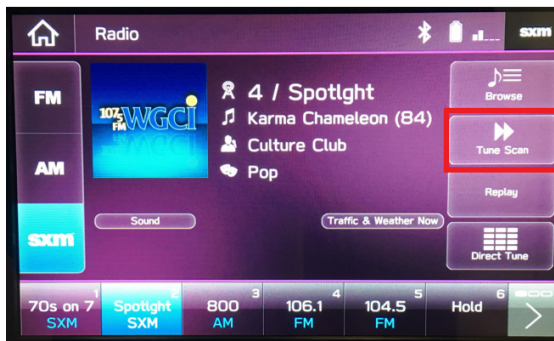
- 3) <Scan> previously displayed on SXM screen was changed to <Tune Scan> (a.k.a. SEEK).

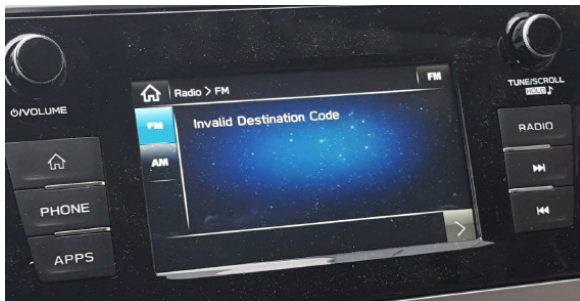
- 4) US State names corrected when using voice guidance.
- 5) Correction made for Pop / Crackling-type sound when using AM radio.
- 6) Navigation system freezes during loading / start-up.
- 7) Music skips/cuts out while using Apple CarPlay.
- 8) Hands-free feature freezes intermittently while loading.
- 9) Navigation system freezes after entering a particular address using Voice Recognition.
- NOTE:** All other functions are not affected.
- 10) The voice guidance volume no longer changes After Ignition Off/On. Once the Voice Guidance has been muted, the system retains that setting even after switching the ignition Off/On.
- 11) Invalid Destination Code message appears on the display while listening to the radio.

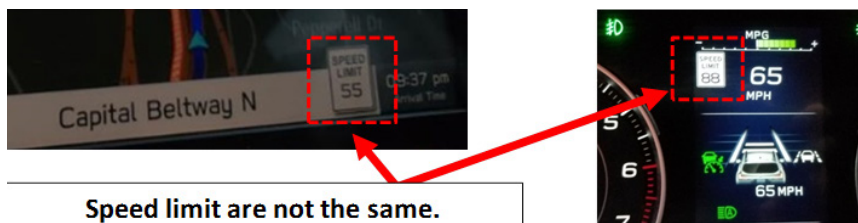
- 12) Spanish version FOTA (Firmware Over The Air) translation corrected.
- 13) Mismatch of Speed Limit between Navigation display and the Speed Limit displayed in the Combination Meter Multi-Function Display (MFD).

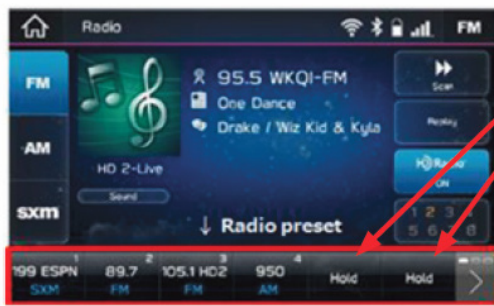
- 1) Station presets are lost. Touch buttons read “Hold”. (Applicable for software versions Rel_4.18.25.50 (or before)). Included in software version Rel_U1.18.38.50.
