# Technical Service Bulletin

REAR CONSOLE LID DOES NOT SLIDE SMOOTHLY

Bulletin No.: 09-024/20

2020 CX-30

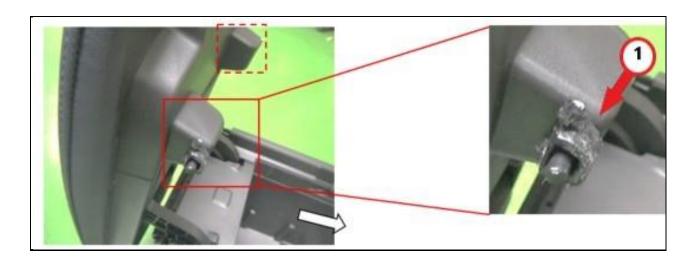
Some customers may complain that the rear console lid does not slide smoothly. This may be caused by improperly positioned felt pads attached to the rear console lid lock, which may have moved out of position after repetitive use. The exposed adhesive residue may stick to the rail and disrupt smooth sliding operation.

- 1. Verify the customer concern.
- 2. Open the lid and remove the felt pads (1) glued onto the locks, as shown below.

**NOTE:** The white arrow indicates the front side.
