### 37 Oil appears to be leaking from the transmission pan gasket or the transfer case

37 20 01 2039650/2 July 16, 2020. Supersedes Technical Service Bulletin Group 37 number 15-55 dated February 5, 2015 for reasons listed below.

Model(s)	Year	VIN Range	Vehicle-Specific Equipment
A4	2011 - 2016	All	0BK Transmission
A5, A5 Cabriolet, and Q5	2011 - 2017	All	0BK Transmission
A6, A7	2012 -2018	All	0BK Transmission
A8	2011 - 2018	All	0BK Transmission

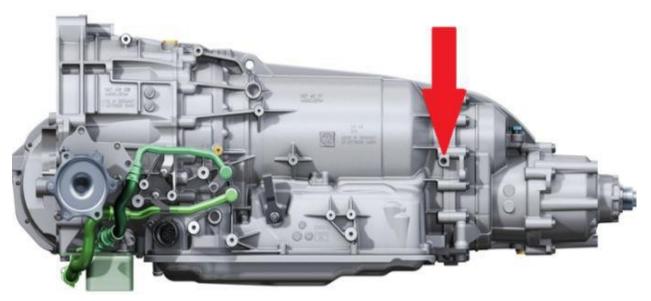
You must check the weep hole of the double seal between the transmission and transfer case, which is located on the driver's side of the vehicle (Figure 1). A leak from this location can appear to be from the pan gasket if the oil is not cleaned off and a proper diagnosis performed using oil leak tracing powder.

Figure 1. Location of the double seal weep hole.

- 3. If the transmission oil is leaking from the weep hole of the double seal (Figure 1) skip to step 6.
- 4. If the transmission oil is leaking from a serviceable gasket or external seal, repair per the repair manual and this TSB does not apply.
- 5. If the transmission oil is leaking from a non-serviceable part and the vehicle is covered under warranty, open an Audi Technical Assistance Center (TAC) case with pictures of the oil leak attached and your diagnosis information. Then contact the Audi Technical Assistance Center (TAC). *If the vehicle is no longer covered under a new vehicle warranty or Certified Pre Owned warranty you may continue with your diagnosis and repair.*

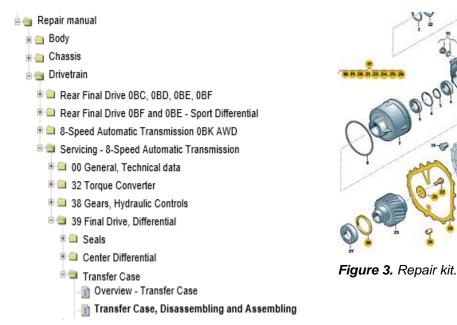
Figure 2. Location of the repair instructions.

6. An oil leak from the weep hole of the double seal is repairable and the instructions are available in the Elsa Repair Manual at: Drivetrain >> Servicing – 8-Speed Automatic Transmission >> 39 Final Drive, Differential >> Transfer Case >> Transfer Case, Disassembling and Assembling (Figure 2). There is a repair kit in the parts catalog containing the double seal, transfer case gasket, and hardware that will be needed for the repair (Figure 3).
