Subject: Modine e-fan Harness Rework			
Field Change Program: Field Campaign	FCP Number: 480	Revision: A	Date: 07/21/2020
Coach Section: 06-Cooling	P/N: 06-01-1648, 06-01-1655		Type: Product Integrity

1.0 Description

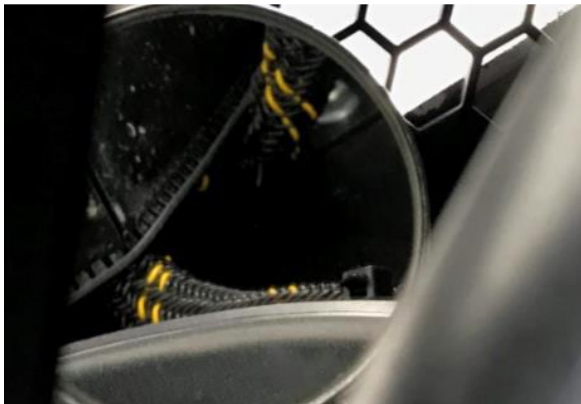
If there is any visible red wire resting on the fuse compartment edge as shown below, continue to Section 5.0. Otherwise, continue to Section 6.0.

Good

If no red wire is visible, continue to Section 6.0

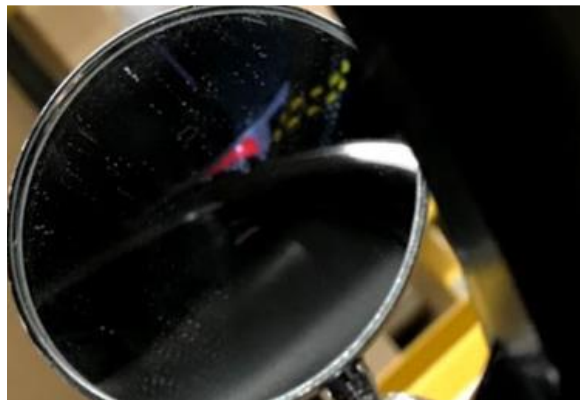
Bad

If red wire is visible, continue to Section 5.0

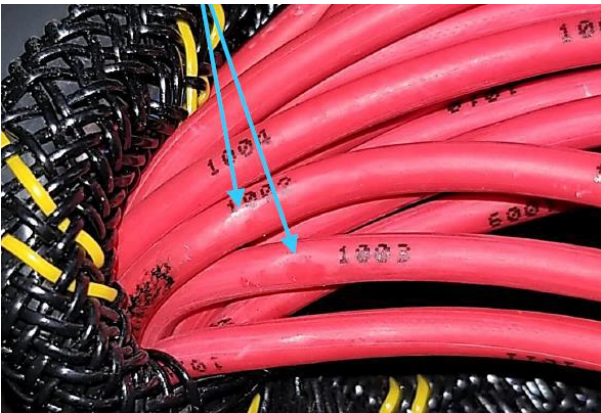
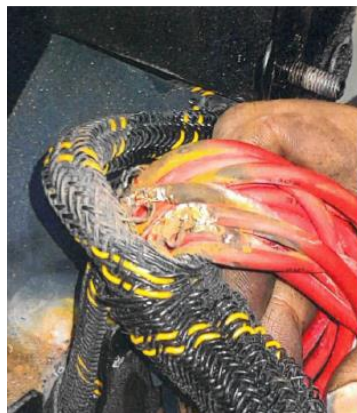
Inspect the red wire for abrasion or exposed conductors. If no damage is found, continue to the next steps. Otherwise, refer to the maintenance manual to replace the harness.

Good

Bad

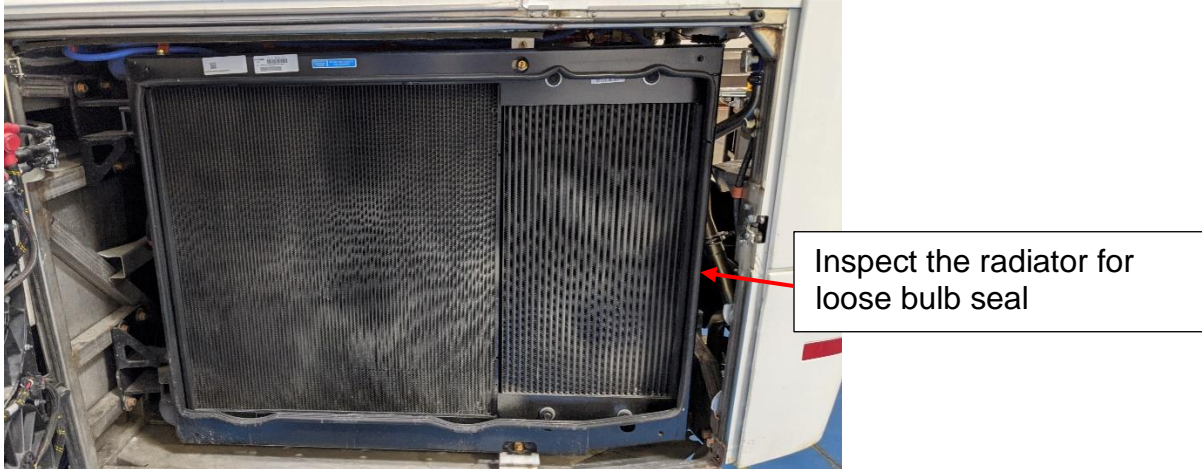
Inspect the radiator for loose bulb seal.

If bulb seal is found loose, continue to Section 6.2. Otherwise, procedure is complete.
