Technical Service Bulletin

51 Cracking noises in right rear roof area during steering thrust

51 20 14 2060145/1 July 24, 2020.

Model(s)	Year	VIN Range	Vehicle-Specific Equipment
Q8,	2019 - 2020	All	Not Applicable
RSQ8	2020	All	Not Applicable

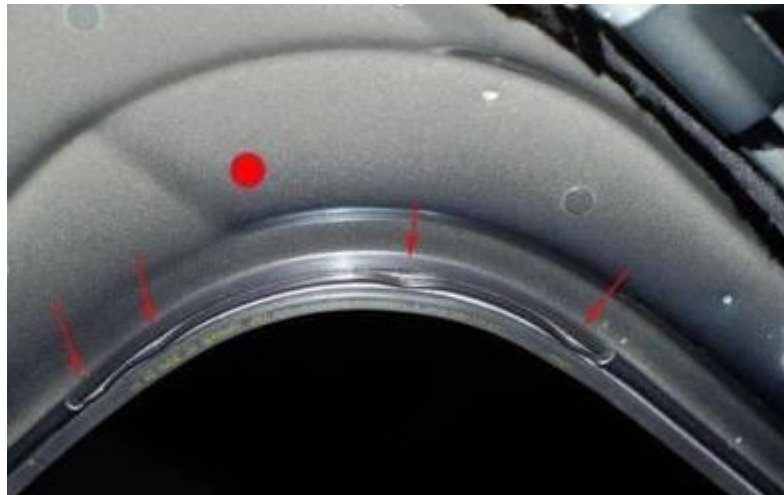
Figure 2. The red dot shows the location of the 10 mm hole to be drilled.

2. A 10 mm diameter hole is to be drilled in the spot marked with the red dot shown in Figure 2.

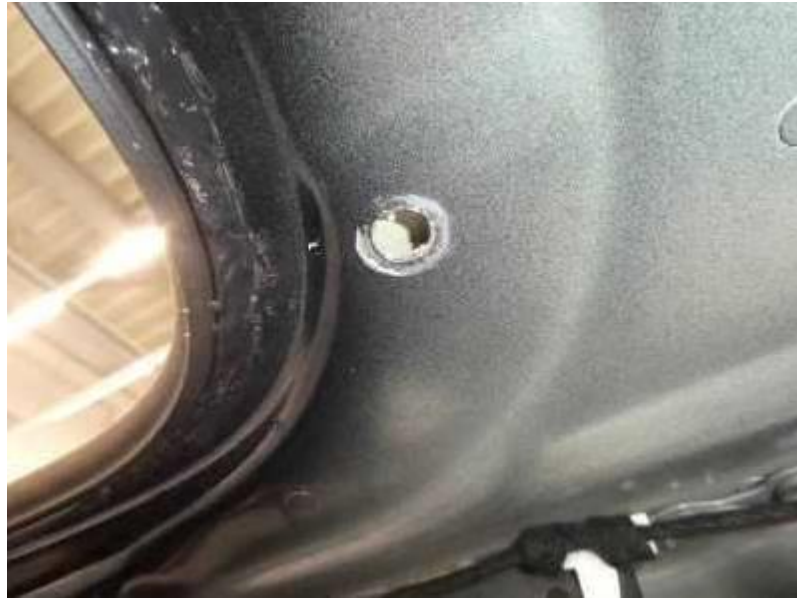
Figure 5. Hole drilled.

5. Figure 5 shows the drilled hole.

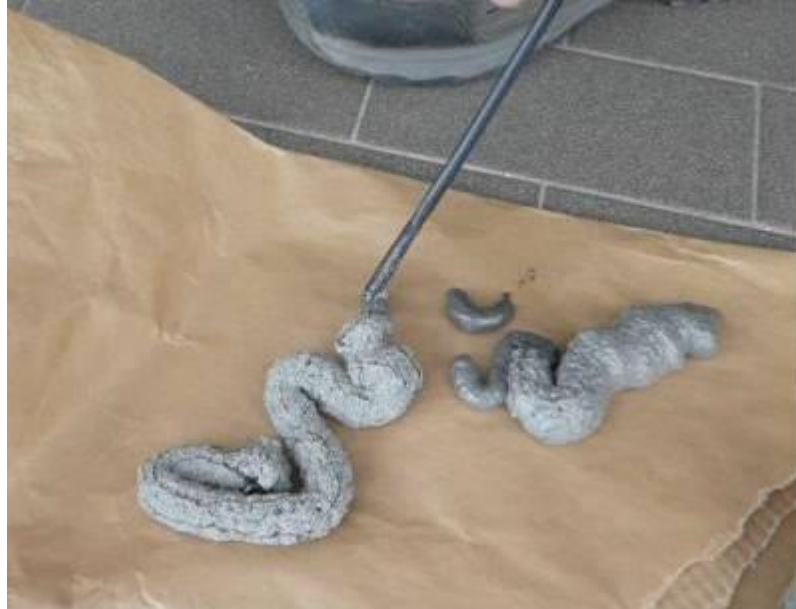
Figure 7. Purging air from the nozzle in preparation of the cavity fill.

7. The canister must be held vertically with the nozzle pointing down whenever the foam is ejected. Before injecting the foam the nozzle and tube must be purged of air released (Figure 7). Blow out about a 20 cm stream of foam.

Remember to hold the can vertically with the nozzle pointing down. When the trigger is fully pulled, about 0.25 liters of foam is ejected per second. The foam will expand up to 100%.

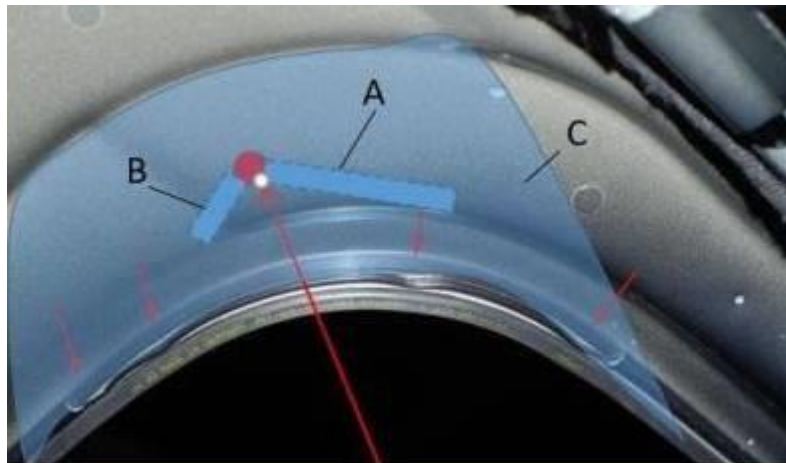
Figure 8. Foam nozzle hose positioning and cavity fill area.

8. The shaded area in Figure 8 is the area on each side where the foam is to be injected. To do this the foam must fill the cavity by first inserting the hose in the 'B' direction to a length of 2 cm, then inserted in the 'A' direction 3 – 4 cm and filling for 1 full second of trigger activation per hose direction shown in Figure 8. This should fill the area with the appropriate volume. Do not exceed 1 full second of trigger pulse per fill as the volume of foam injected will be too great.

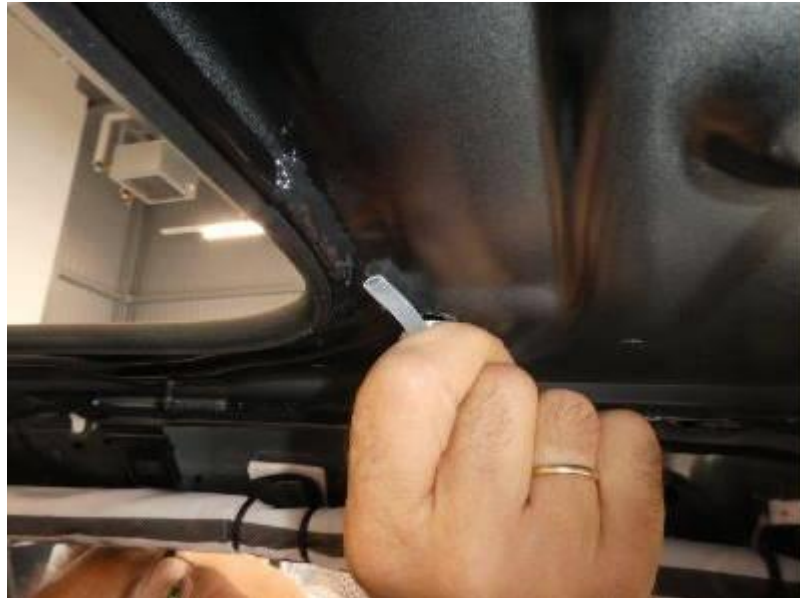
Figure 9. Hose insertion simulation in the 'B' direction.

9. Figure 9 illustrates the hose as it will be inserted in the 'B' direction.

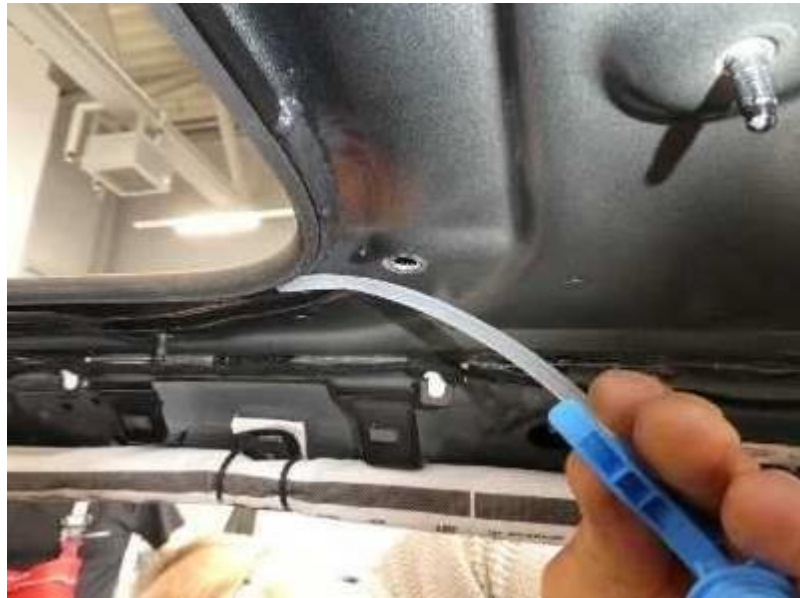
Figure 10. Hose insertion simulation in the 'A' direction.

10. Figure 10 illustrates the hose as it will be inserted in the 'A' direction.

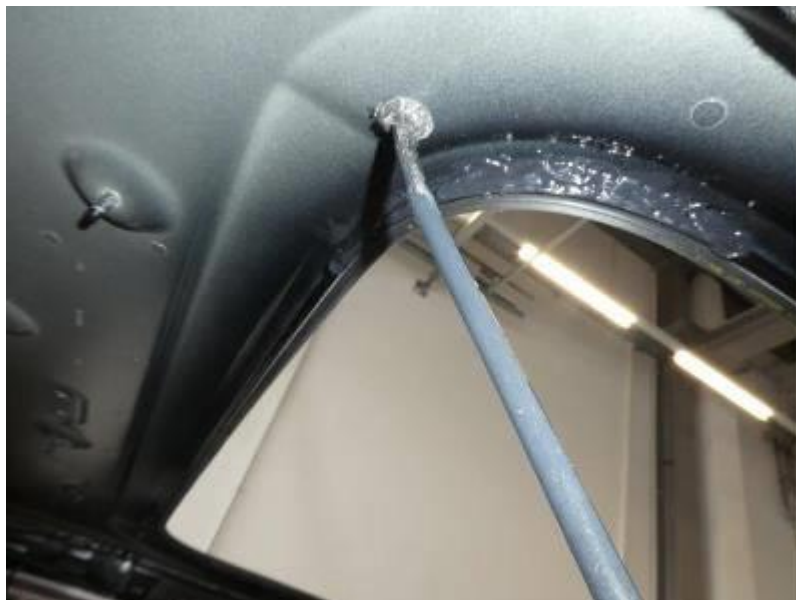
Figure 11. Filling the cavity with foam.

11. Fill the cavity (Figure 11).
