# Technical Service Bulletin

## 57 Exterior door handles do not return to the zero position

57 20 71 2060196/2 July 24, 2020. Supersedes Technical Service Bulletin Group 57 number 20-70 dated July 16, 2020 for reasons listed below.

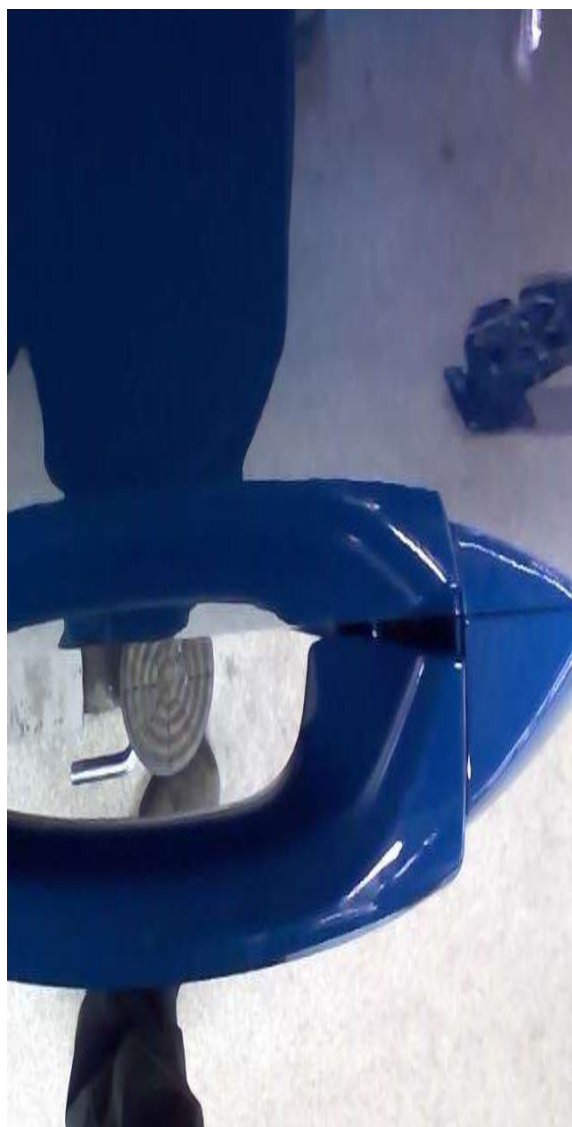
- Exterior door handles are binding and are not returning to the zero position.

Due to material tolerances, the door handle guide is binding within the door handle mounting bracket.

*Figure 1. Door handle binding and not returning to zero position.*

1. Check the function of all door handles. Door handles should return to the zero position without binding and/or jamming (Figure 1).

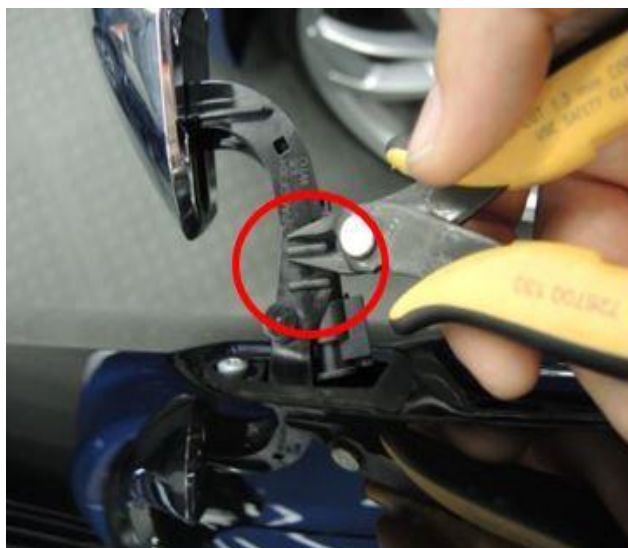
**Figure 2.** #1 and #2 door handle ribs prior to removal.

3. Using precision diagonal cutting pliers, remove door handle rib #1 and #2 on the pivot side of the mounting bracket, towards the front of the vehicle (Figure 2).

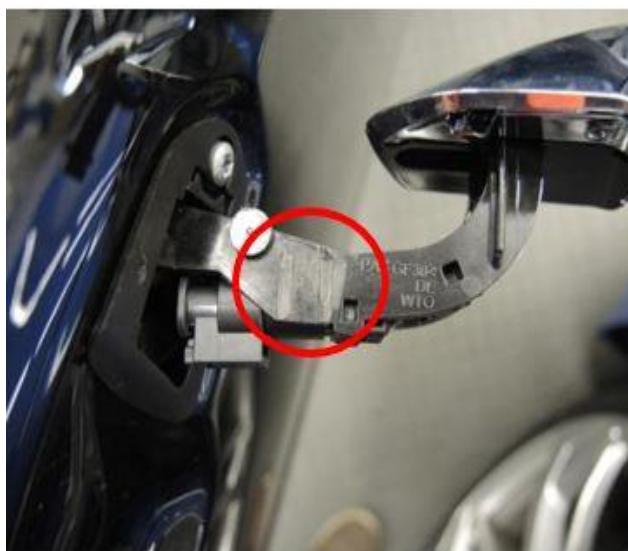
**Figure 3.** The door handle is shown with #1 and #2 ribs removed, leaving an even surface.

4. After removing both ribs, ensure that the resulting surface is smooth and without any protrusions (Figure 3).

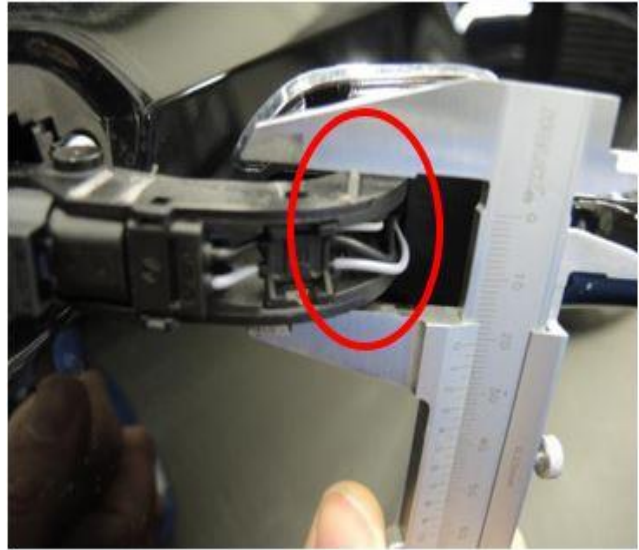
**Figure 4.** Measuring dimension of a door handle at rib #3.

5. Using a vernier caliper, measure the dimension from the bottom edge of the door handle to the top of rib #3 (Figure 4).

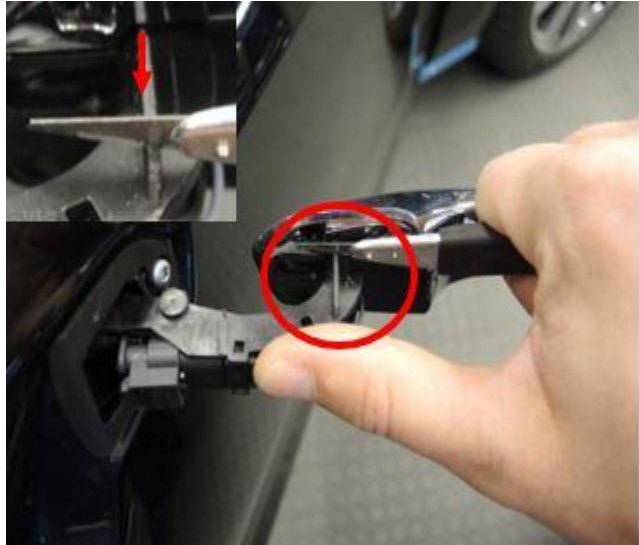
**Figure 5.** Rib #3 shown with the direction of scraping motion.

6. If the dimension is larger than 20.9 mm (~ 0.82 inches), scrape the top of rib #3 with a precision/utility knife in direction of the arrow (Figure 5).

7. Repeat steps #5 and #6 until the dimension of the door handle at rib #3 is less than 20.9mm.

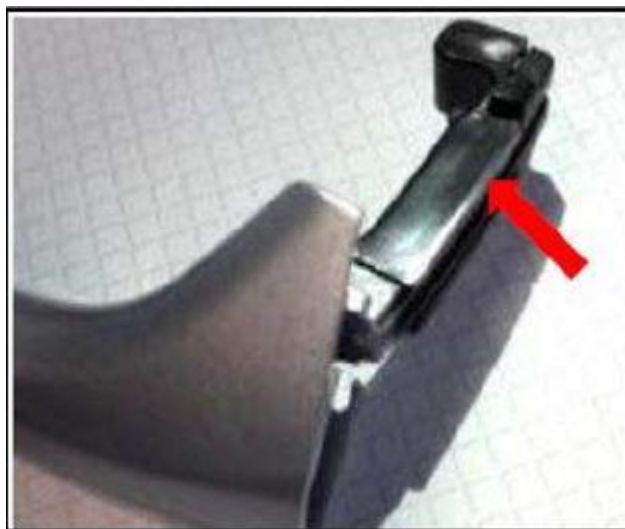
**Figure 6.** The door handle guide piece to be replaced.

8. Replace the door handle guide piece on the lock cylinder side, towards the back of the vehicle (Figure 6) with a new guide piece (check parts table for part number).
