Technical Service Bulletin

91 Audi Smartphone Interface (ASI): Apple CarPlay or Android Auto display screen intermittently goes blank in FPK

91 20 88 2060264/1 July 22, 2020.

Model(s)	Year	VIN Range	Vehicle-Specific Equipment
R8, TT, and TTRS	2018 - 2020	All	Not Applicable

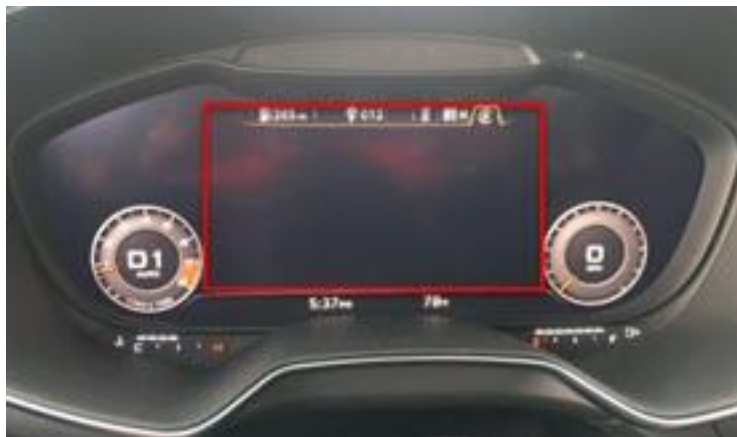
- The FPK (Free-Programmable Kombi/Cluster) screen goes blank intermittently when viewing the Audi Smartphone Interface (ASI) screen (Figure 1).
- This can occur while using Apple CarPlay or Android Auto.

Figure 1. FPK screen is blank.

This condition is caused by an MMI software configuration issue. Model Year 2019-2020 vehicles can have this issue with the factory-installed MMI software. Additionally, Model Year 2018 vehicles that received a recent MMI software update could also experience this issue. It's important to note that the issue is intermittent and does not always occur during a drive based on driving conditions. However, for some customers, this issue can occur during each trip each day.

1. Follow all instructions in TSB 2047576: *91 MIB2 High Navigation Software Update Instructions (PR Code 7UG).*
2. Update the infotainment system using the SVM action code and SD-Card as listed in the table below, if necessary:
