Service Action – USA Only

Code: 91X9

Subject Car-Net® Button Array

Release Date July 29, 2020

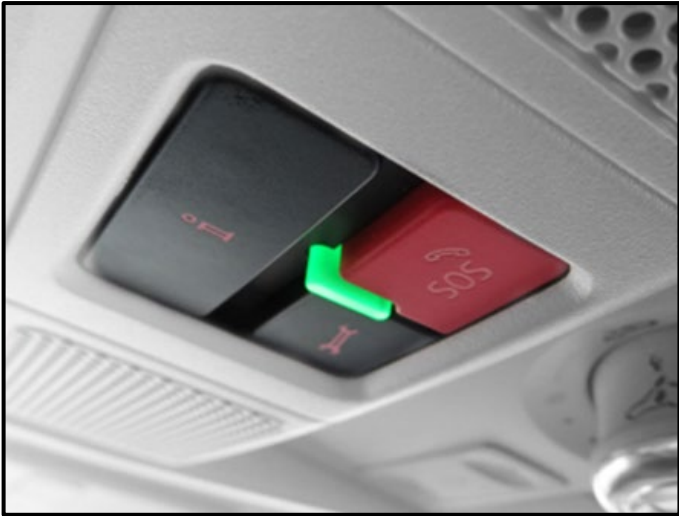
Repair Overview

Problem Description On certain vehicles, the Car-Net button array was not enabled.

- Perform software configuration for the infotainment control module.

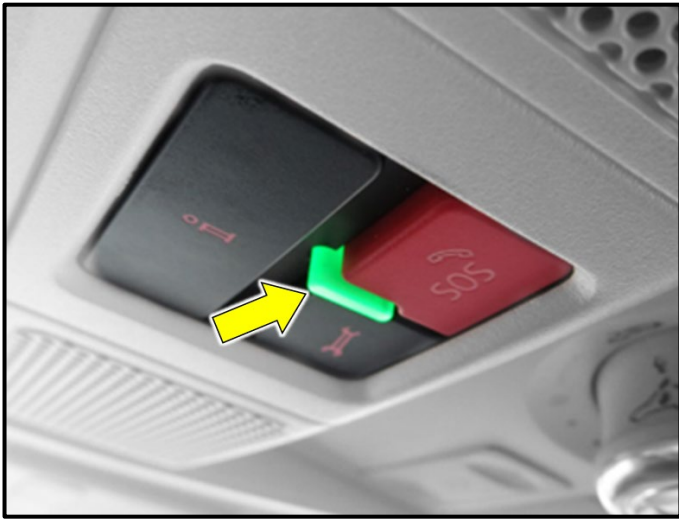
Prior to performing the software configuration, take note if the Car-Net status light <arrow> is either green or not illuminated.

- Open the hood.
- Open the battery cover.
- Switch the ignition on.
- Apply the parking brake.
- Switch off all consumers (headlights, heated seats, climate control, etc.).
- Connect the VAS6150X/VAS6160X Diagnostic Tester to the vehicle.
- Start the ODIS program.
- Attach the GRX3000VAS Tester/Charger (or equivalent) to the vehicle battery.
