Service Alert

| Subject: ENGINE NO START DUE TO LOW BATTERY VOLTAGE | Service Alert No.: SA-054/20 |

2019-2020 Mazda3
2020 CX-30

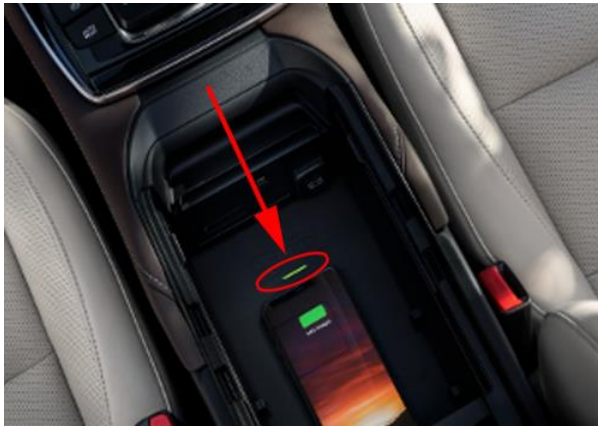
- No: Go to step 4.
3. Turn the ignition OFF. Is the Mazda Wireless Charger LED indicator is ON?
- Yes:
 - **Mazda3** - The Mazda Wireless Charger installation is incorrect. Replace the Mazda Wireless Charging kit and install it using the North America installation instructions (go to MXConnect - Parts and Accessories - Accessories - Genuine Mazda Accessories (GMA) - Accessory eCatalogue - Wireless Charging - Related Documents - Installation Instructions).
 - **CX-30** - Go to [MSP57](#)
 - No: Go to step 4.
