Complaint - Headliner is Sticking Out in the Door Seal Area: Re-Aligning Headliner (98/20)

Model Line: **Panamera (971)**

Model Year: **As of 2017**

Subject: **Headliner**

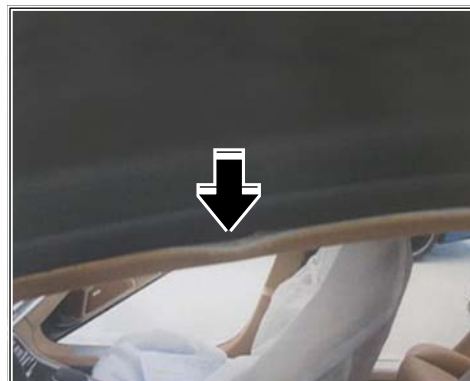
Headliner

Information: The headliner in the door area can stick out over the inner door seal due to manufacturing tolerances ⇒ *Headliner*.

- Remedial Action:
- Detach and check headliner.
 - Replace door seals in accordance with instructions.
 - Rework and align headliner.

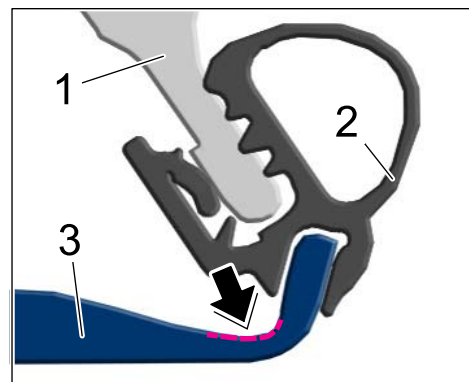
Checking for kinks

Check whether the headliner ⇒ *Checking for kinks -3-* is kinked in the critical area ⇒ *Checking for kinks -Arrow-* and replace it if it is damaged.
