July 27, 2020

Version 1

2018-20 Odyssey: Popping or Crackling from the Speakers; No Sound from the Audio System; *Network Loss* Message

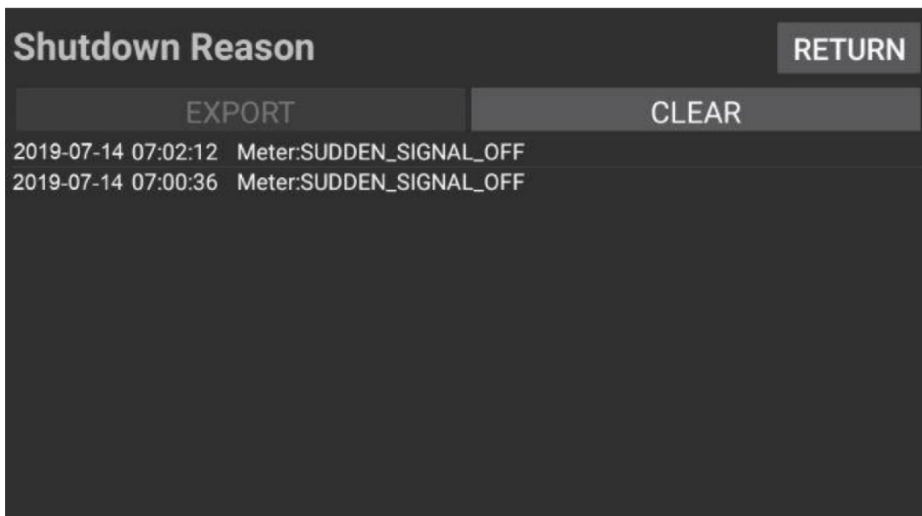
In this example, the cause of the failure can be identified as **Meter:SUDDEN_SIGNAL_OFF**.

Write down any failures; they will be collected on the warranty claim. Then, clear the data.

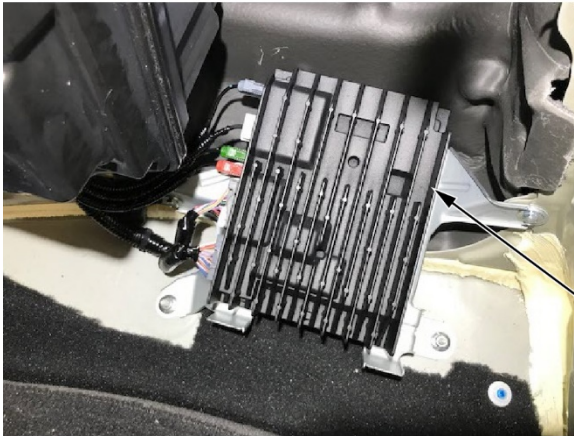
STEREO AMPLIFIER OR
TUNER-AMPLIFIER

There is a loose connection in the MOST bus network.

25. Disconnect the red and green FAKRA connectors from the stereo amplifier (Elite) or tuner-amplifier unit (EX, EX-L, Touring), gauge control module, and infotainment unit using the straight FAKRA puller.
