JLRTB02044NAS1

TECHNICAL BULLETIN

Charge Air Cooler Intake Pipe Leaking

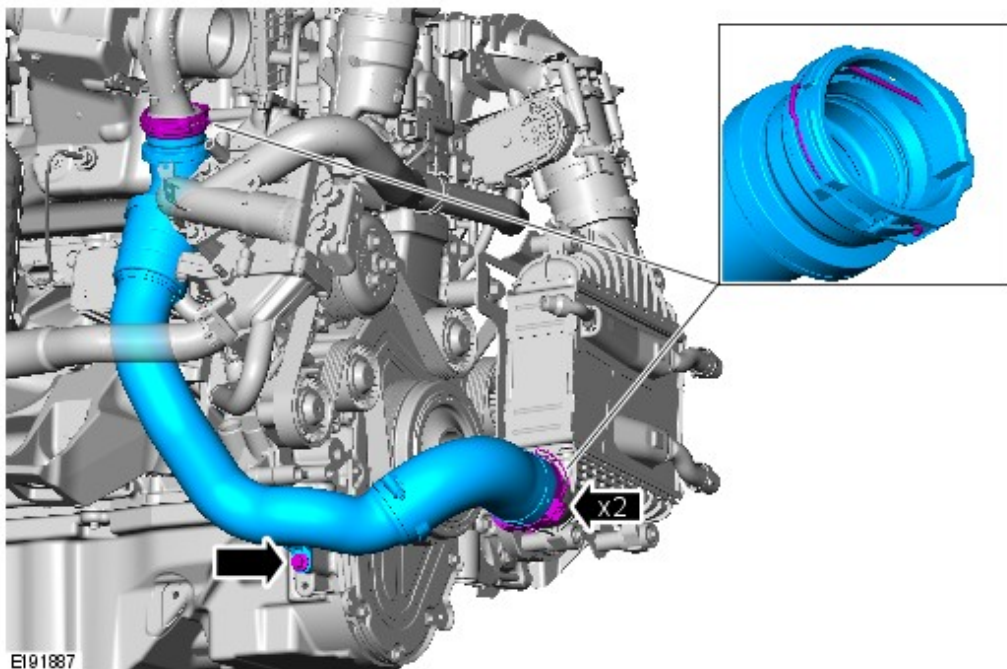
3.

Remove the charge air cooler intake pipe.

- ■ Disconnect the 2 retaining clips.
- ■ Remove the bolt.

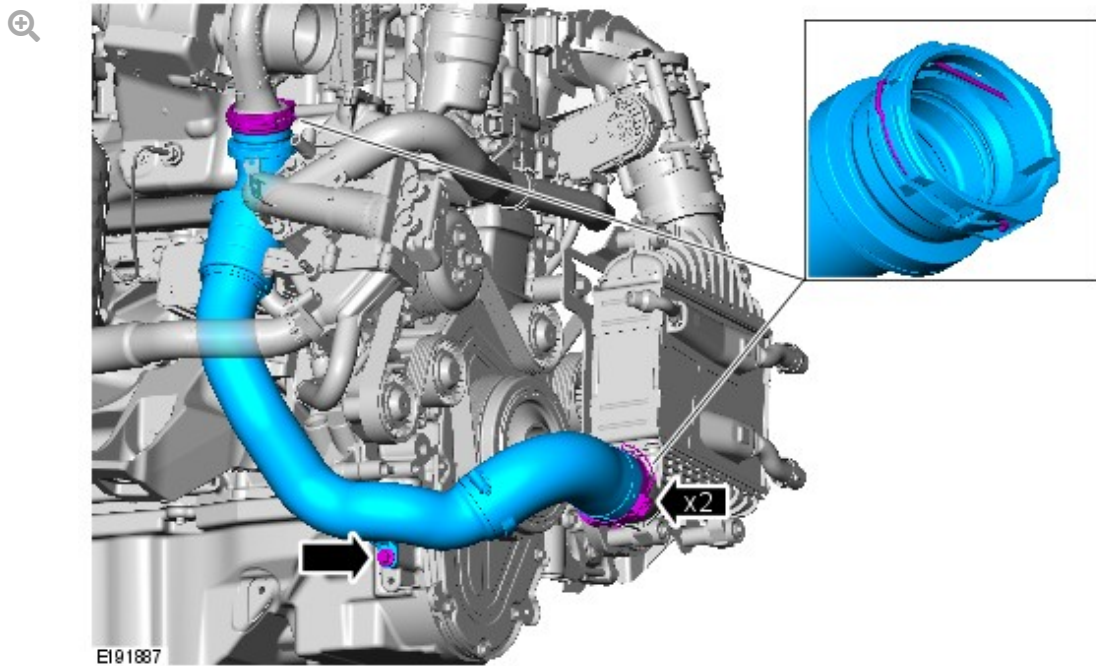
6.

Install the charge air cooler intake pipe.

- ■ Secure the 2 retaining clips.
- ■ Install the bolt.
 - ■ Torque: **9 Nm**
