Latest Vehicle Concern Fixes

3.0P Supercharger FEAD idler and Supercharger tensioner noise

17MY Onward Range Rover, RR Sport, RR Velar, Discovery, F-TYPE, F-PACE, XE, XF, XJ equipped with AJ126

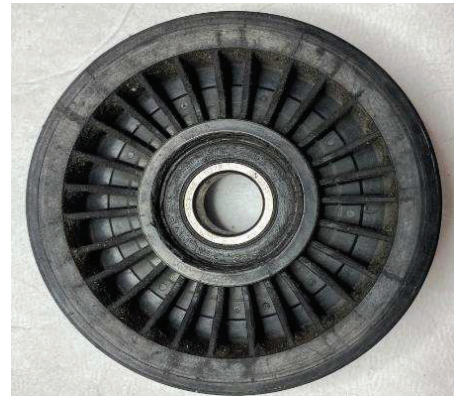
- The root cause of the noise is the idler pulley and/or tensioner on the Supercharger FEAD Belt.

- Reference SSMS 74810 and 74811.
- Raise an EPQR and include the following:
 - Video or sound file of the noise.
 - Photographs that detail any evidence of contamination of the pulley and the origin of the contamination.
 - Service history from the vehicle.
