Latest Vehicle Concern Fixes

| Air Conditioning Hose Clash | 20MY Defender |

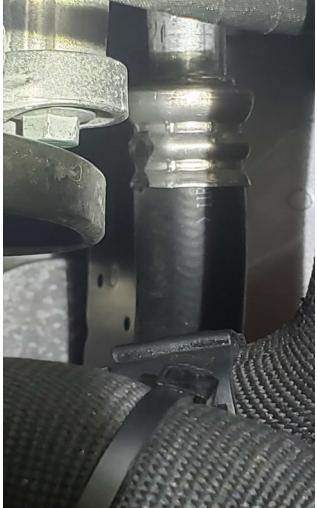
| Air Conditioning Hose Clash | 20MY Defender |
|---|--|
| <p><u>Customer Voice:</u></p> <ul style="list-style-type: none">• A customer may report an abnormal noise (like a humming, buzzing, or grinding) when accelerating or decelerating. <p><u>Technical Description:</u></p> <ul style="list-style-type: none">• The air conditioner refrigerant line may clash with the FEAD belt tensioner pulley intermittently as the tensioner moves based on belt load, due to misalignment of the line in the retaining bracket.• This applies to INGENIUM I6 engine variants only. <p><u>Status:</u></p> <ul style="list-style-type: none">• A SSM is being drafted for publication to address this concern.• The a/c refrigerant line position in the clamping bracket will required repositioning to correct the clash condition.• Take care when adjusting AC hoses not to induce stress as this may generate cracks or leaks in the system. | |

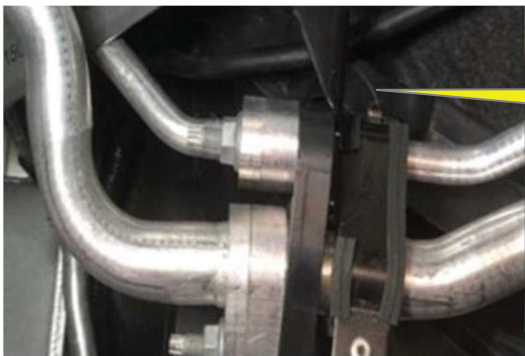
Incorrect

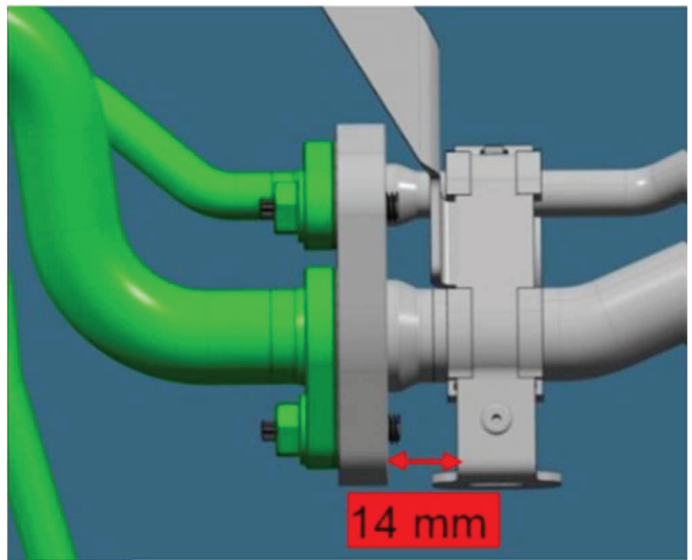
14 mm

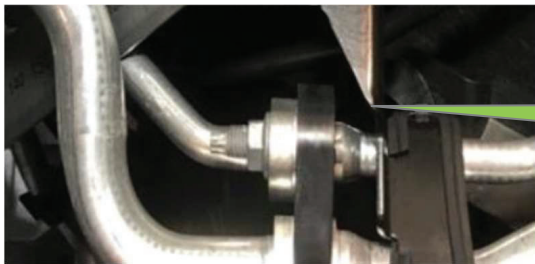
correct
