# HYUNDAI Technical Service Bulletin

20-BD-014H

**SUBJECT:** INFORMATION FOR LAMP CONDENSATION

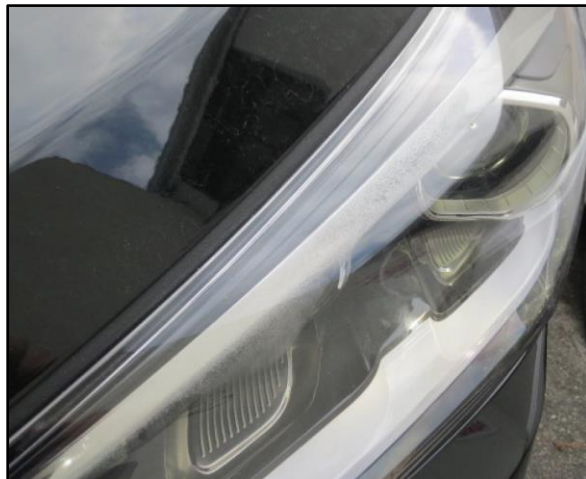
Condensation occurring inside the lamp assembly during or after a car wash cycle is considered a natural occurrence. This condition occurs when water vapor inside the lamp assembly is exposed to temperature variations.

This condensation is **NORMAL** and replacement is **NOT REQUIRED**.

*Normal condensation in the headlamp*

See page 4 of the service procedure for removing normal condensation.

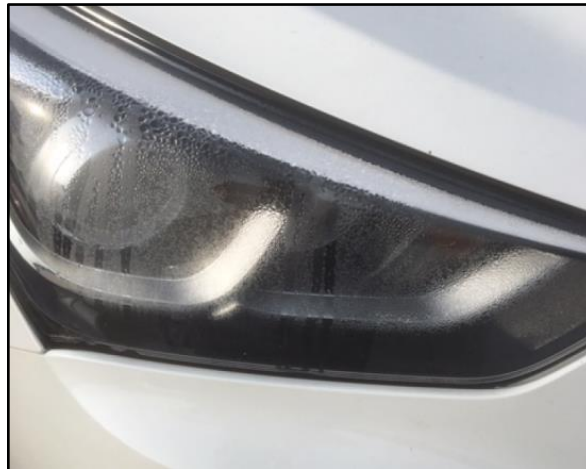
If water is collecting at the bottom of the lamp assembly, or the condensation remains after the lamps have been on for 30 minutes or more, there may be a water leak in the assembly. The leak may be caused by a poor seal between the lamp housing and lens, cracks in the lamp assembly, or poor fitment.

*Water collecting inside the headlamp*

The condition should be diagnosed and repaired as necessary.

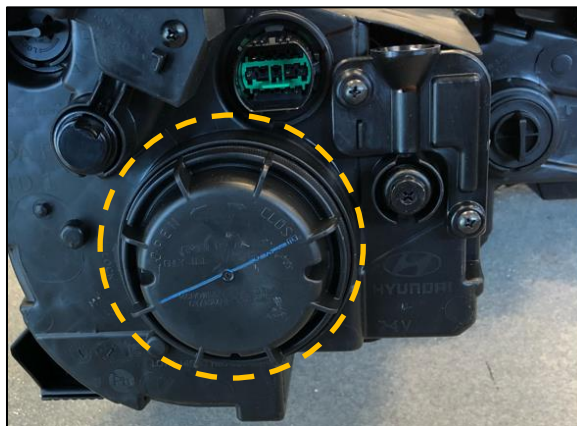
Example of dust cap location

- Ensure that the vehicle is parked in a well ventilated area and that the dust cap(s) have been removed prior to drying the lamp assembly.
- Certain lamp assemblies may have two dust caps. Remove both dust caps if applicable.
- To avoid battery discharge, the engine must be running while the lamps are on.
- Allow the vehicle to idle for 30 minutes with the engine running and lamps turned on for moisture / condensation to evaporate.
- Remember to reinstall the dust cap(s) after drying the lamp assembly.
