Technical product information

Topic	Noises from Panoramic sun roof
Market area	Bentley: worldwide (2WBE),Hongkong-Macau (5HK)
Brand	Bentley
Transaction No.	2054210/3
Level	EH
Status	Released for publishing
Release date	02-Jul-2020

Bentayga series

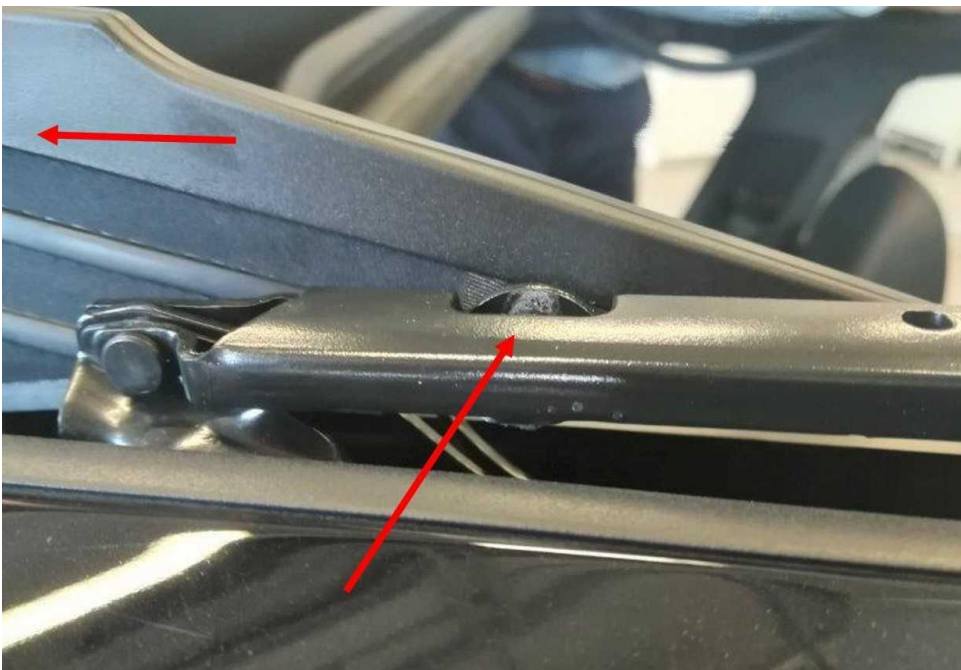
2) The above illustration shows the left mechanical system. The upper left arrow points to the driving direction. The lower arrow points to the first mounting point of the glass panel.

- For a better access to the points to be greased move the mechanical system (slightly) rearwards
- Apply grease spray G 060 567 A2 to the points shown within the onward instructions
