Technical product information

Topic	Rear end lowering function does not work
Market area	Bentley: worldwide (2WBE),Hongkong-Macau (5HK)
Brand	Bentley
Transaction No.	2055217/2
Level	EH
Status	Released for publishing
Release date	03-Jul-2020

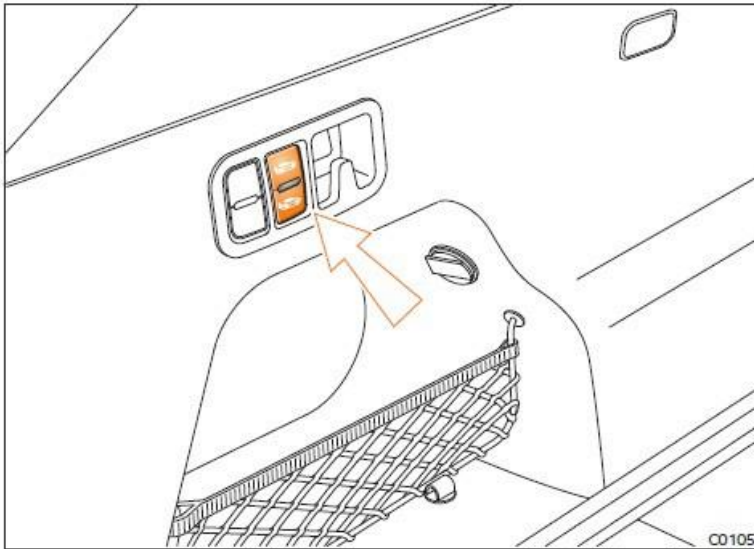
If the button for the rear end lowering is unintentionally operated when driving (for example by objects in the boot), the rear end lowering is sporadically not available. At least one of the two event entries C11B515 / C11B615 is logged.

Talk to the customer about the above issue. Replacing the button for the rear end lowering is not effective.

- Erase the applicable DTC's and check the functionality of the rear end lowering system
