# Technical product information

| <b>Topic</b> | Continental Series and Flying Spur - Camshaft Timing Over Advanced - V8T |
| <b>Transaction No.</b> | 2047762/4 |

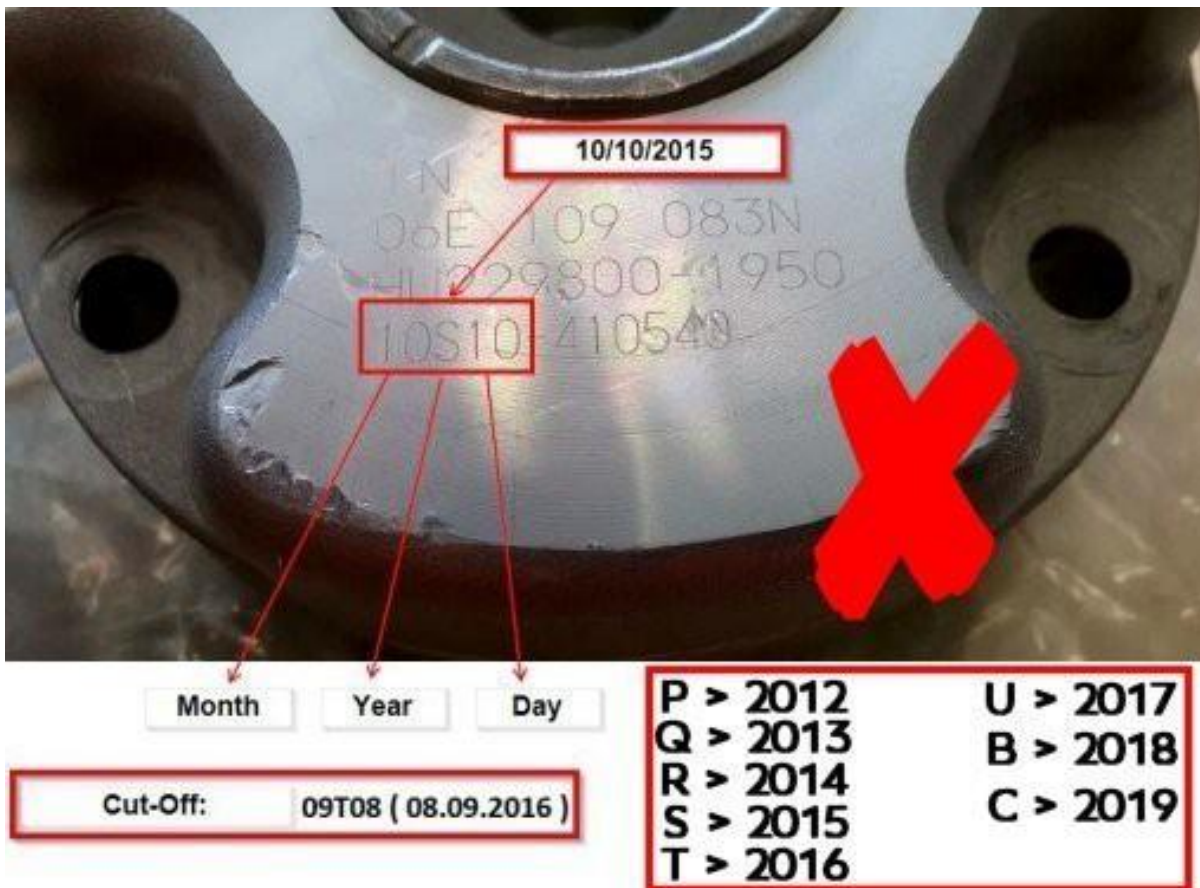
Internal failure of Inlet or Exhaust Camshaft Adjuster may result in Malfunction Indicator Lamp illumination and DTC's stored within the ECM.

Modified locking pin within the Camshaft Adjuster introduced 08.09.2016.

- Check the date code marked on each of the four Camshaft Adjusters, any found to be prior to 8/9/2016 (Date code 09T08) - Figure 1 - should be replaced. When changing a Camshaft Adjuster the relevant Camshaft Control Valve should also be replaced.
- Camshaft adjusters later than date code 8/9/2016 (09T08) do not need to be changed – Figure 2 - unless the fault code stored is specifically for that particular Camshaft Adjuster.
