## Technical product information

<b>Topic</b>	Convertible hood cannot close - Temporary repair solution - Header trim flap eyelet broken
<b>Market area</b>	Bentley: worldwide (2WBE)
<b>Brand</b>	Bentley
<b>Transaction No.</b>	2060120/1
<b>Level</b>	EH
<b>Status</b>	Approval
<b>Release date</b>

### New Continental GTC

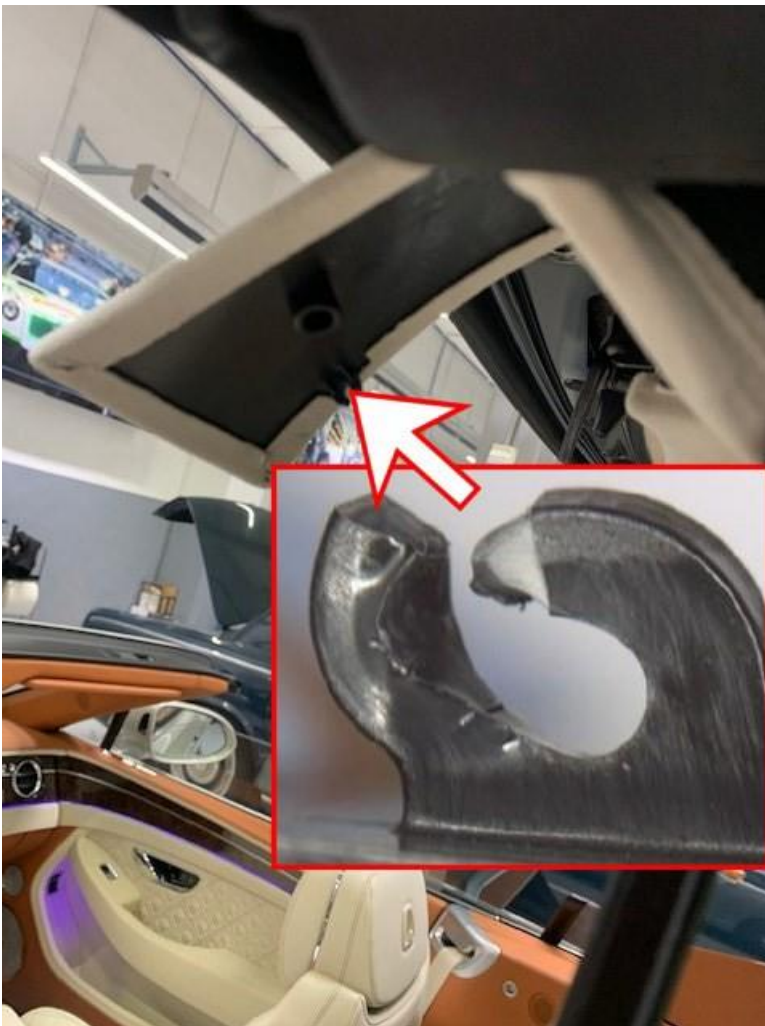
Figure 1

Convertible hood cannot close/latch due to a broken eyelet. The eyelet is part of the header trim flap (Figure 1)

Should the issue be as shown in Figure 1, please refer to the two possible temporary repair options within the Technical background section

*Option 1* - Manually assist the flap to allow the hood to fully close and latch as shown in the video within the Bentley Hub reference TPI 2060120/-

*Option 2* - Remove the affected flap assembly from the header trim panel **NOTE:** The convertible hood can be used as normal in this scenario although the flap assembly is removed

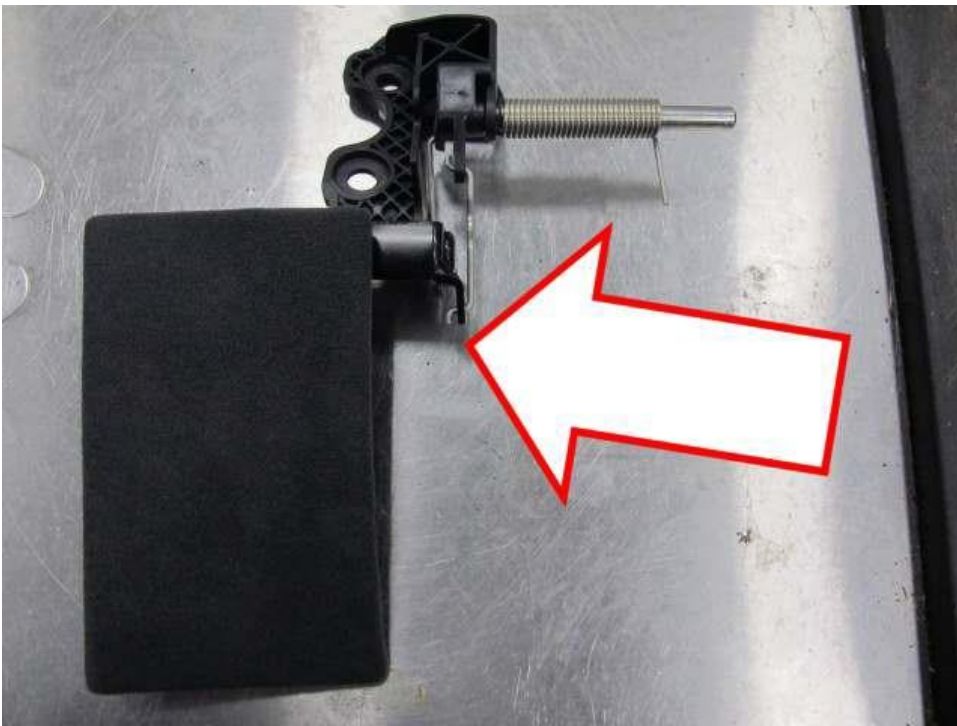
Figure 8

- The removed assembly should be as shown (Figure 8)

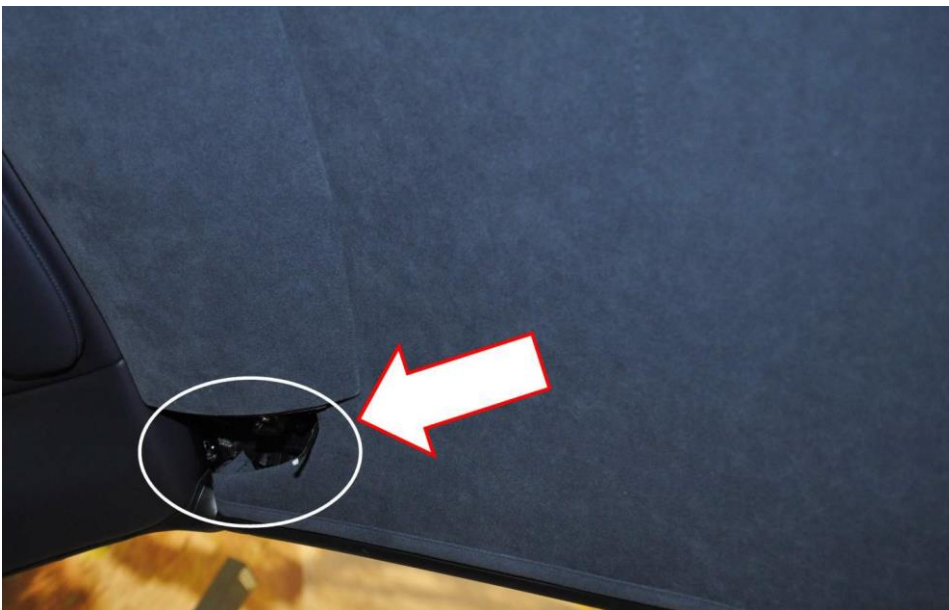
7) The header trim panel can now be refitted - Refer to Rep.Gr 61 – Once refitted the header trim panel gap will be as shown in Figure 9
