Technical product information

Topic	New Continental GT and GTC - Rear quarter glass not fully
Market area	United States E05 Bentley USA and rest America (6E05)
Brand	Bentley
Transaction No.	2060079/1
Level	EH
Status	Approval
Release date

New Continental GT and GTC

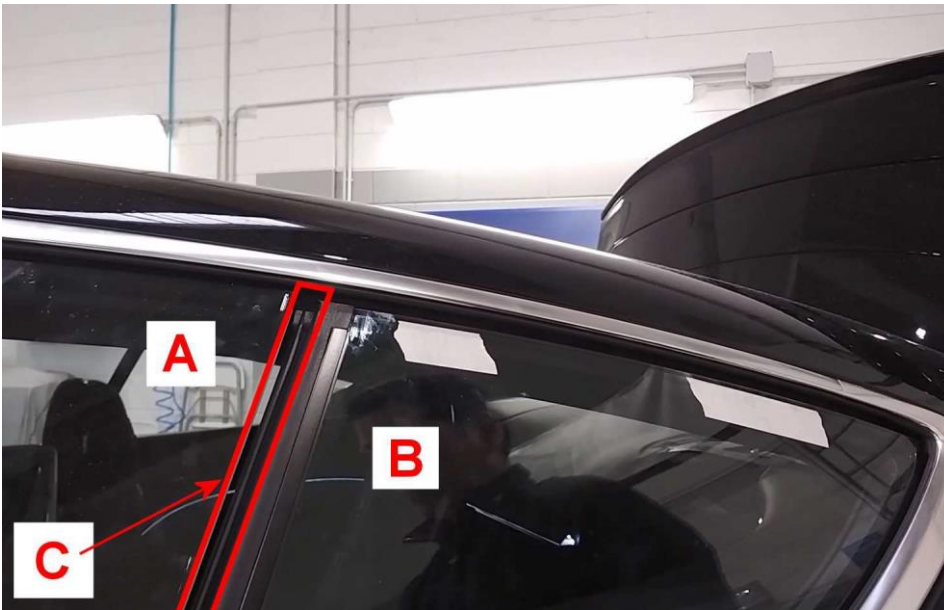
During window and/or door close operation, the front door drop glass closes and seals (Point A) however, the rear quarter glass does not fully close and seal (Point B) leaving a gap between the front and rear glass (Point C) – Figure 1.

All vehicles from VIN SCBCG13S5LC081983 have the latest level of software installed at the time of production
