Technical product information

Topic	Transmission communication DTC's (Numerous)
Market area	Bentley: worldwide (2WBE)
Brand	Bentley
Transaction No.	2059068/2
Level	EH
Status	Approval
Release date

New Continental GT and New Continental GTC

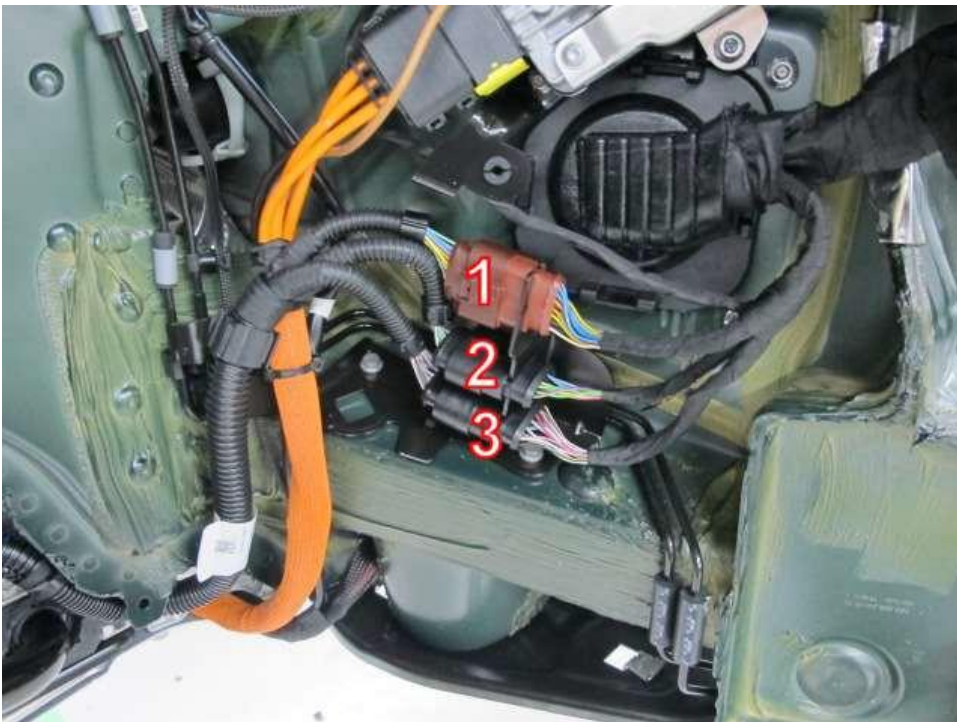
-
- Ensure the ignition is switched off for the duration of this procedure
- 1) Remove the left hand front wheel arch liner - Refer to Repair manual Rep.Gr 66
- 2) Gain access and disconnect the transmission control module plug T58g - Refer to Repair manual Rep.Gr 37
 - Referring to Figure 2 and the applicable current flow diagram - Disconnect the three connections
- 3) Once disconnected carry out pin/terminal grab checks on all male and female connections (All three connections)

The male connections of the plugs shown in Figure 2

6) Should any issues be found on either end of the link harness, the link harness should be replaced.

Please raise a DISS query and await feedback before carrying out any further work

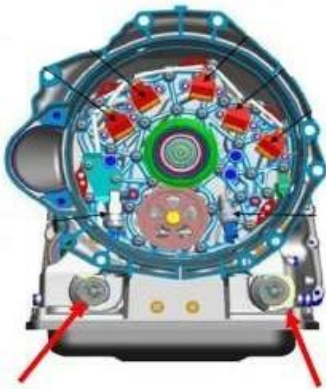
Figure 4

5) Disconnect the connections (Figure 4 - Arrows) from the Mechatronic unit for dual clutch gearbox -J743-

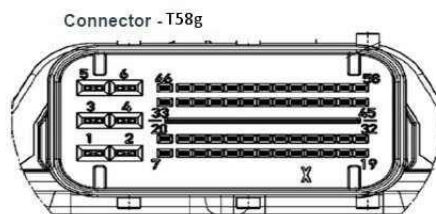
Referring to the applicable current flow diagram and Figure 5 and 6- Carry out resistance and pin/terminal grab checks on all disconnected connections from the T58g connector to T20ch and T20ci on the harness.

Check T58g to connector T20ci

Connector T58g		Connector T20ci	Resistance
PIN 1	∞	PIN 4	0.4
PIN 3	∞	PIN 2	0.2
PIN 4	∞	PIN 3	0.5
PIN 6	∞	PIN 1	0.4
PIN 9	∞	PIN 8	0.4
PIN 10	∞	PIN 6	0.1
PIN 11	∞	PIN 10	0.3
PIN 12	∞	PIN 20	0.3
PIN 13	∞	PIN 13	0.5
PIN 16	∞	PIN 17	0.4
PIN 22	∞	PIN 5	0.4
PIN 23	∞	PIN 7	0.4
PIN 24	∞	PIN 9	0.4
PIN 25	∞	PIN 11	0.4
PIN 26	∞	PIN 12	0.4
PIN 27	∞	PIN 14	0.4
PIN 29	∞	PIN 16	0.5

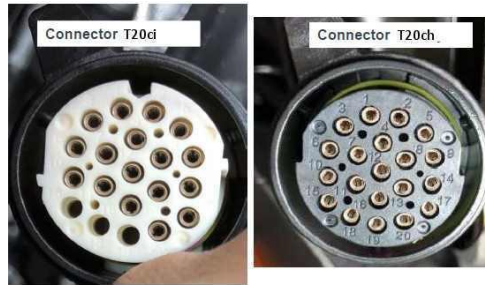
Figure 6

Connector T20ci	Resistance
PIN 1	to PIN 5 5.1
PIN 1	to PIN 7 5.3
PIN 2	to PIN 6 5.2
PIN 2	to PIN 20 5.3
PIN 3	to PIN 8 5.3
PIN 3	to PIN 9 5.3
PIN 3	to PIN 10 5.3
PIN 3	to PIN 12 10.9
PIN 3	to PIN 13 1.1
PIN 3	to PIN 14 1.1
PIN 4	to PIN 11 5.3
PIN 16	to PIN 17 1800

Connector T58g	Power supply	Resistance
PIN 2	to Ground	0.2
PIN 5	to Fuse box 5K 20A	0.2
PIN 55	to TV48	0.3
