Technical Service Bulletin

SUBJECT:	_		No:	TSB-20-51-002	
Roof Rack Center Cover				July 2020	
			MODEL: Cross	2018-2019 Eclipse	
CIRCULATE TO:	[] GENERAL MANAGER	[X] PARTS MANAGER	[[X] TECHNICIAN	
[X] SERVICE ADVISOR	[X] SERVICE MANAGER	[X] WARRANTY PROCESSO	OR [[] SALES MANAGER

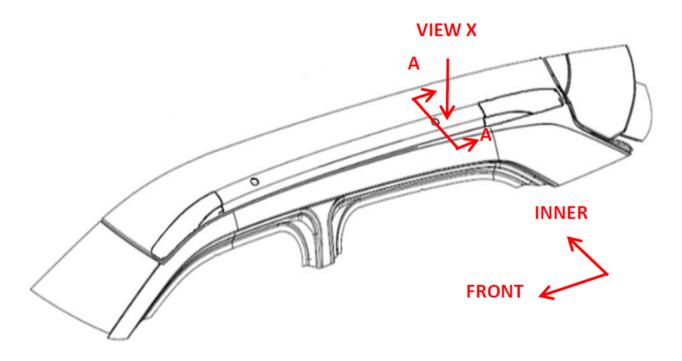
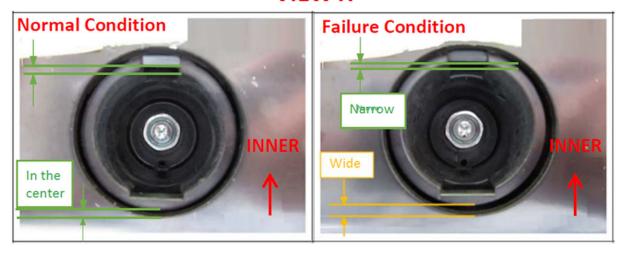
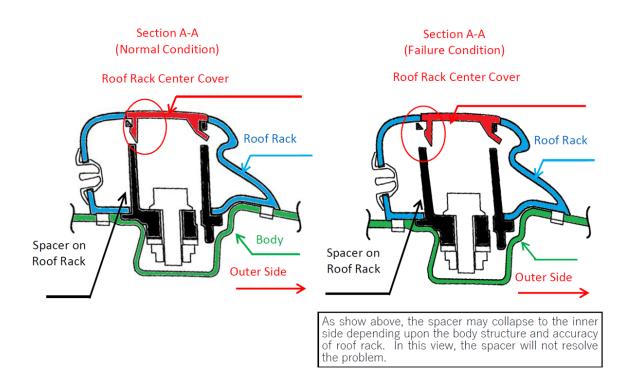
2. Failure Condition:

A customer may report a condition in vehicles equipped with a roof rack cover and roof rack; where the rearward roof rack center cover will loosen and possibly fall off. The cover and roof rack clip do not properly fit due to the contour of the vehicle and roof rack. The integrity of the roof rack itself is not at risk.

There is a possibility that the roof rack center cover will fall off of the vehicle due to the body structure of the vehicle and roof rack. The integrity of the roof rack itself is not at risk.

This TSB instructs dealers to slant and change the form of the bottom rearward roof rack spacer in order to absorb the difference in contours.

Please remove the roof rack, modify the spacer and re-install the roof rack according to the procedure below.
