SERVICE BULLETIN

Classification: EL20-017	Reference: NTB20-048	Date: July 7, 2020
-----------------------------	-------------------------	-----------------------

2020 ALTIMA; BLIND SPOT WARNING AND/OR REAR CROSS TRAFFIC ALERT NOT FUNCTIONING PROPERLY

APPLIED VEHICLES: 2020 Altima S with Driver Assist (L34)
2020 Altima SR (L34)

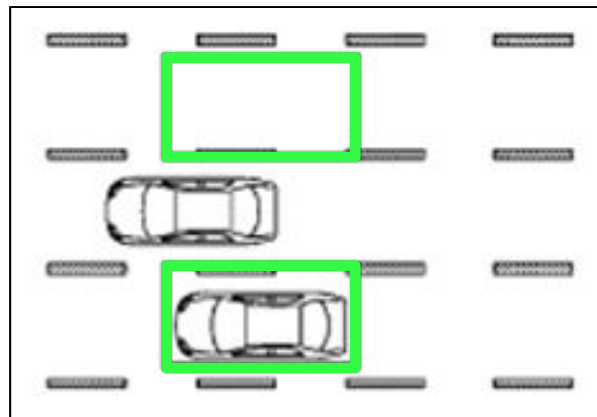
Figure 1

- The customer states the Blind Spot Warning indicator does not illuminate while driving when there is a vehicle in one of the detection zones (outlined in green in Figure 1).

- The customer states the Rear Cross Traffic Alert indicator does not illuminate while in reverse and a car is approaching the side of the vehicle near the rear bumper.

1. Confirm the current ICC/ADAS 2 part number.
2. Reprogram the ICC/ADAS 2 and perform the blind spot warning action test, if applicable.

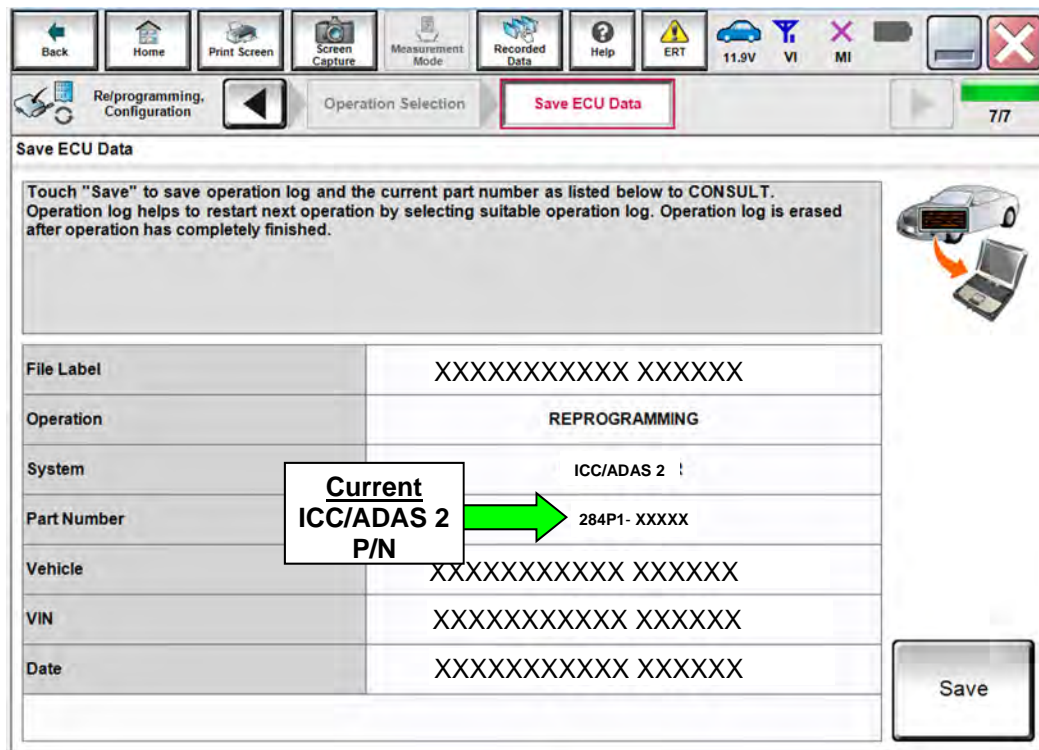
Figure 10

20. When you get to the screen shown in Figure 10, confirm that a reprogram is available as follows.

- A. Find the ICC/ADAS 2 **Part Number** and write it on the repair order.

B. Compare the P/N you wrote down to the numbers in the **Current ICC/ADAS 2 Part Number** column in **Table A**.

- If there is a match, continue with the reprogramming procedure.
- If there is a not a match in **Table A**, this bulletin does not apply. See the ESM (Electronic Service Manual) for further diagnostic information.

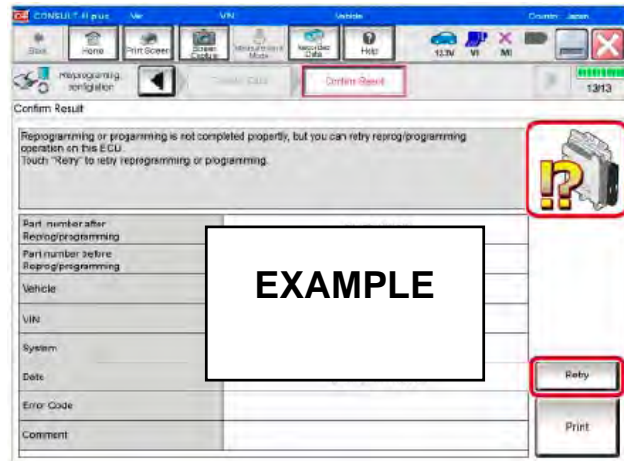
Figure 22

If reprogramming does not complete and the “!?” icon displays as shown in Figure 22:

- Check battery voltage (12.0 - 15.5 V).
- Ignition is ON, engine OFF.
- External Bluetooth® devices are OFF.
- **All** electrical loads are OFF.
- **Select retry and follow the on screen instructions.**
- **“Retry” may not go through on first attempt and can be selected more than once.**

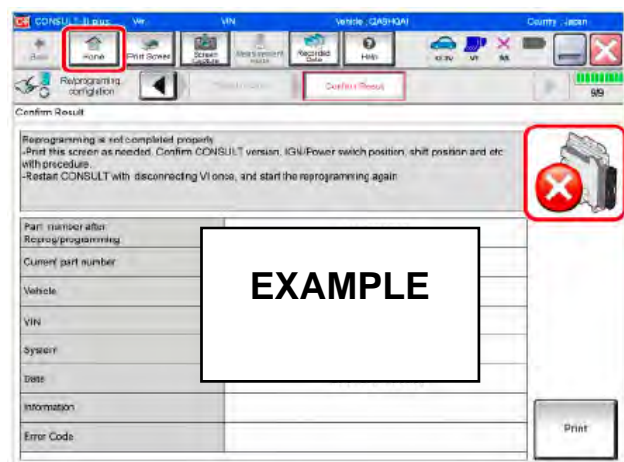
Figure 23

If reprogramming does not complete and the “X” icon displays as shown in Figure 23:

- Check battery voltage (12.0 - 15.5 V).
- CONSULT A/C adapter is plugged in.
- Ignition is ON, engine OFF.
- Transmission is in Park.
- All C-III plus / VI cables are securely connected.
- All C-III plus updates are installed.
- **Select Home, and restart the reprogram procedure from the beginning.**
