## CAMPAIGN BULLETIN LED Headlamp Dealer Inventory

Reference: PC747

Date: July 31, 2020

# PC747 - 2019 TITAN LED HEADLAMP INSPECTION

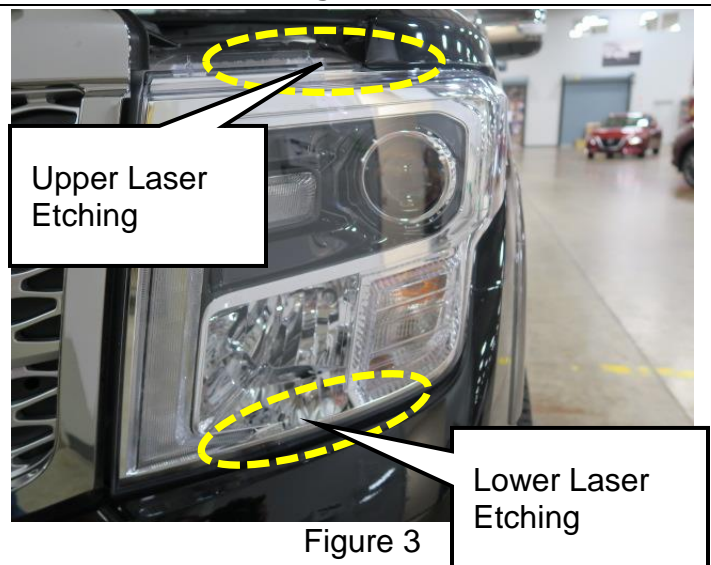
Figure 3

2. Locate the two areas for inspection on the driver side (Left) LED headlamp (Figure 3).
  - Upper laser etch marking
  - Lower laser etch marking

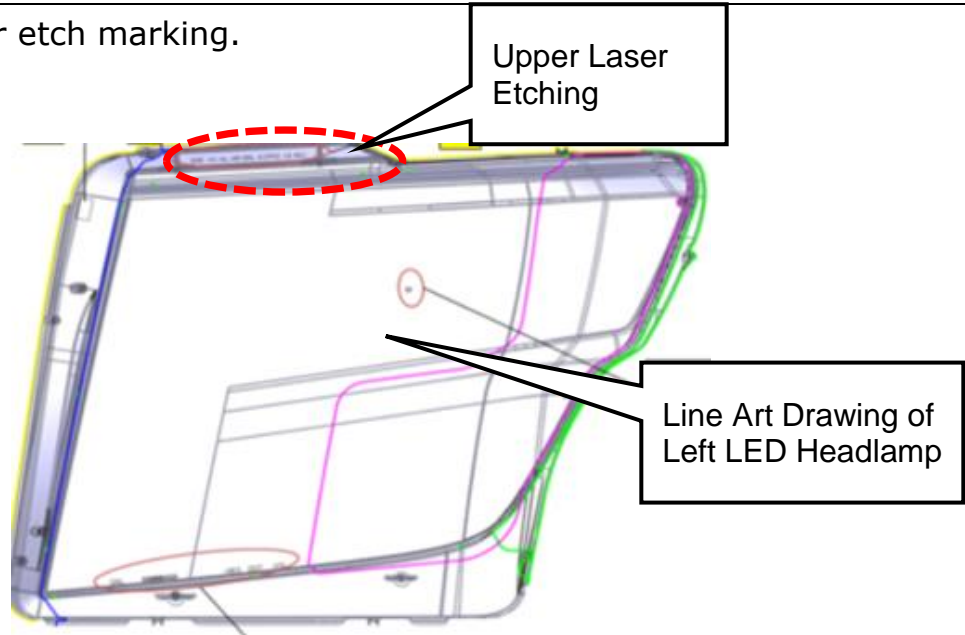
Figure 4

3. Inspect upper laser etch marking.

**CORRECT ETCH MARK (Blank)**

**INCORRECT ETCH MARK (H11)**

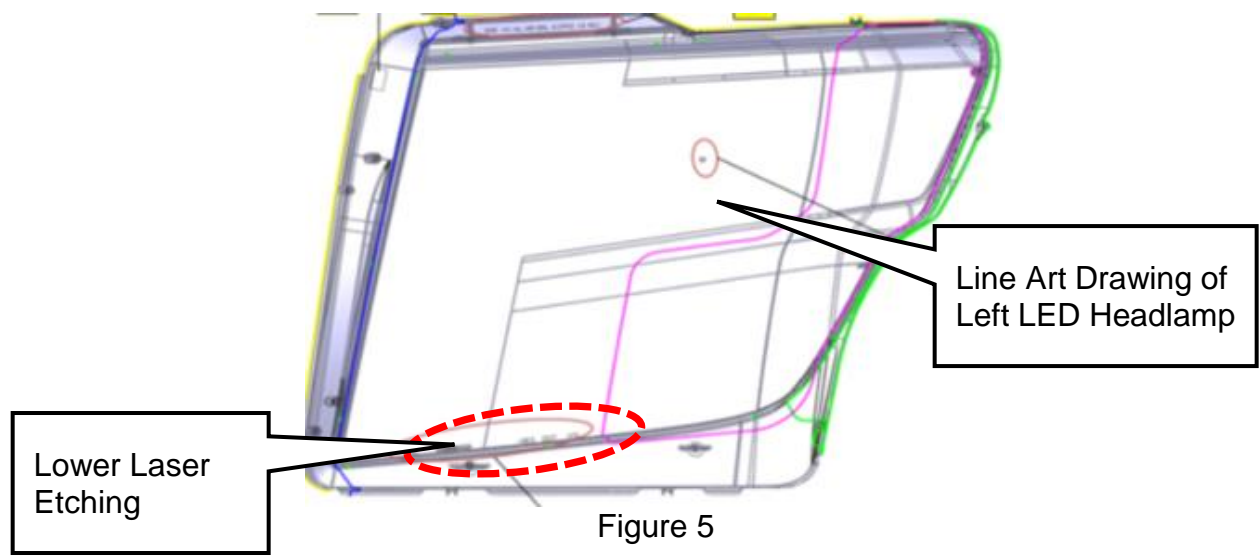
Figure 5

4. Inspect lower laser etch marking.

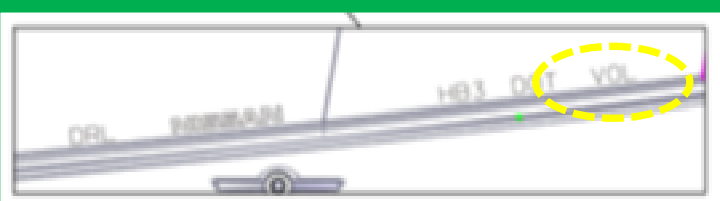
**CORRECT ETCH MARK (VOL)**

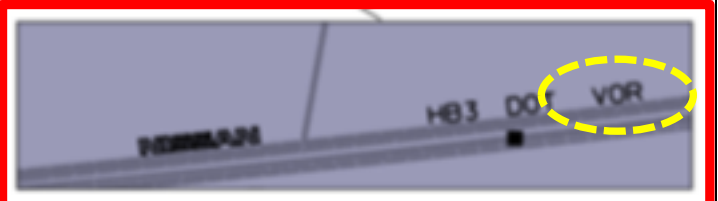
**INCORRECT ETCH MARK (VOR)**

7. If any of the headlamp etching marks has an inspection result of Incorrect, then **do not submit a Warranty claim.**

A. Continue to Hold the vehicle.

B. Send an E-mail identifying which headlamp has the incorrect etching marks to:
